## **APPENDIX D**

### **LATEST AVAILABLE BRIDGE REPORTS**

## BRIDGE RE-EVALUATION SURVEY REPORT

STATE STRUCTURE NO. 13000W7  
COUNTY STRUCTURE NO. W7  
GREEN AVENUE OVER DEBBIES CREEK  
Brielle Borough  
MONMOUTH COUNTY

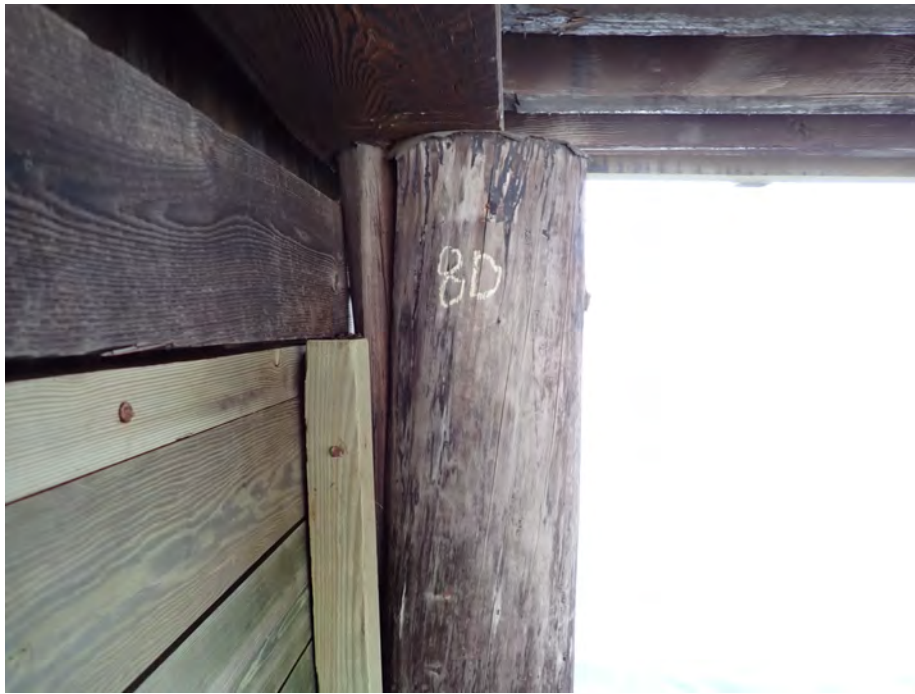
| Photo 9 | Category: | 60 - Priority Repair , 30 - Abutments |

| | Description: | South abutment, Pile 2W, looking west. Priority 1: Pile is split up to 2.5" wide at the top for 3LF. (2023). Note the pile cap does not rest fully on the pile. |

Priority 1 (Recall): Install full height structural jackets on timber piles and replace the wale and sheeting at the northeast wingwall. (PR1\_2021\_13949)

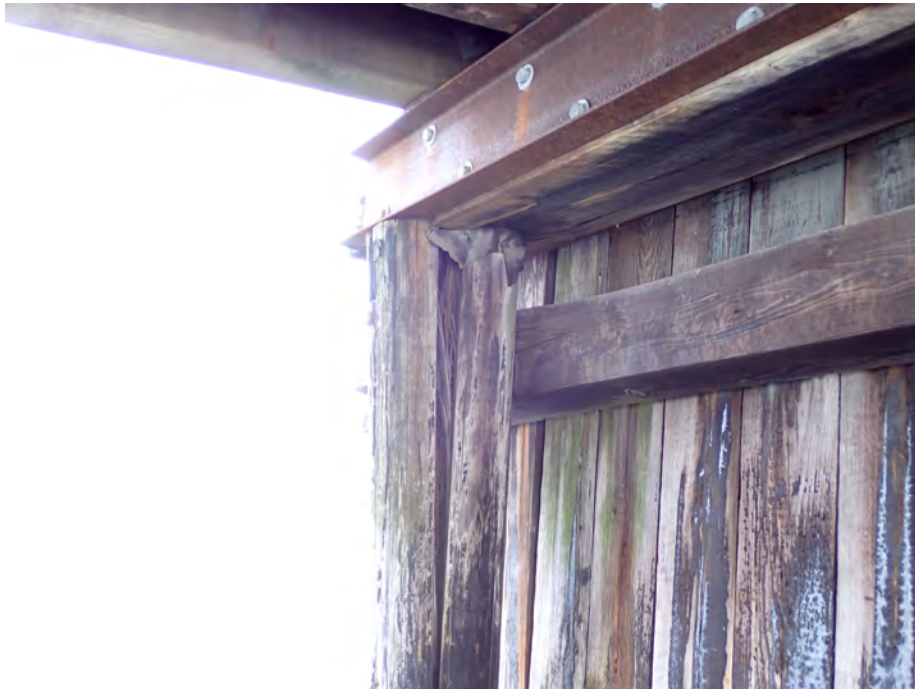
| Photo 10 | Category: | 30 - Abutments, 60 - Priority Repair |

| | Description: | North abutment, Pile 1W, looking northwest. Priority 1: Pile is split up to 2.5" wide at the top for 5LF. (2023) |

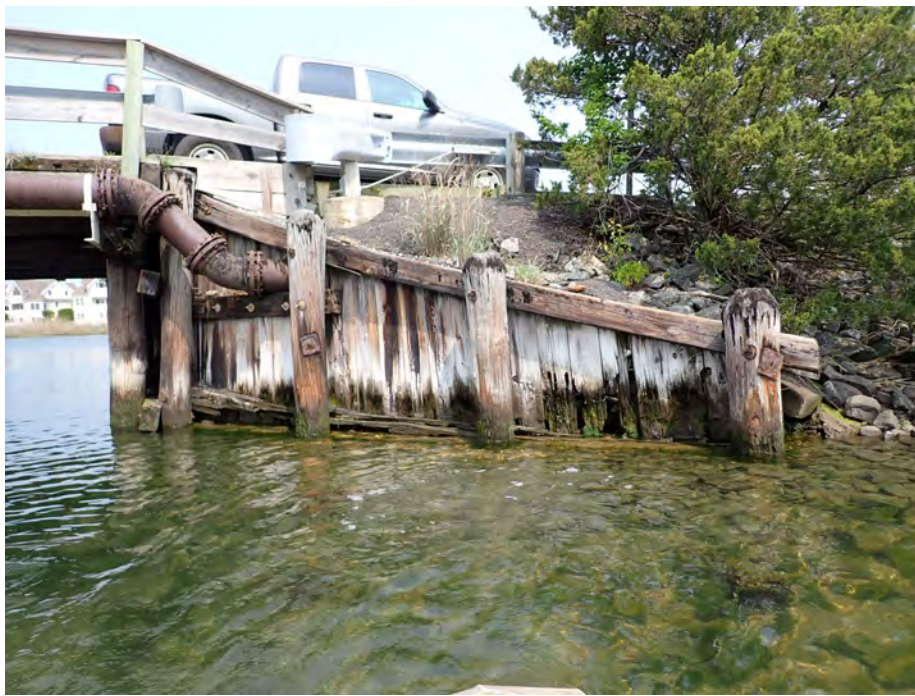
| Photo 11 | Category: | 31 - Wingwalls/Retaining Walls/Headwalls, 60 - Priority Repair |

| | Description: | Northeast wingwall, looking west. Priority 1: Advanced decay to sheeting with up to 100% section loss at the bottom between Piles 1 to 4 and severely deteriorated/decayed with up to 100% section loss to bottom wale. (2023) |

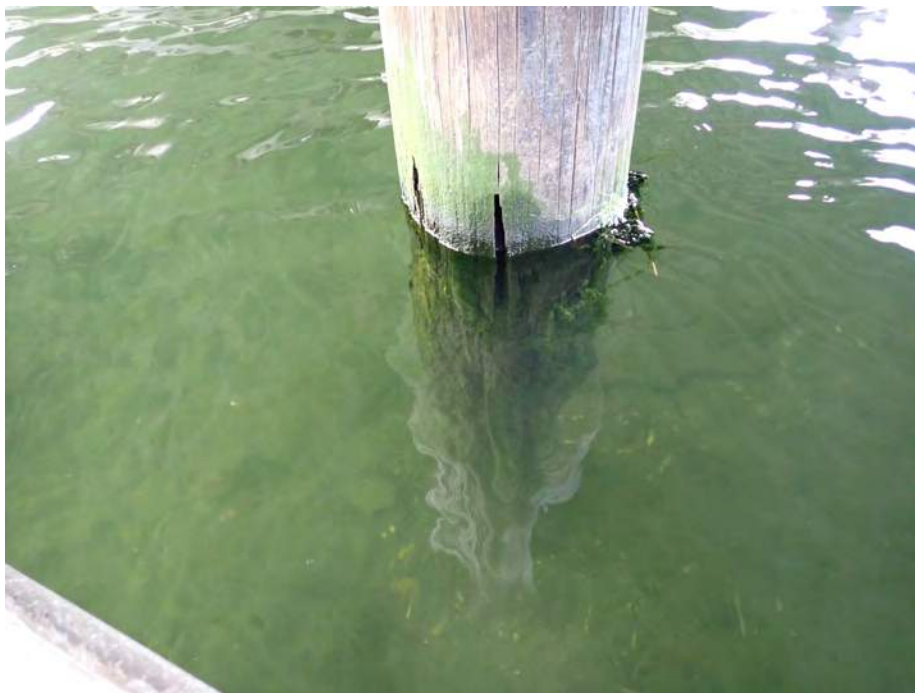
| Photo 12 | Category: | 60 - Priority Repair , 35 - Pile Bent/Cap/Bracing/Foundation |

| | Description: | Pier 2S, Pile 3W, looking south. Priority 1: Section loss to base of pile. (2023) |

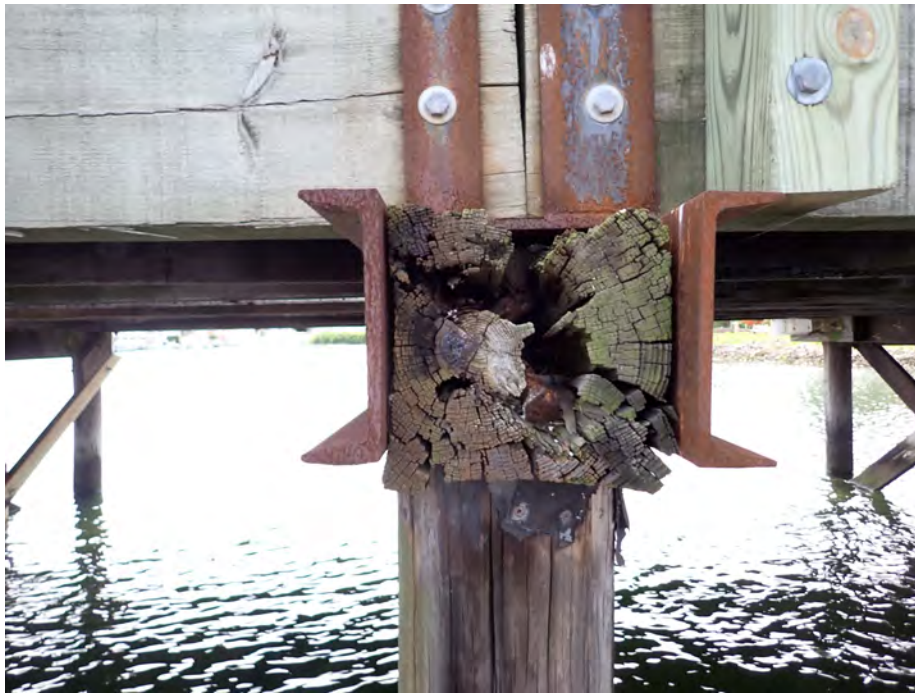
| Photo 13 | Category: | 35 - Pile Bent/Cap/Bracing/Foundation |

| | Description: | Pier 2S Cap, west end, looking east. Advanced decay with heart rot of 40% for 5'. Previous Work Done: Steel C-channel's have been bolted to both sides of timber cap and Stringer 1W replaced (all spans). (2023) |

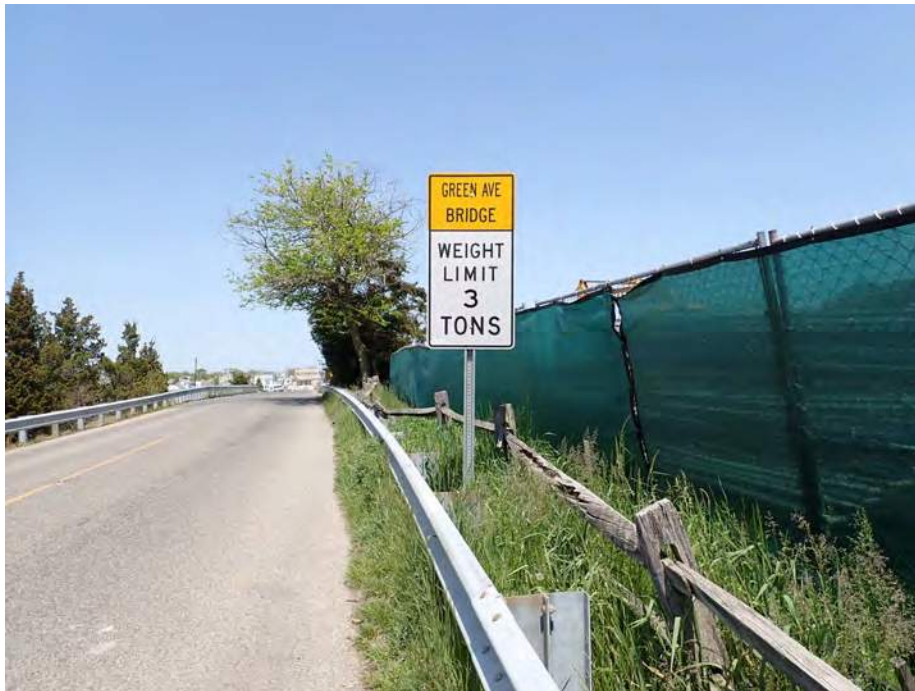
| Photo 14 | Category: | 61 - Work Done, 10 - Signs/Posting |

| | Description: | Southeast approach, looking north. Work Done: Posting sign added and updated to note it is for Green Ave. Bridge. (2023) |

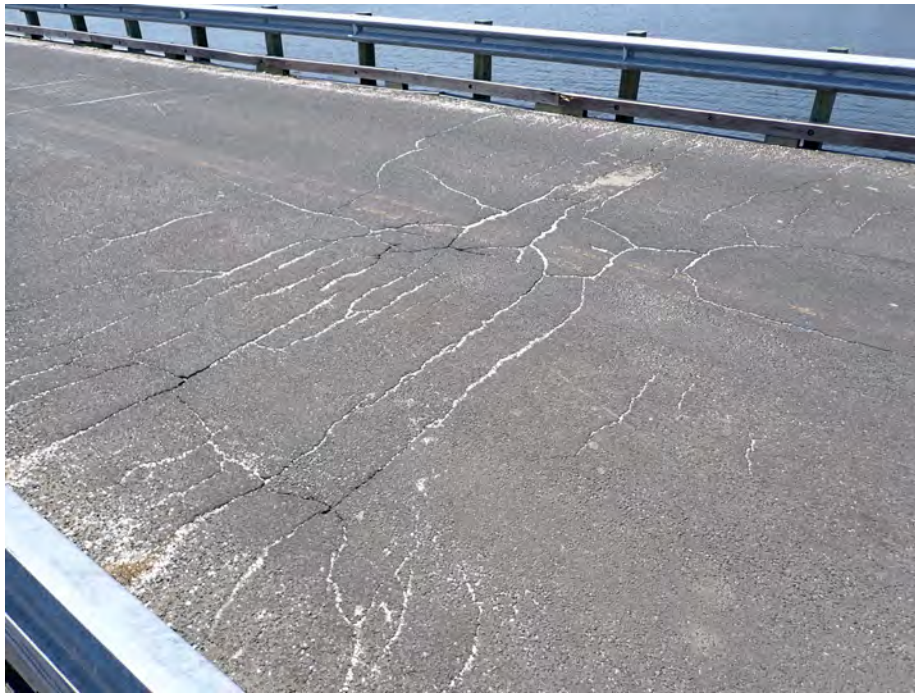
| Photo 15 | Category: | 01 - Deck Defects |

The deck is in satisfactory condition due to the wide transverse cracks throughout all spans, and the loose railing posts of the pedestrian railing. See Photo(s) 15, 16

| | Description: | Top of deck, Span 7S, looking southwest. Moderate wear and medium to wide transverse and longitudinal cracks throughout (typical all spans). |

| RATING | COMPONENT | REMARKS |
|---|---|---|
| 6 | Wearing Surface | Bituminous. ¼" wide transverse cracks throughout (85 LF). Mainly in the Southbound Lane.<br>[See Photo(s): 15] |

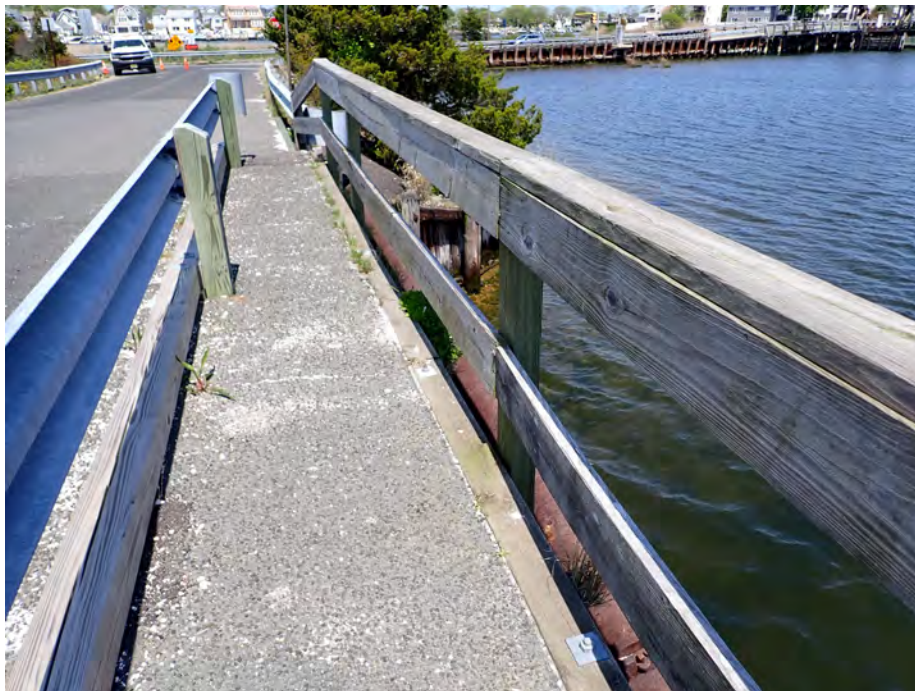
| Photo 16 | Category: | 06 - Parapets/Balustrades/Median/Railings |

| | Description: | Pedestrian railing, east side, looking north. Posts move due to decay at stringer connection. (Typical) |

| RATING | COMPONENT | REMARKS |
|---|---|---|
| 6 | Pedestrian Railing | Timber pedestrian railing on the east side. A few pedestrian railing posts exhibit movement due to decayed stringers.<br>[See Photo(s): 16] |

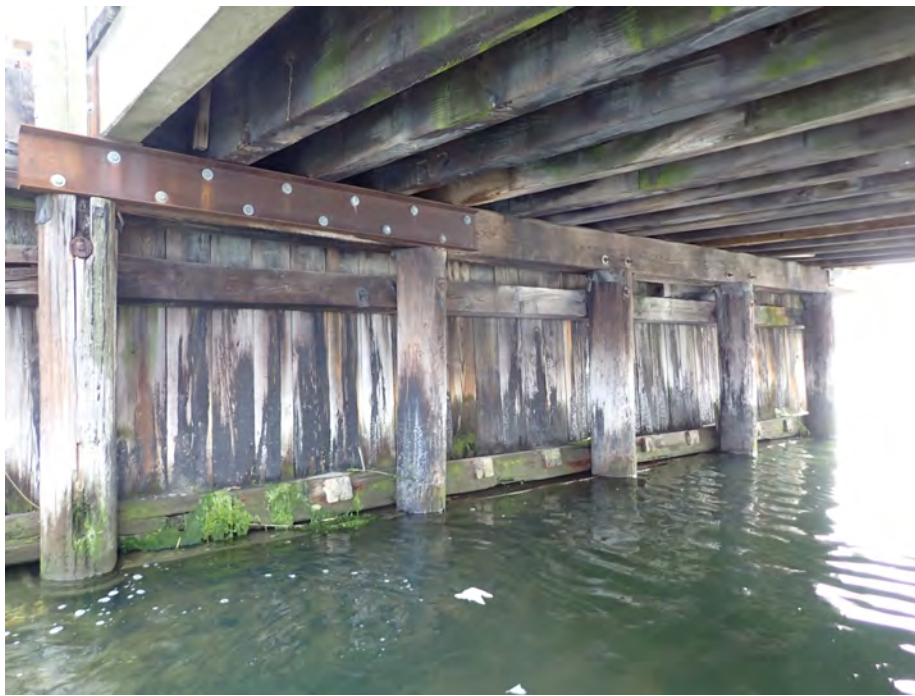
| Photo 17 | Category: | 30 - Abutments |

| | Description: | North abutment, looking northeast. Deteriorated sheeting. Note the steel channel bolted to the timber pile cap. |

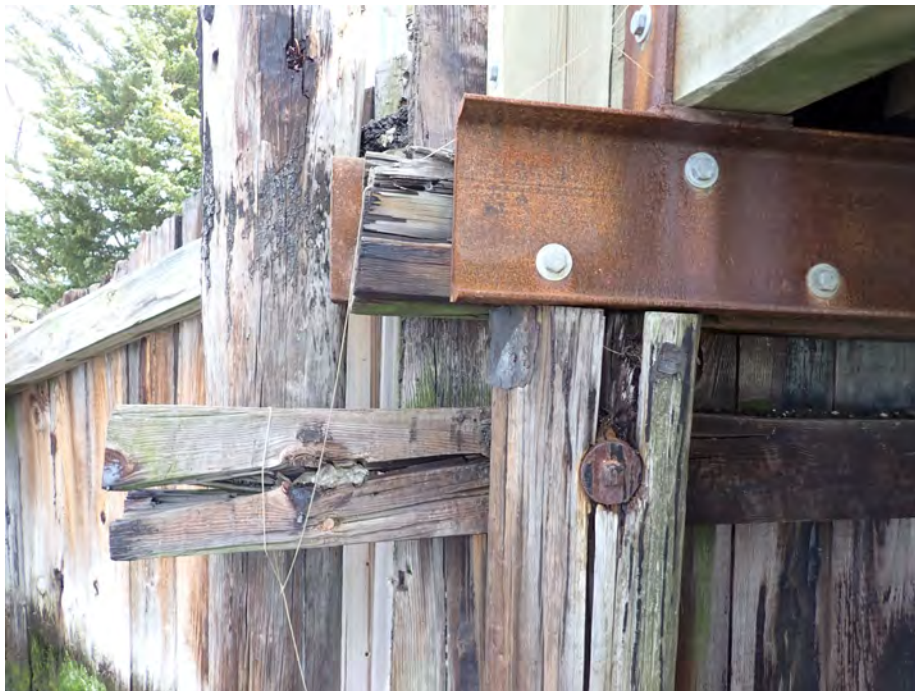
| Photo 18 | Category: | 30 - Abutments |

| | Description: | North abutment, west end of cap, looking north. Wide split and advanced decay with up to 30% section loss with bolted steel channel. Note wide split to the wale. |

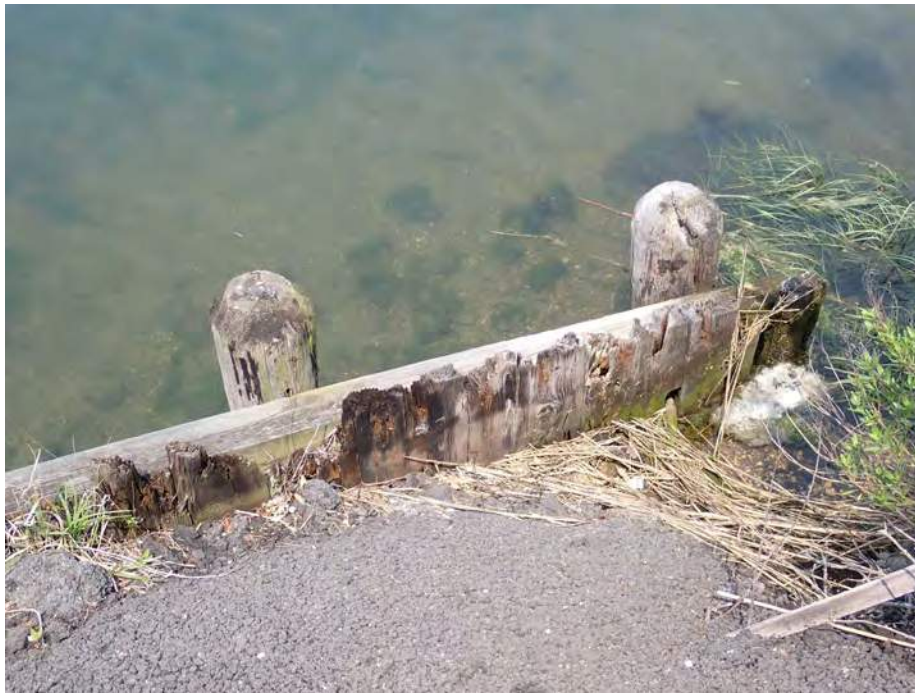
| Photo 19 | Category: | 31 - Wingwalls/Retaining Walls/Headwalls |

| | Description: | Northwest wingwall, looking west. Advanced decay to top of sheeting. |

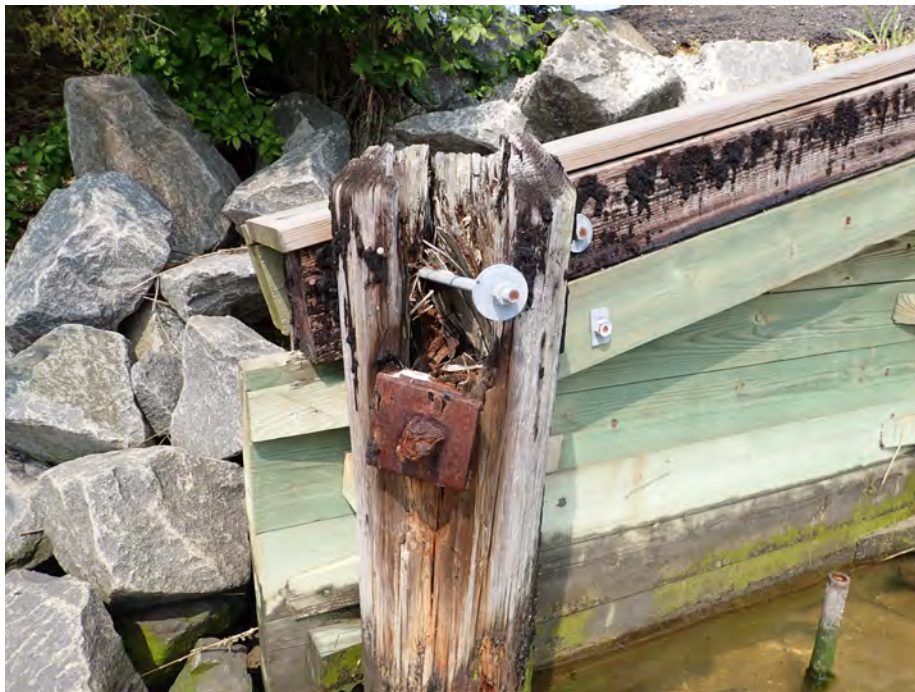
| Photo 20 | Category: | 31 - Wingwalls/Retaining Walls/Headwalls |

| | Description: | Southeast wingwall, Pile P4 from bridge, looking southwest. Advanced decay and heart rot (42" dp.) at the top and corrosion to tie rod plate. |

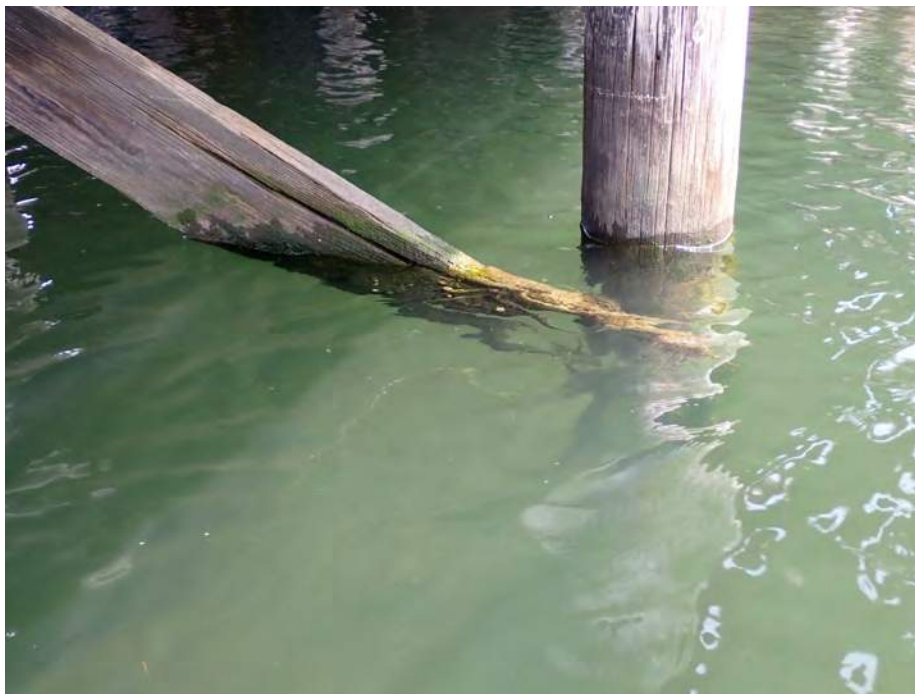
| Photo 21 | Category: | 35 - Pile Bent/Cap/Bracing/Foundation |

| | Description: | Pier 6S, cross bracing connection at Pile 5W, looking north. Advanced decay with 80% section loss and detached from pile. |

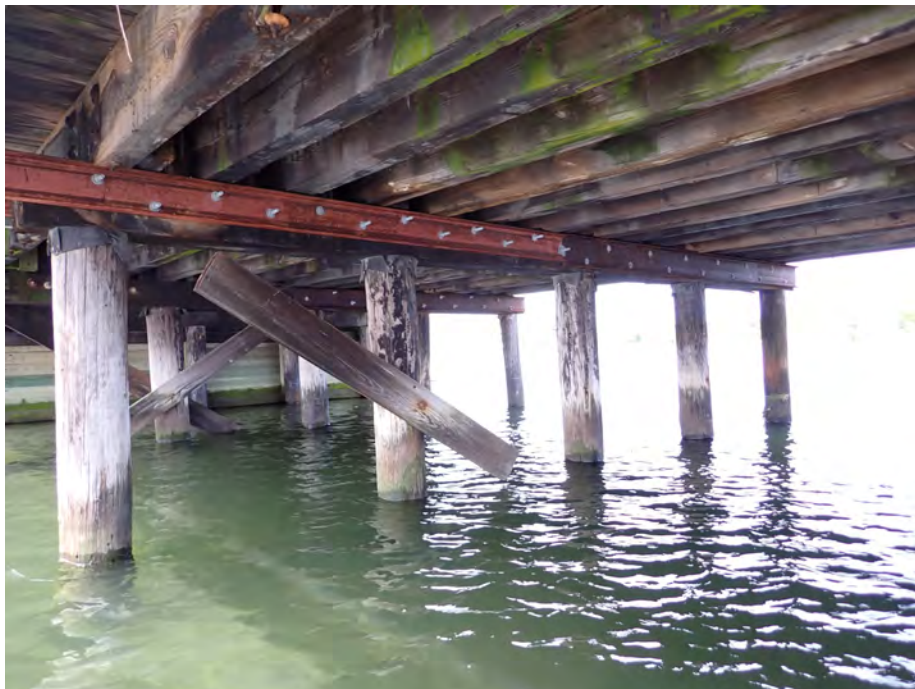
| Photo 22 | Category: | 35 - Pile Bent/Cap/Bracing/Foundation |

| | Description: | Pier 2S, cross bracing, looking southwest. Missing cross bracing and fine to medium checks in piles. |

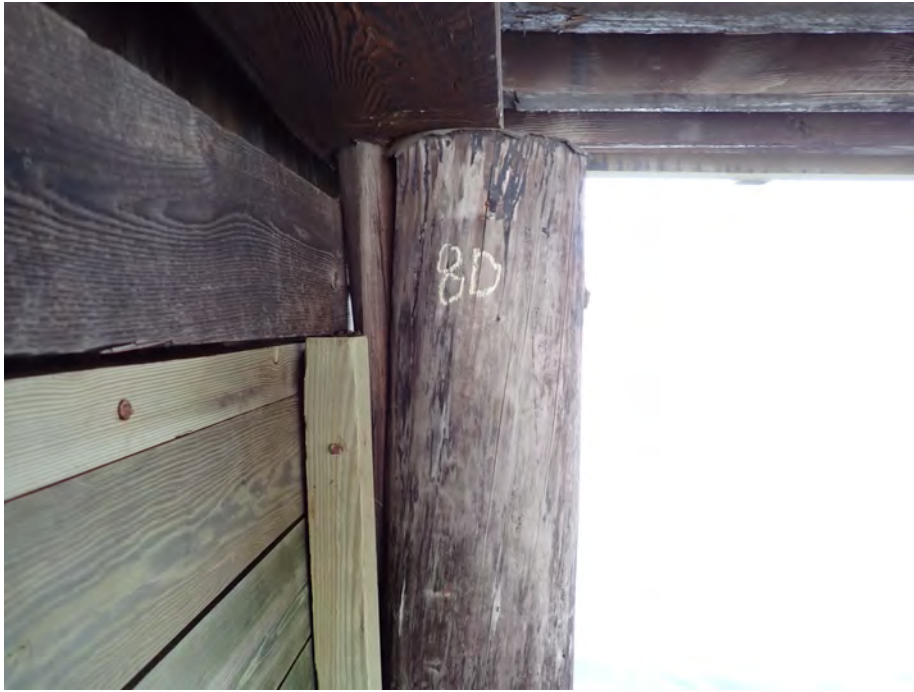
| Photo 2 | Category: | 30 - Abutments, 60 - Priority Repair |

| | Description: | South abutment, Pile 2W, looking west. Priority 1: Pile is split up to 2.5" wide at the top for 3LF. (2023). Note the pile cap does not rest fully on the pile. |

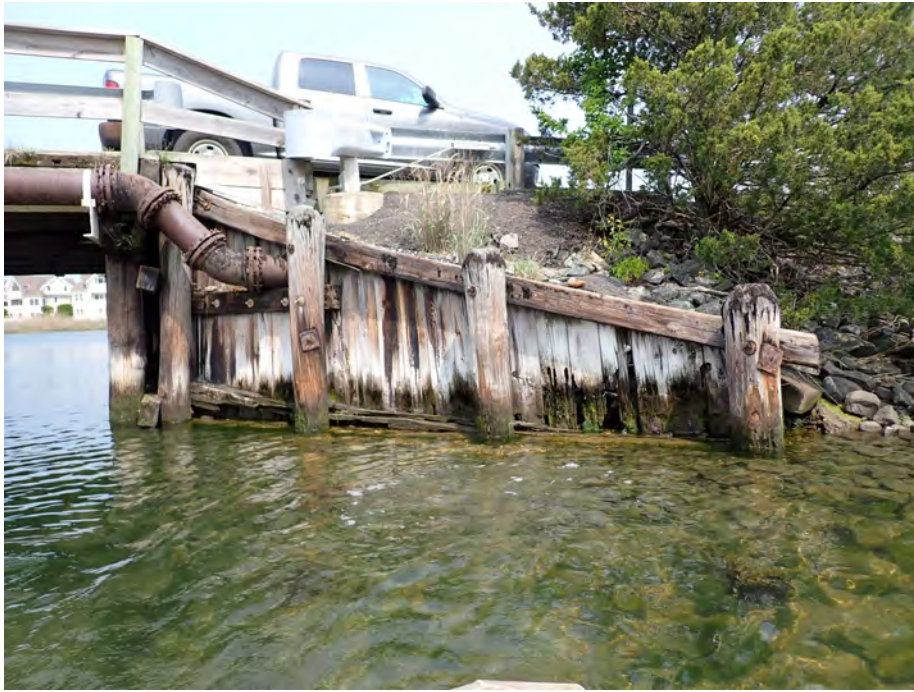
| Photo 4 | Category: | 31 - Wingwalls/Retaining Walls/Headwalls, 60 - Priority Repair |

| | Description: | Northeast wingwall, looking west. Priority 1: Advanced decay to sheeting with up to 100% section loss at the bottom between Piles 1 to 4 and severely deteriorated/decayed with up to 100% section loss to bottom wale. (2023) |

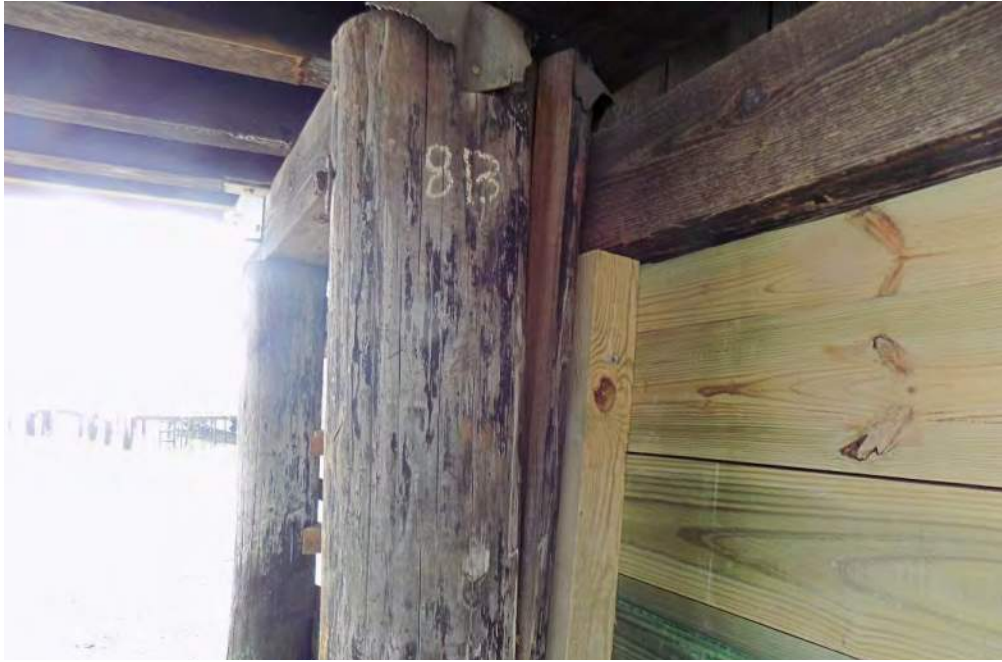
| | | <p><b>Photo No: UW-05</b></p> |

| <b>Location:</b> | South abutment, Pile W4, looking southeast. | |
| <b>Description:</b> | Pile is split up to 2.5" wide at the top for 5 LF high. ( <a href="#">See Priority 1 Repair</a> ) | |

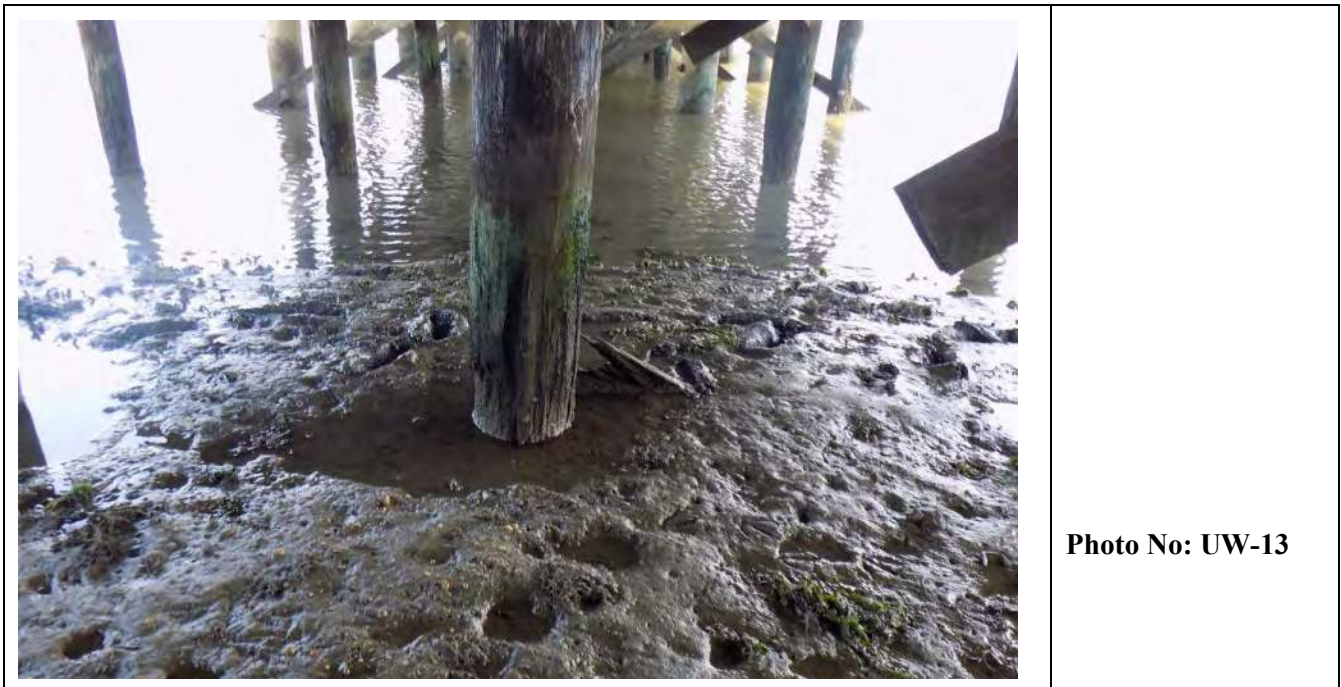
| <b>Location:</b> | Pier 1 (from south), pile W3, looking north. |
| <b>Description:</b> | Typical condition of the timber piles and cross bracing. Note the checking and decay throughout the timber members. Also note the detached lower connection hardware. |

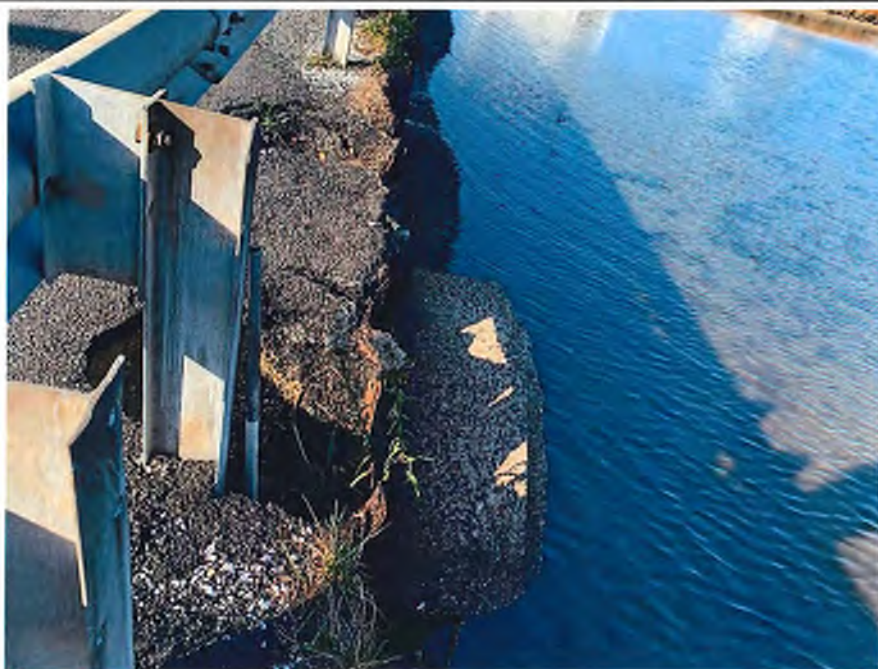
| Photo 8 | Category: | 60 - Priority Repair , 50 - Culverts/Frames/Arches, 51 - Erosion |

| | Description: | West end of culvert, looking south.<br>Note: Heavy erosion has been noted above west end of pipe. (Refer to Priority Repair Letter 2_2022_16941) |

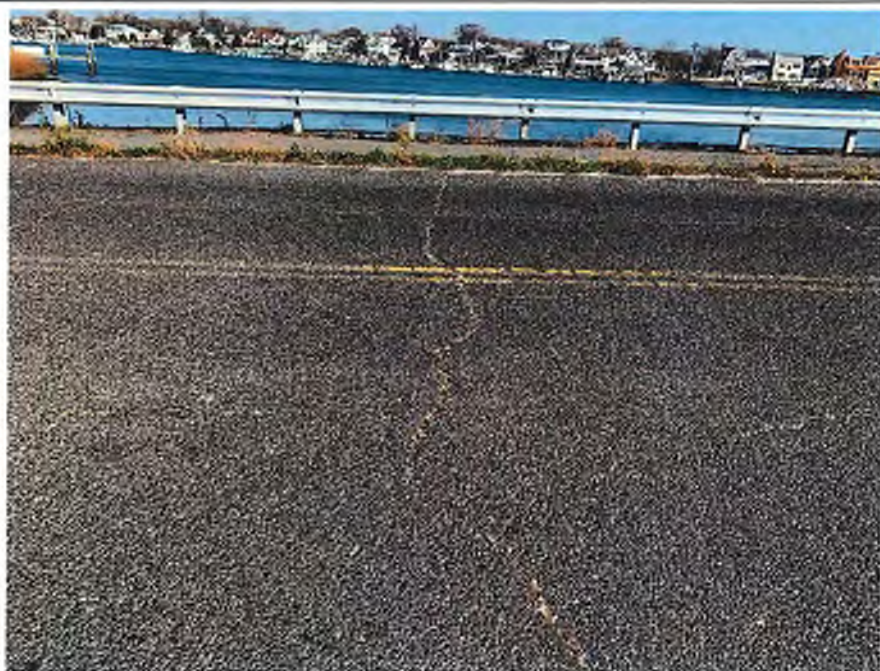
Photo 9

Description: Roadway looking west. Note Wide transverse crack with vegetation growth above the arch.

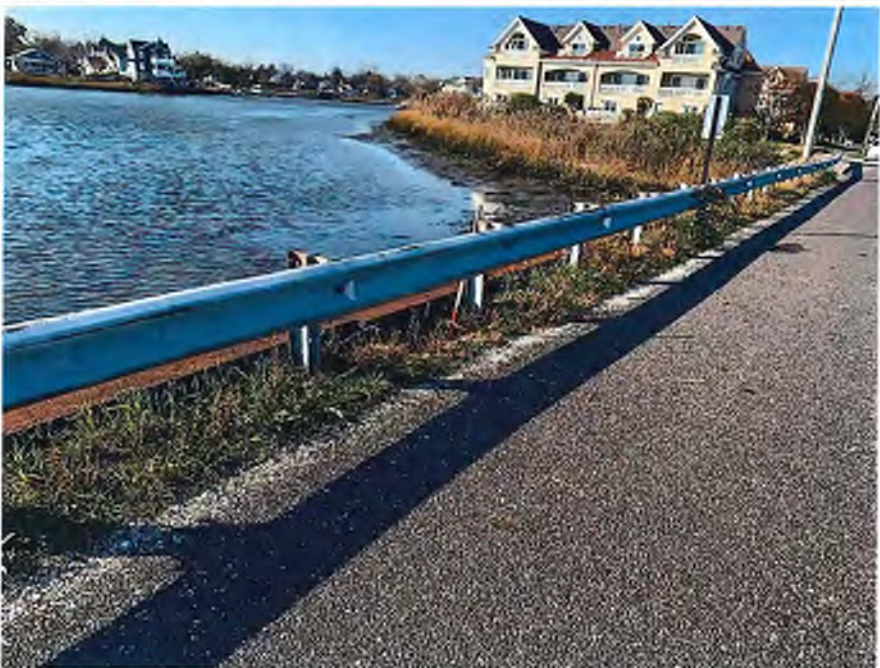
Photo 10

Description: Roadway looking southeast.  
Note: The deteriorated east timber curb with checks.

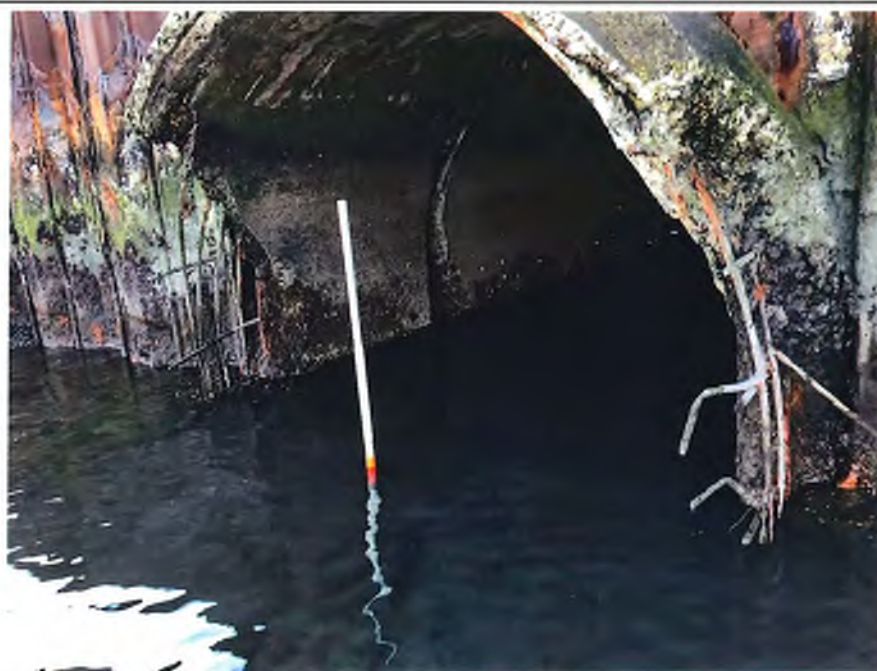
| Photo 11 | Category: | 50 - Culverts/Frames/Arches |

| | Description: | West end of arch, looking northeast. Note 100% loss of concrete with exposed corroded cage from mud line up to 4' high. |

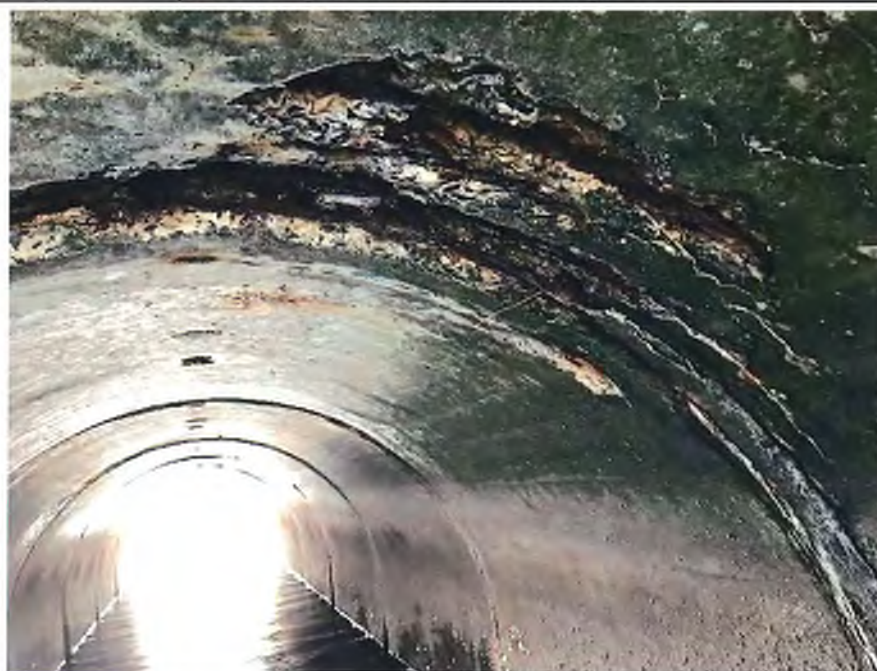
| Photo 12 | Category: | 50 - Culverts/Frames/Arches |

| | Description: | Joint 1 from west, looking southeast. Note 8 SF spall with exposed corroded rebar that exhibits heavy section loss. |

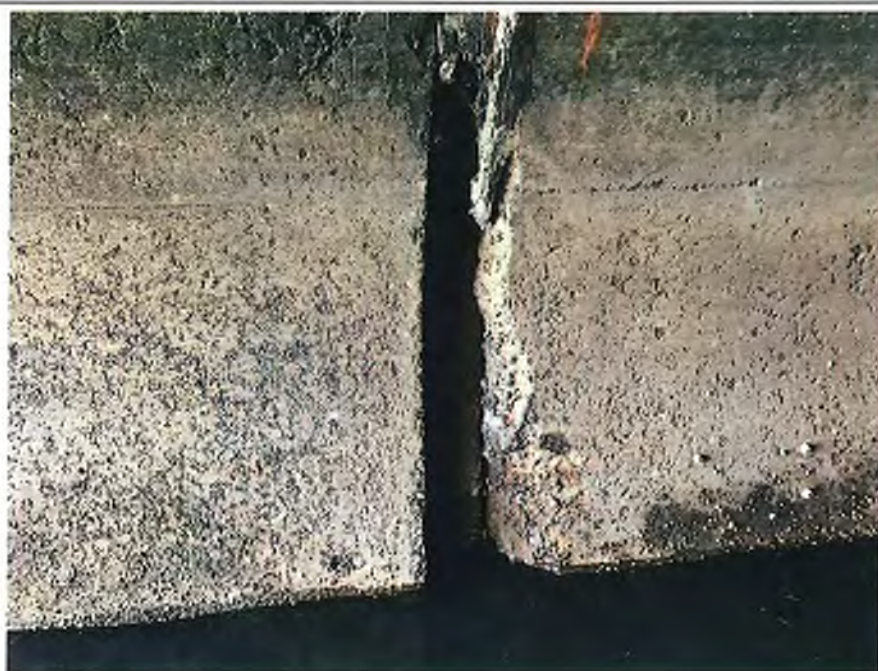
| Photo 13 | Category: | 50 - Culverts/Frames/Arches |

| | Description: | Segment 4, joint 4 looking north. 4 SF spall with exposed corroded rebar that exhibits heavy section loss |

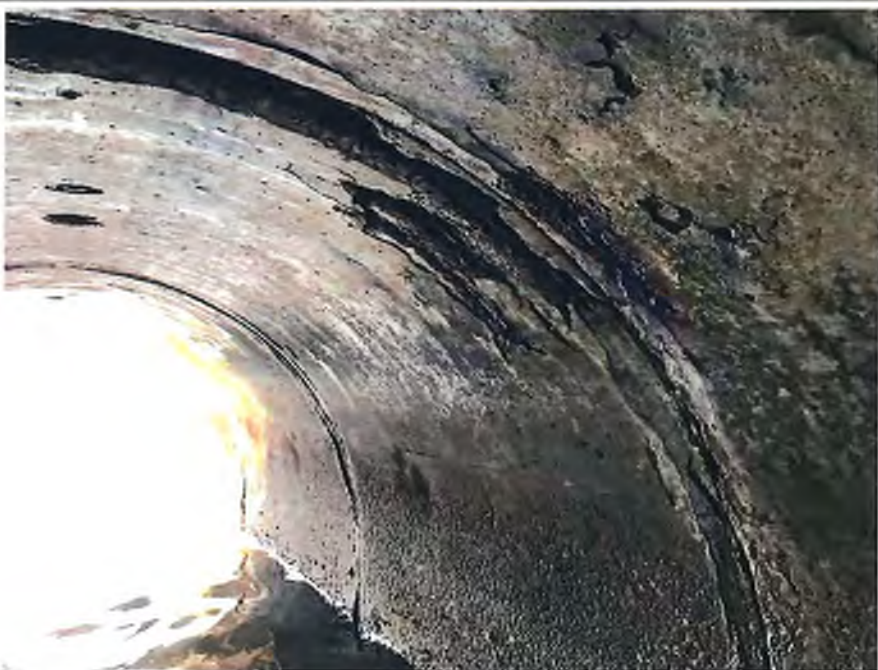
| Photo 14 | Category: | 50 - Culverts/Frames/Arches |

| | Description: | Joint 5 from west, looking southeast. Note 6 SF spall with exposed corroded rebar that exhibits heavy section loss. |

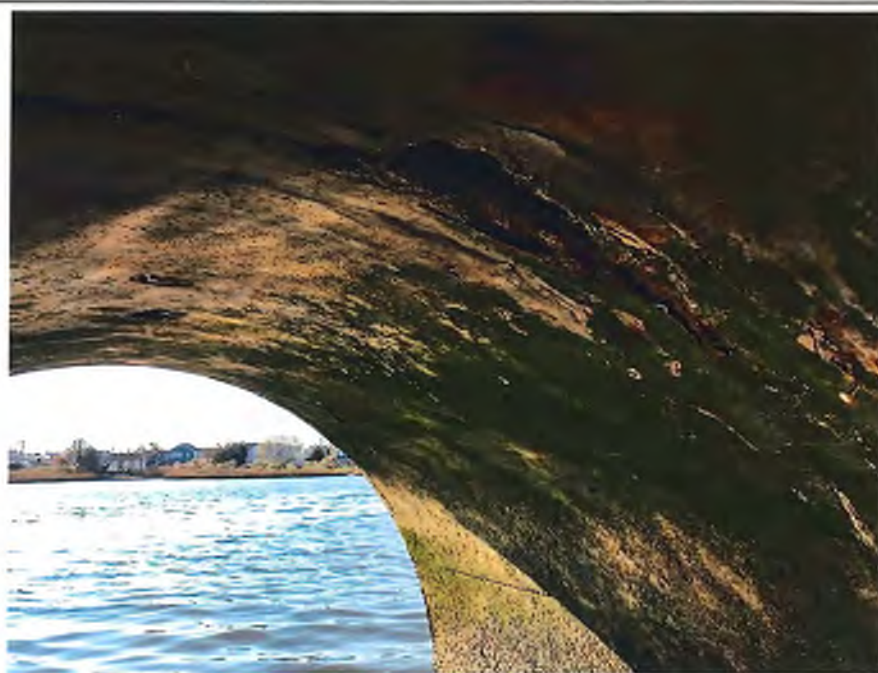
Photo 15

Description: Joint 7 from west, looking southeast. Note radial spall with exposed, corroded rebar.

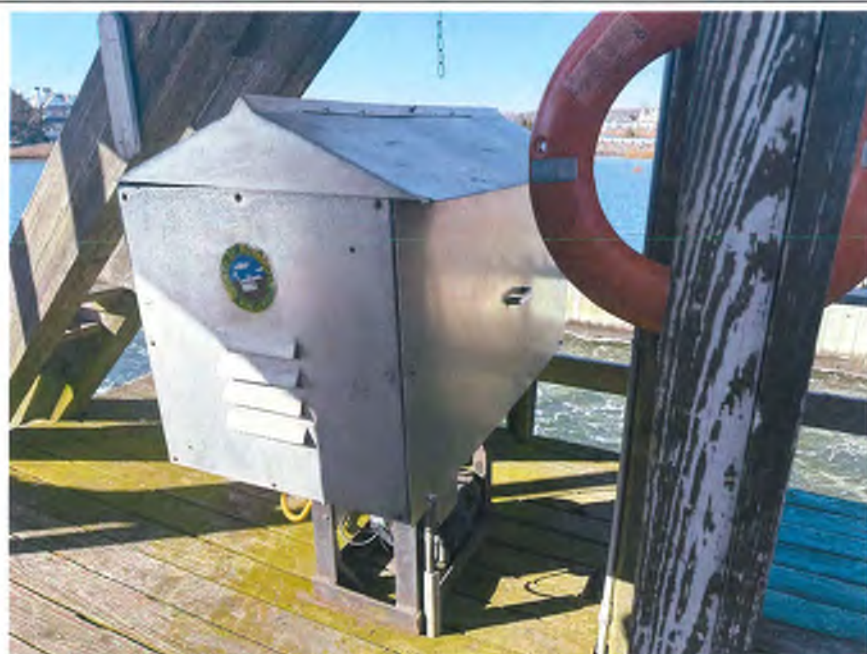
| Photo 9 | Category: | 59 - Other, 60 - Priority Repair |

| | Description: | Genset on the operator's platform, looking east. Genset is inoperable. |

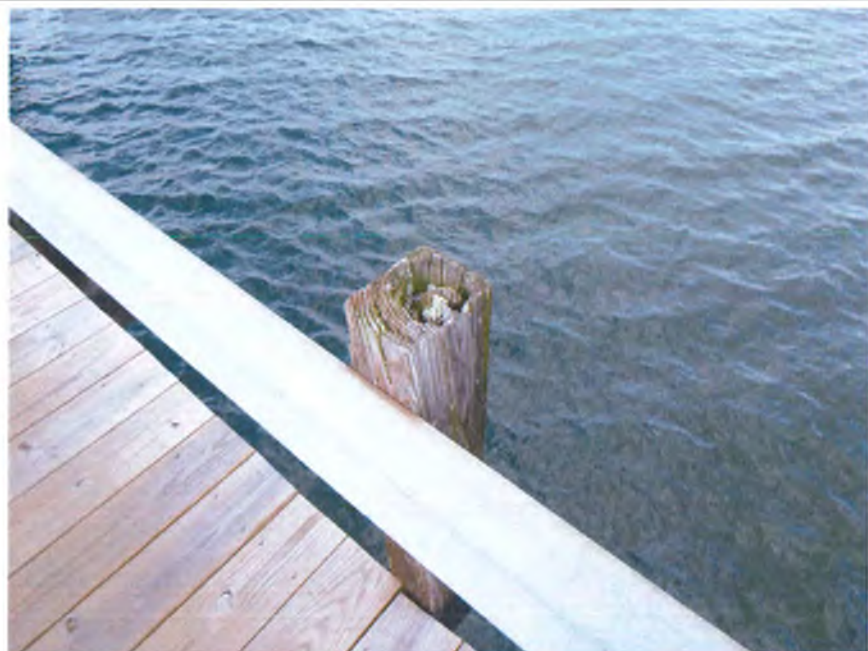
| Photo 11 | Category: | 06 - Parapets/Balustrades/Median/Railings |

| | Description: | North bridge railing, Span 10, looking northwest. Heart rot in post. |

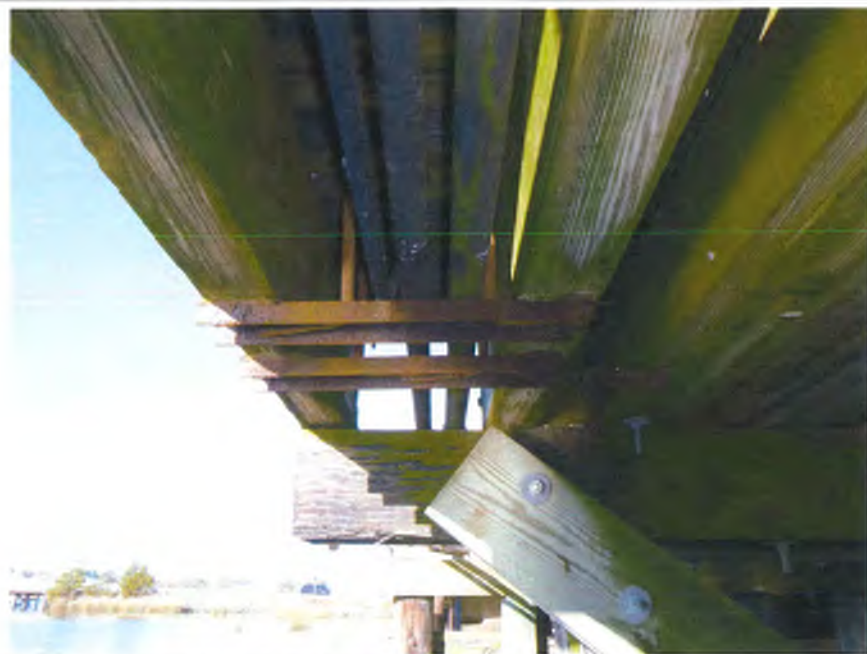
| Photo 13 | Category: | 01 - Deck Defects |

| | Description: | South fascia lamppost supports, looking west. Supports are severely corroded. |

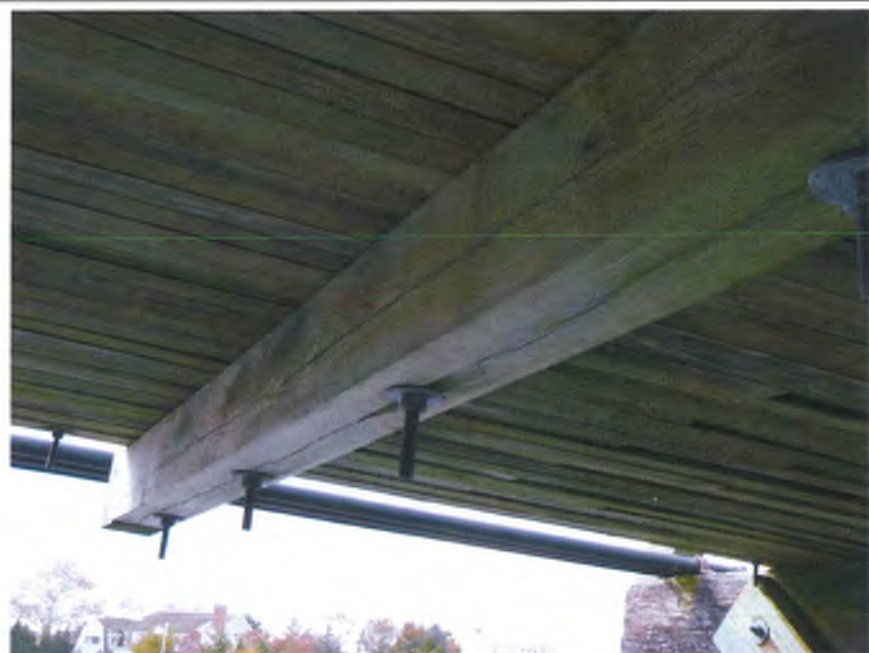
| Photo 19 | Category: | 20 - Superstructure Defects |

| | Description: | Medium to wide checks in transverse tie in Span 4, looking south. |

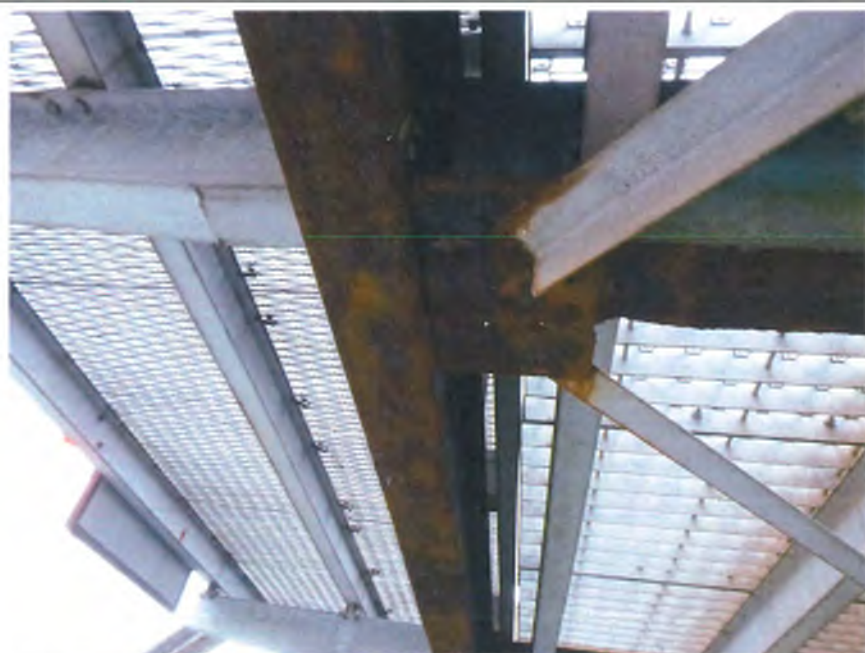
| Photo 21 | Category: | 20 - Superstructure Defects |

| | Description: | North girder, Span 6, looking east. Typical section loss (1/8") at bottom flange. |

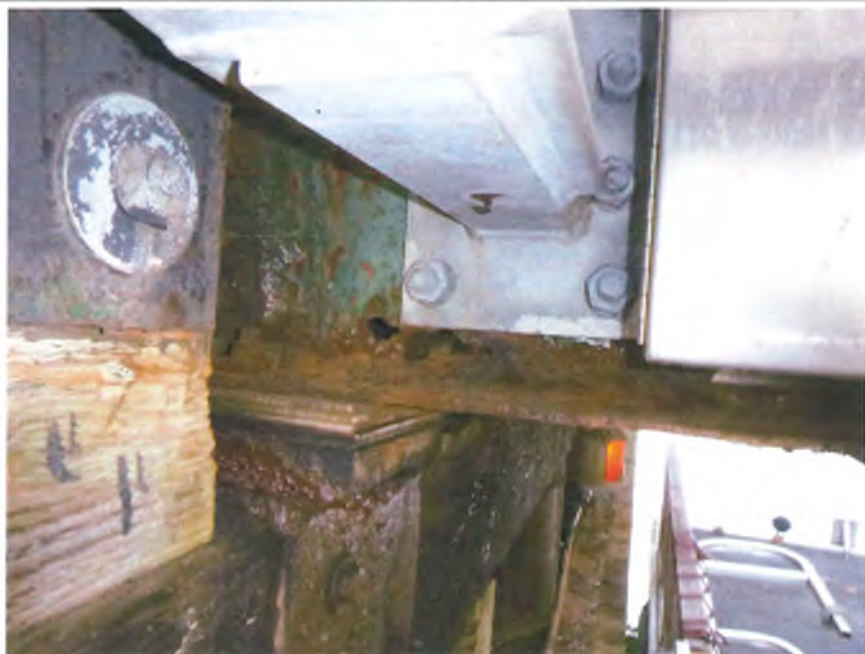
| Photo 22 | Category: | 35 - Pile Bent/Cap/Bracing/Foundation, 20 - Superstructure Defects |

| | Description: | North girder at the east end, looking south. Hole in web near bottom flange. Masonry plates at Bent 6 are moderately rusted. |

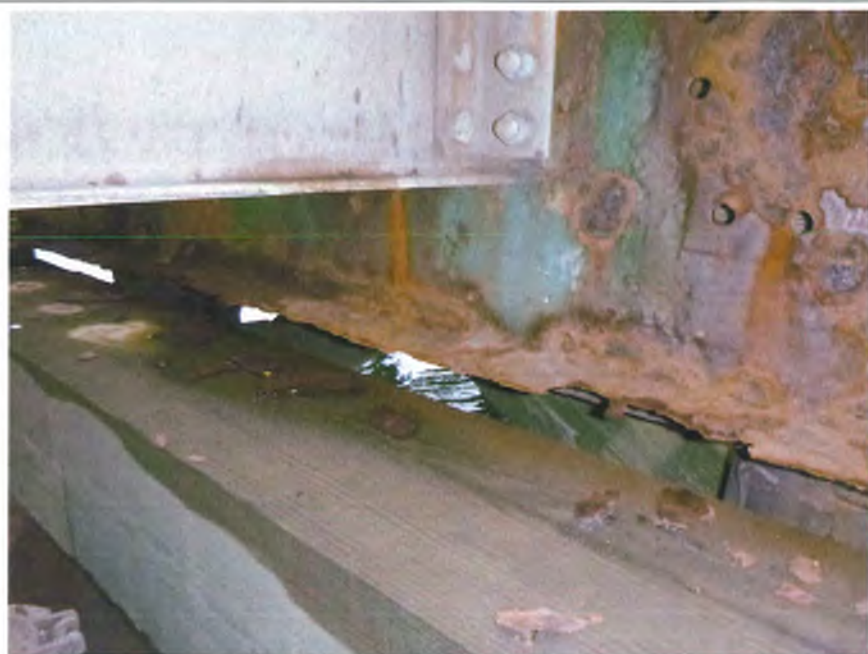
| Photo 23 | Category: | 20 - Superstructure Defects |

| | Description: | Floorbeam 1 in Span 6, looking southwest. Section loss to bottom flange between Stringers 5 and 7, |

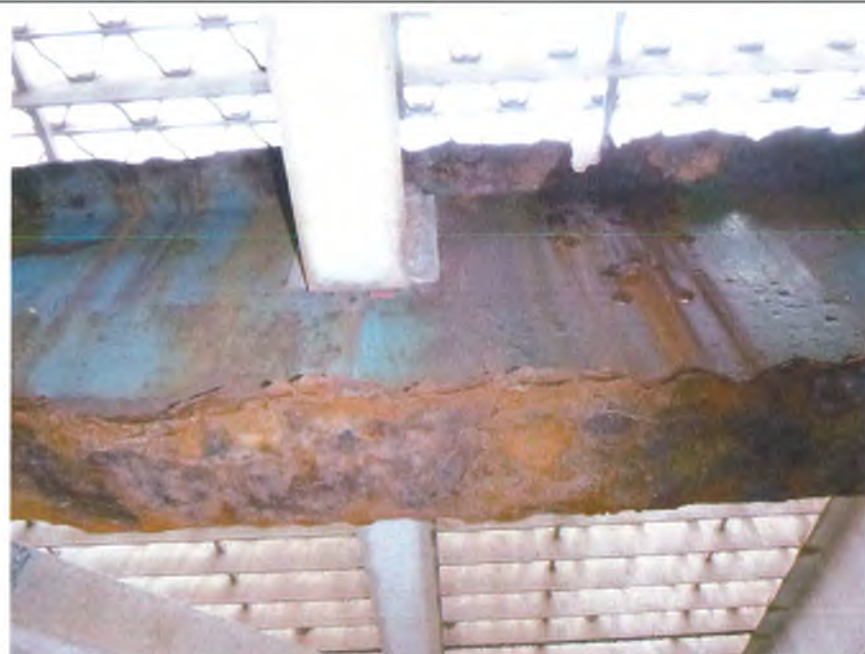
| Photo 25 | Category: | 20 - Superstructure Defects |

| | Description: | Section loss in top and bottom flange of Floorbeam 2 in Span 6, between Stringers 6 and 7, looking west. |
