## **APPENDIX D**

### **LATEST AVAILABLE BRIDGE REPORTS**

## BRIDGE RE-EVALUATION SURVEY REPORT

STATE STRUCTURE NO. 13000W7  
COUNTY STRUCTURE NO. W7  
GREEN AVENUE OVER DEBBIES CREEK  
Brielle Borough  
MONMOUTH COUNTY

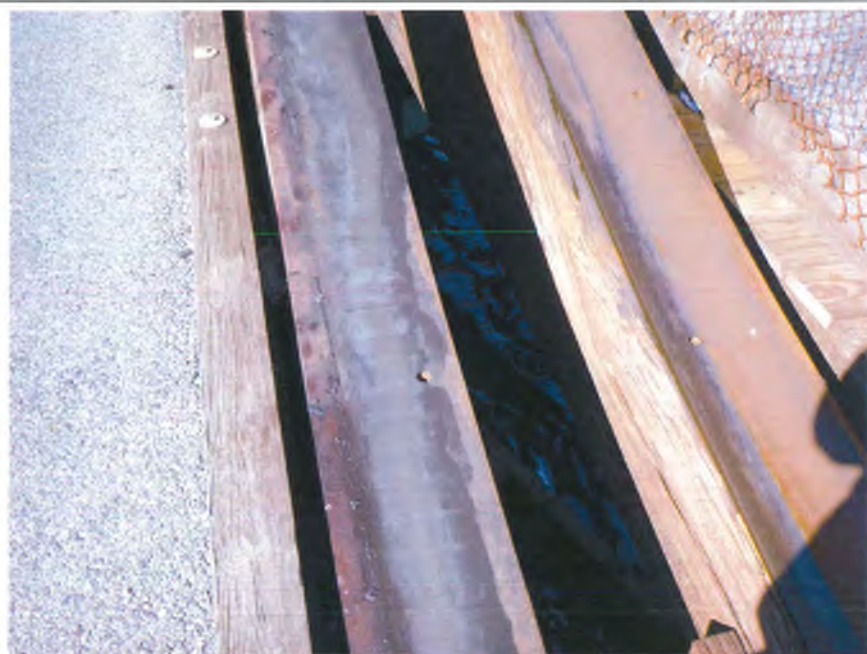
| Photo 29 | Category: | 59 - Other |

| | Description: | Missing connection bolt in north counterweight track, looking west. |

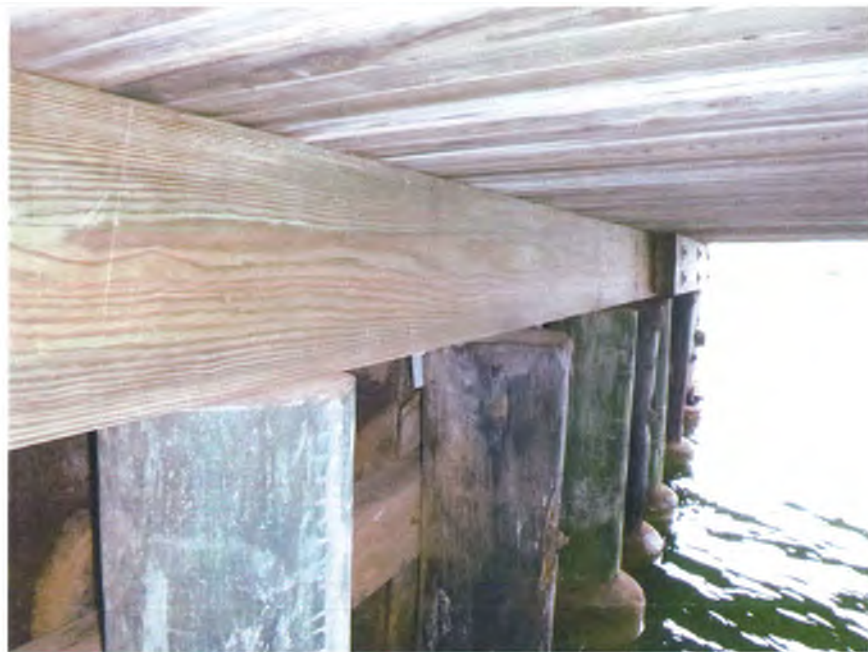
| Photo 31 | Category: | 35 - Pile Bent/Cap/Bracing/Foundation, 30 - Abutments |

| | Description: | West Abutment, looking northeast. Timber piles are offset up to 5" from pile cap. |

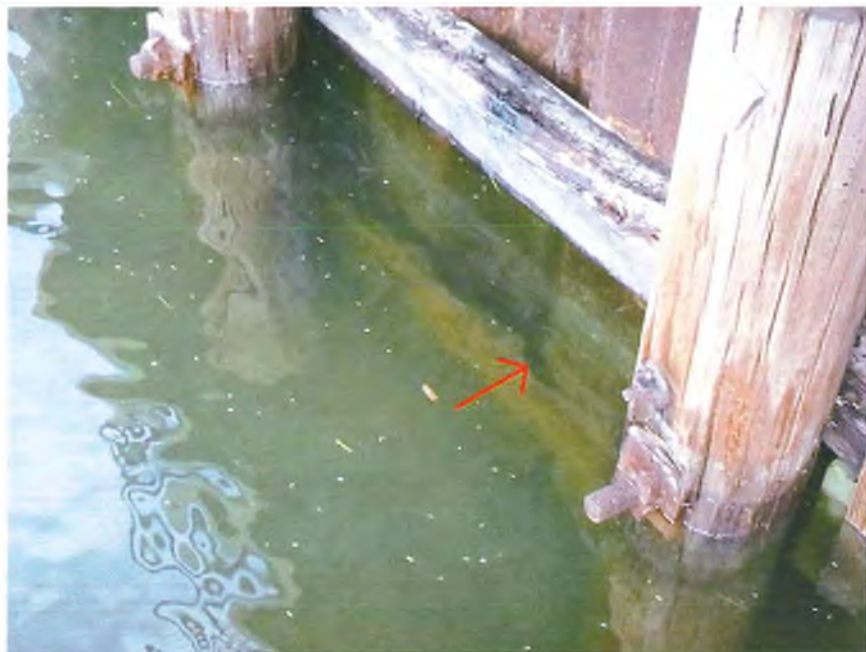
| Photo 35 | Category: | 31 - Wingwalls/Retaining Walls/Headwalls |

| | Description: | Southwest wingwall between Piles 11 and 12, looking northwest. The water below the water surface is deteriorated. |
