## **APPENDIX D**

### **LATEST AVAILABLE BRIDGE REPORTS**

## BRIDGE RE-EVALUATION SURVEY REPORT

STATE STRUCTURE NO. 13000W7  
COUNTY STRUCTURE NO. W7  
GREEN AVENUE OVER DEBBIES CREEK  
Brielle Borough  
MONMOUTH COUNTY

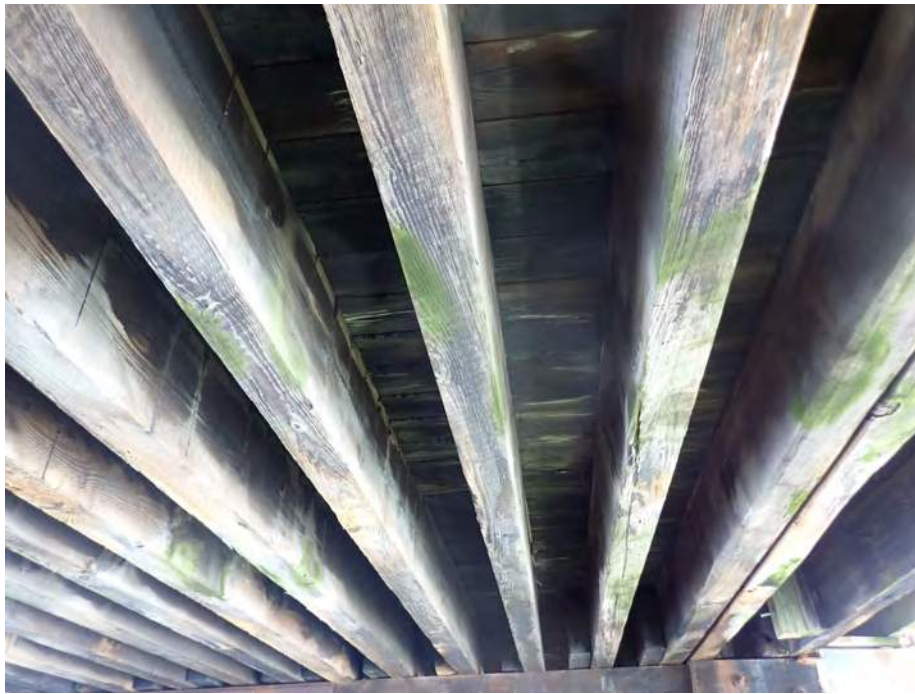
| Photo 7 | Category: | 00 - General View |

The superstructure is in satisfactory condition due to wide splits and random wide checks in a few stringers in each span. See Photo(s) 7

| | Description: | Underside of superstructure and deck, Span 6S, looking north. Note wide check in G14. |

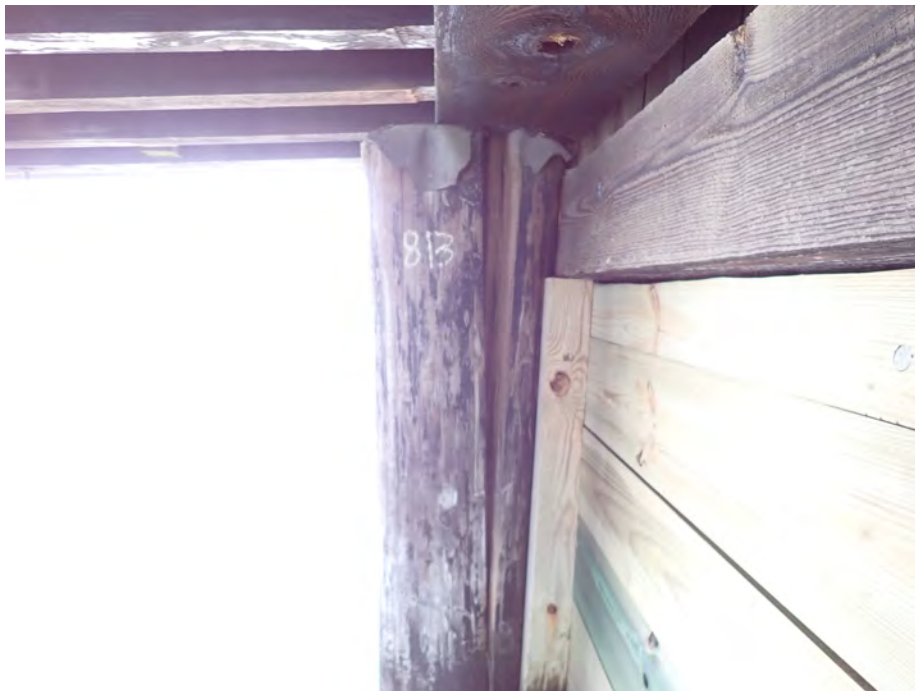
| Photo 8 | Category: | 30 - Abutments, 60 - Priority Repair |

The substructure is in poor condition due to moderate decay with hollow sounding abutment piles, and splits with advanced decay at both abutment pile caps. The west end of both the North and South Abutment Header exhibit wide splits, advanced decay and up to 50% section loss. The wingwalls in the North Abutment exhibits advanced decay with section loss and wide checks throughout the piles. Pile 1 from the west at the North Abutment exhibits a 2 ½" wide split in the top 5' with 50% section loss in the pile. The piles at the bents exhibit decay with checks throughout (see the underwater inspection results below). The cross bracing at the bents exhibit advanced decay with widespread section loss and wide splits in Bents 1S, 2S, and 6S. See Photo(s) 8, 9, 10, 12, 13, 17, 18, 21, 22

| | Description: | South abutment, Pile 4W, looking east. Priority 1: Pile is split up to 2.5" wide at the top for 5LF. (2023). Note the pile cap does not rest fully on the pile. |

Priority 1 (Recall): Install full height structural jackets on timber piles and replace the wale and sheeting at the northeast wingwall. (PR1\_2021\_13949)

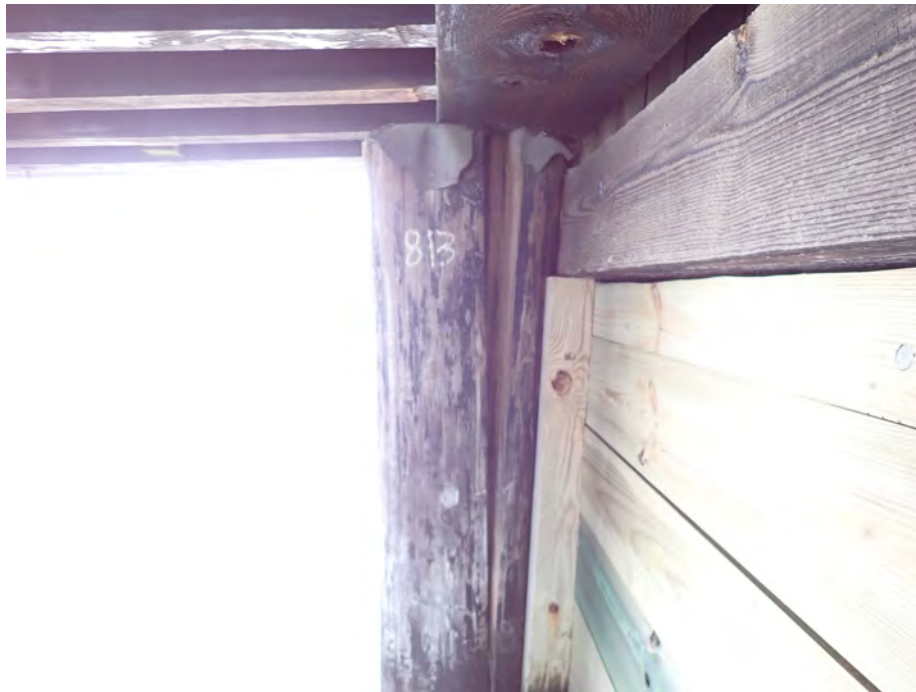
| Photo 1 | Category: | 30 - Abutments, 60 - Priority Repair |

| | Description: | South abutment, Pile 4W, looking east. Priority 1: Pile is split up to 2.5" wide at the top for 5LF. (2023). Note the pile cap does not rest fully on the pile. |

1. Install full height structural jackets on several piles. ([See Priority 1 Repair](#)) 11 Units  
 South abutment: Pile W4, Bent 2: Pile W3; Bent 6: Piles W1, W3, W4, and W5;  
 North abutment: Piles W1 through W5.

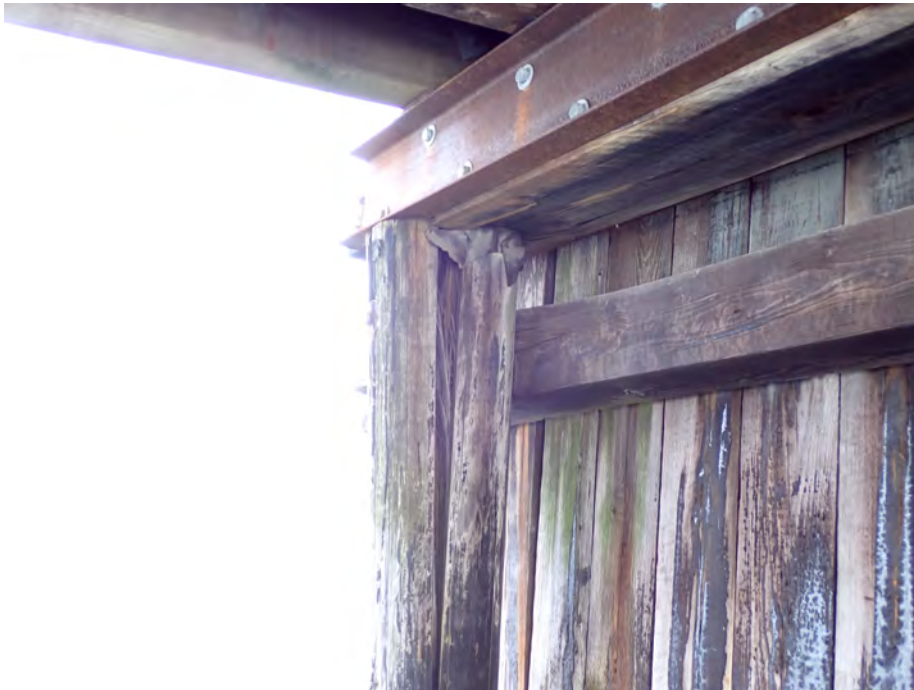
| Photo 3 | Category: | 60 - Priority Repair , 30 - Abutments |

| | Description: | North abutment, Pile 1W, looking northwest. Priority 1: Pile is split up to 2.5" wide at the top for 5LF. (2023) |

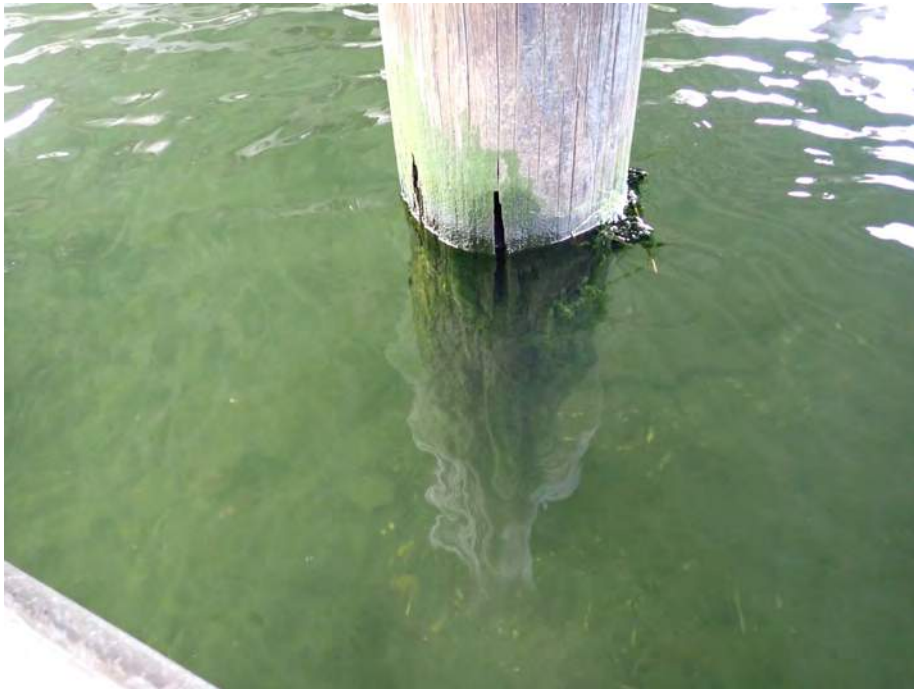
| Photo 5 | Category: | 35 - Pile Bent/Cap/Bracing/Foundation, 60 - Priority Repair |

| | Description: | Pier 2S, Pile 3W, looking south. Priority 1: Section loss to base of pile. (2023) |

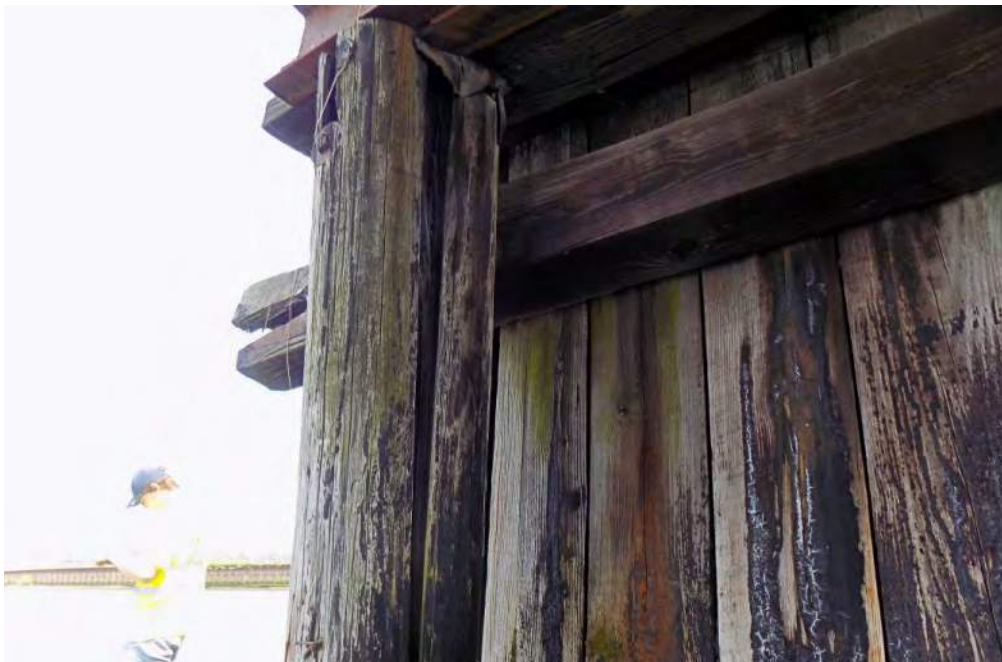
| | | <p><b>Photo No: UW-06</b></p> |

| <b>Location:</b> | North abutment, Pile W1, looking northwest. | |
| <b>Description:</b> | Pile is split up to 2.5" wide at the top for 5 LF high. ( <a href="#">See Priority 1 Repair</a> ) | |

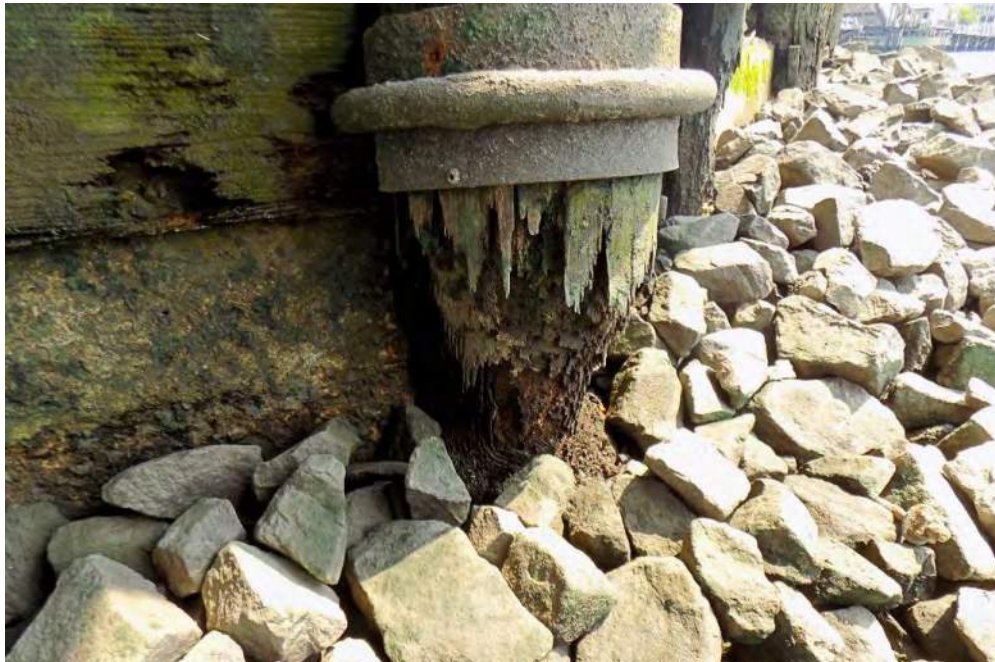
**Photo No: UW-07**

| <b>Location:</b> | North abutment, Pile W5, looking north. |
| <b>Description:</b> | Severe section loss in tidal zone with approximately 4" diameter remaining. ( <a href="#">See Priority 1 Repair</a> ) |

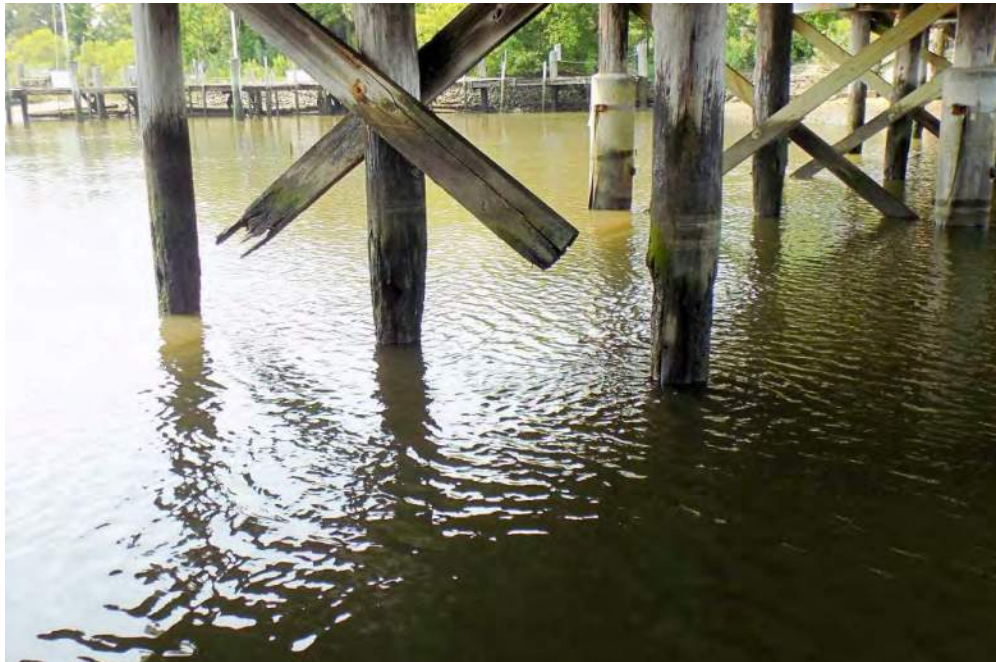
**Photo No: UW-09**

| <b>Location:</b> | Bent 6, Piles W3, W4, and W5, looking southeast. |
| <b>Description:</b> | Section loss through tidal zone up to 3" deep full circumference. (See <a href="#">Priority 1 Repair</a> ) Note severe decay and section loss to cross bracing. |

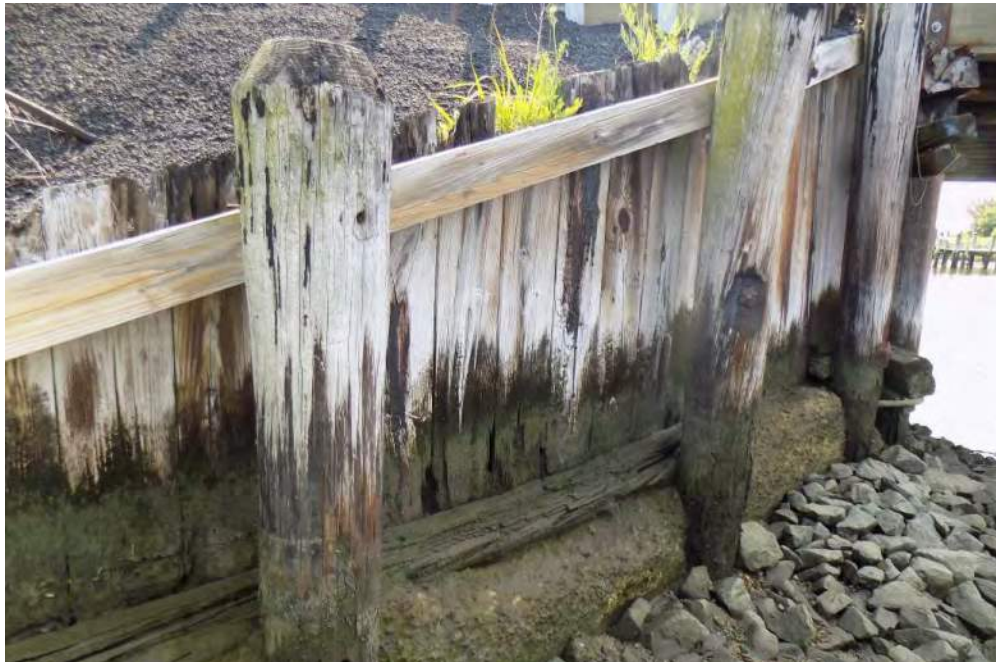
**Photo No: UW-11**

| <b>Location:</b> | Northwest wingwall, looking east. |

| <b>Description:</b> | Timber sheeting exhibits advanced decay with holes along lower water. Note moderate checks and decay in piles. |

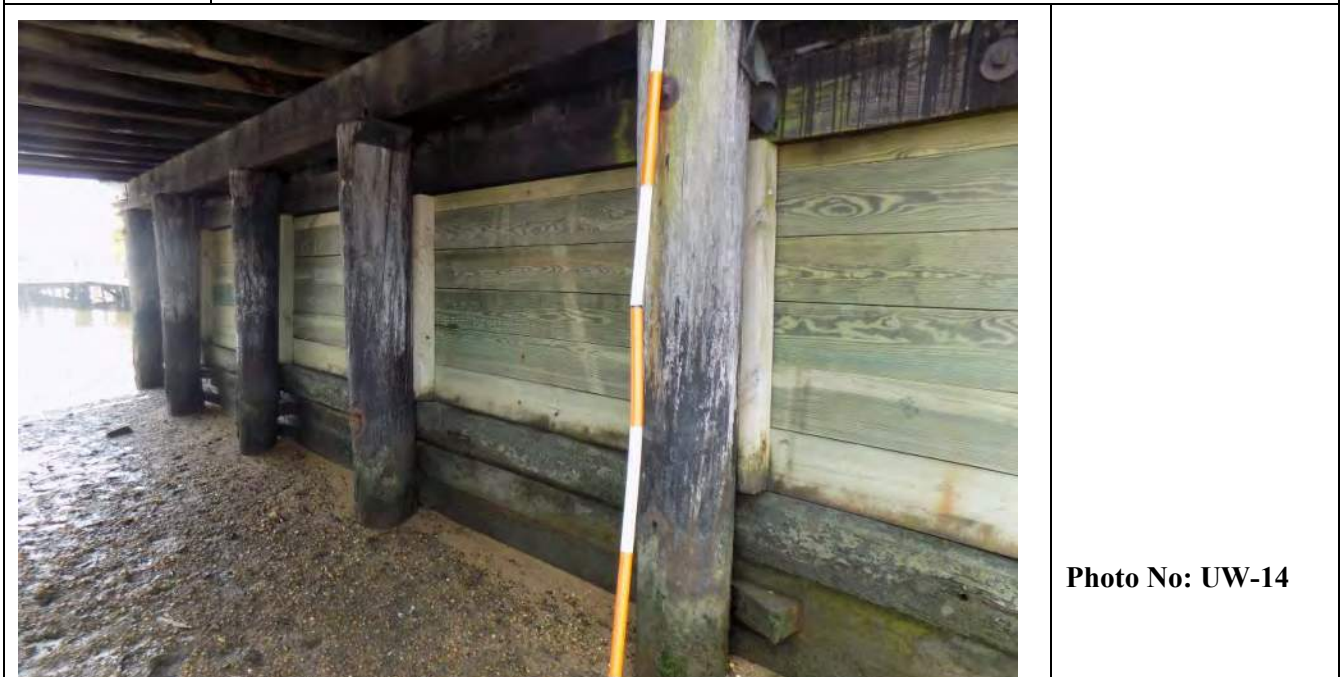
| <b>Location:</b> | South abutment, looking southeast. |
| <b>Description:</b> | Work Done: New timber sheathing and wales installed at abutment. |

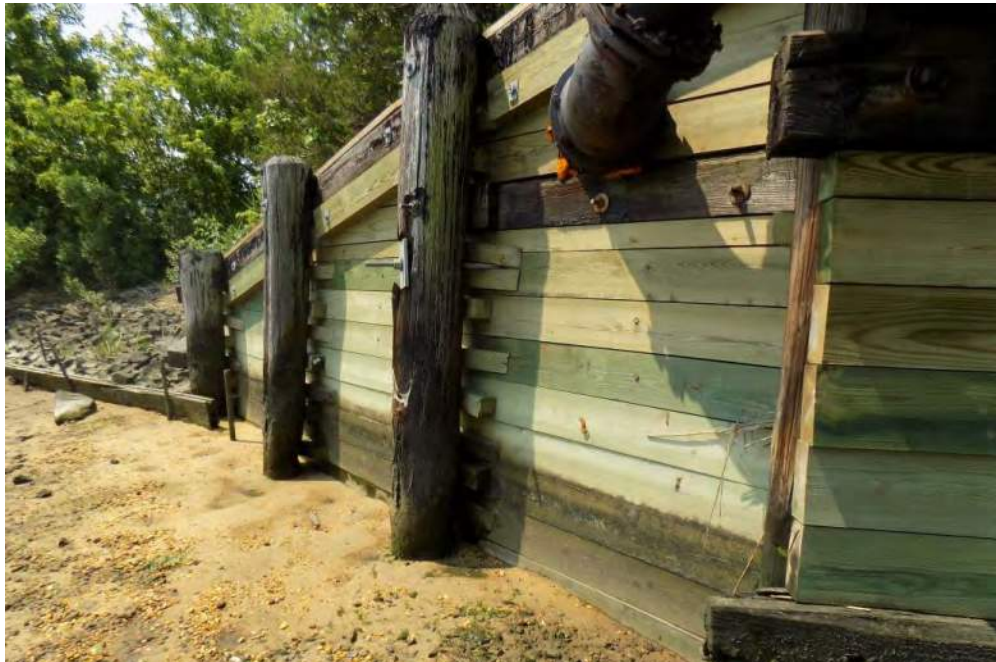
**Photo No: UW-15**

| <b>Location:</b> | Southeast wingwall, looking south. |
| <b>Description:</b> | Work Done: New timber sheeting and wales installed at wingwall. Note moderate checks and splits in the piles. |

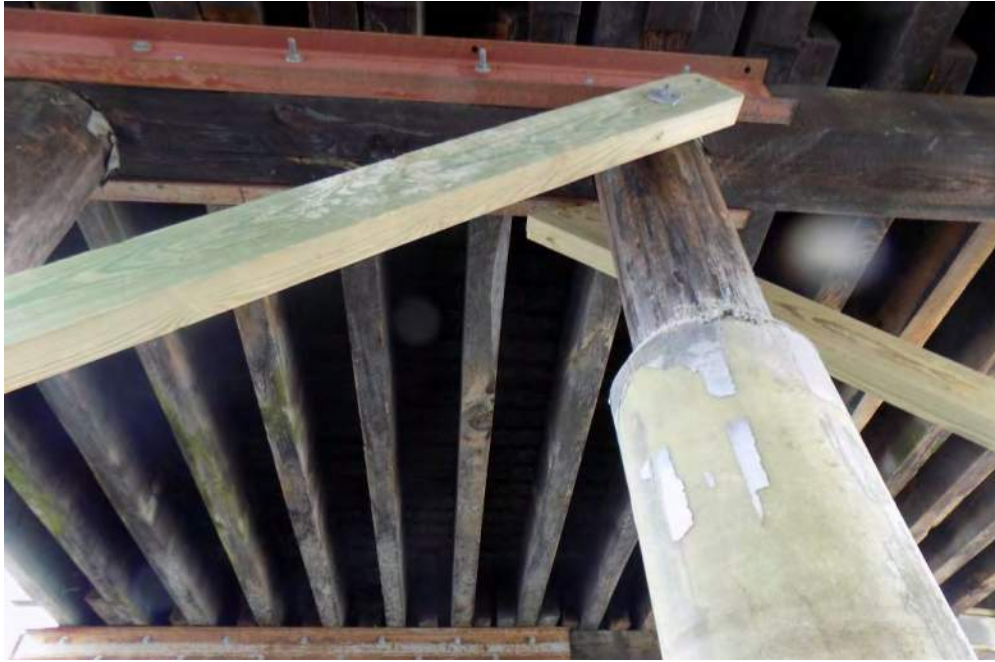
**Photo No: UW-17**

| <b>Location:</b> | Bent 3, Pile W4, looking north. |
| <b>Description:</b> | Work Done: New cross bracing and jacket installed. |

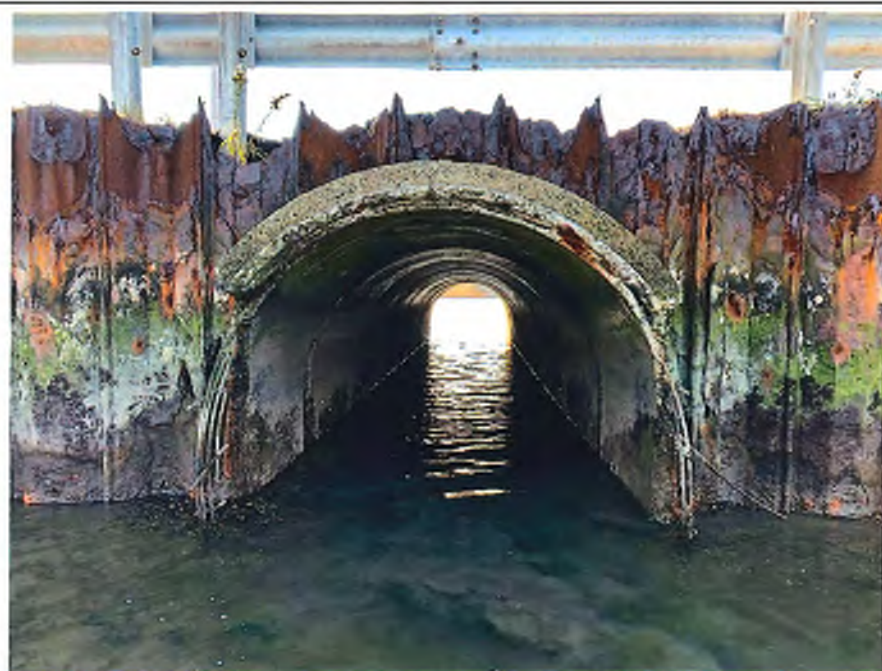
| Photo 1 | Category: | 00 - General View |

| | Description: | West elevation, looking east. |

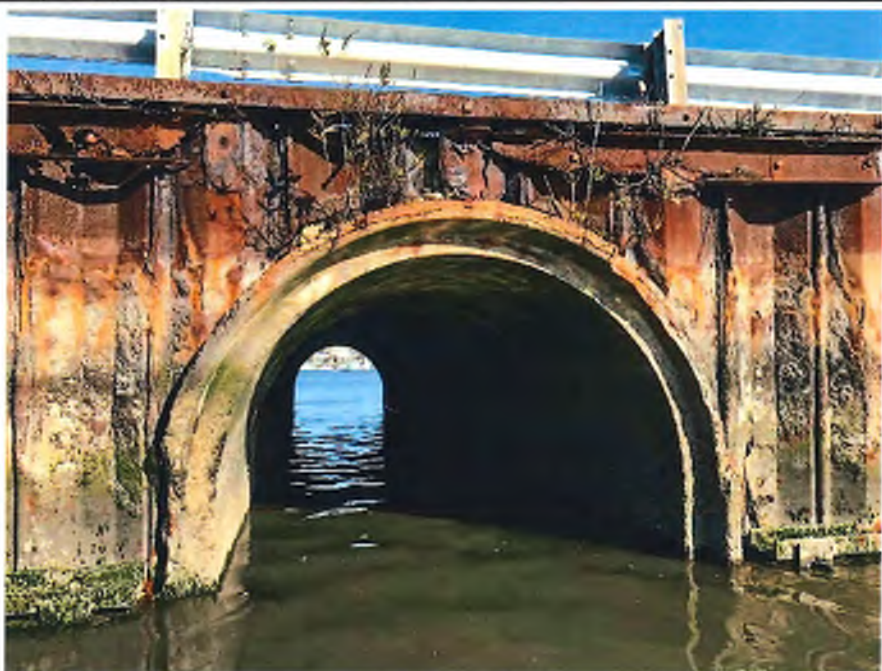
| Photo 2 | Category: | 00 - General View |

| | Description: | East elevation, looking west. |

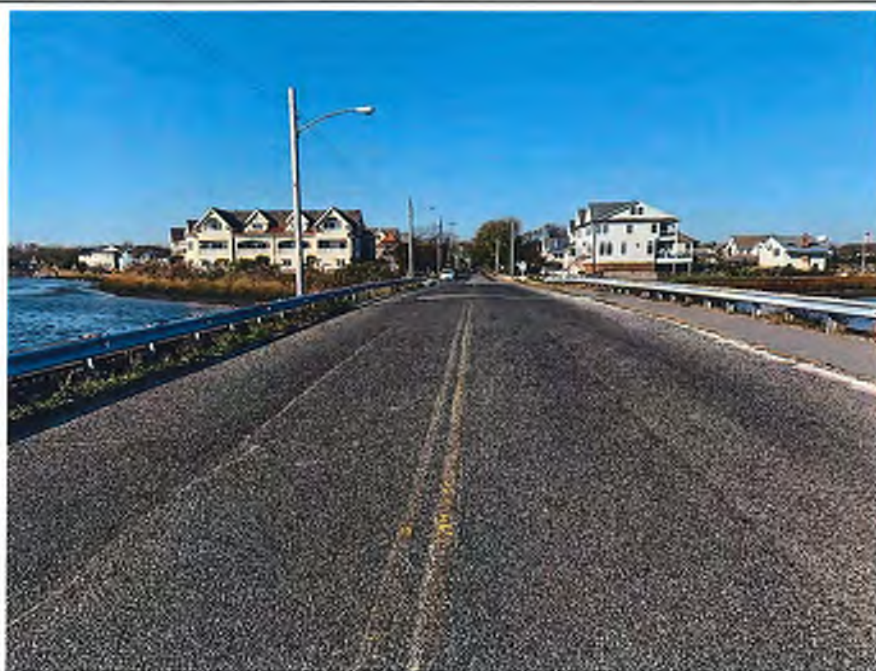
Photo 3

Description: North approach roadway, looking south.

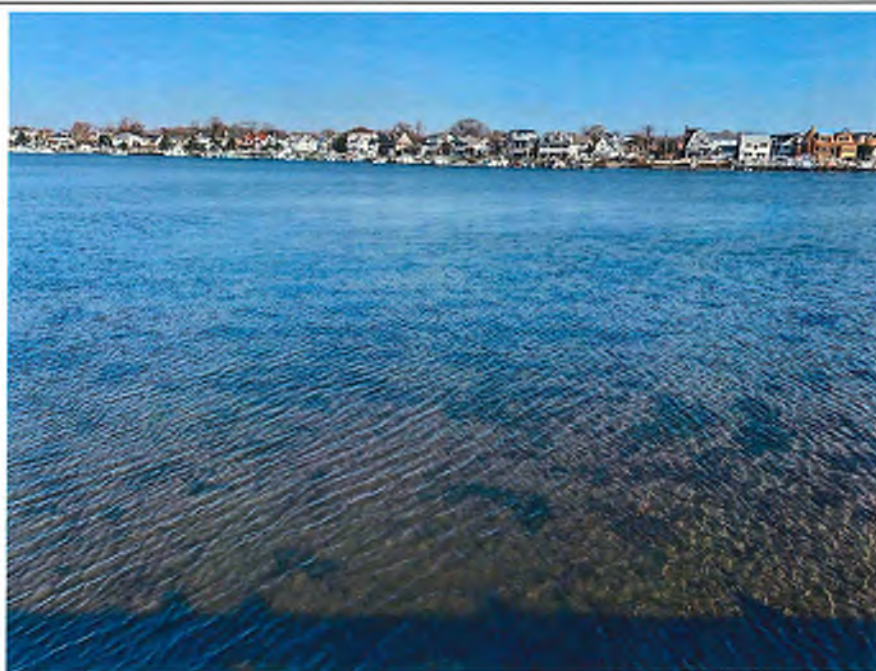
Photo 5

Description: Thalweg, looking west. General view of tidal waterway.

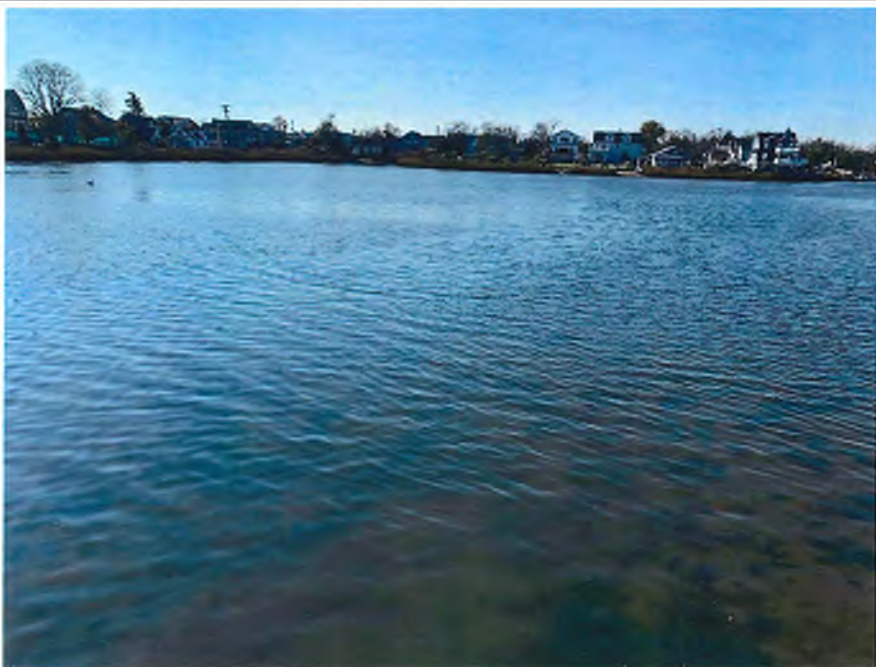
Photo 6

Description: Thalweg, looking east. General view of tidal waterway.

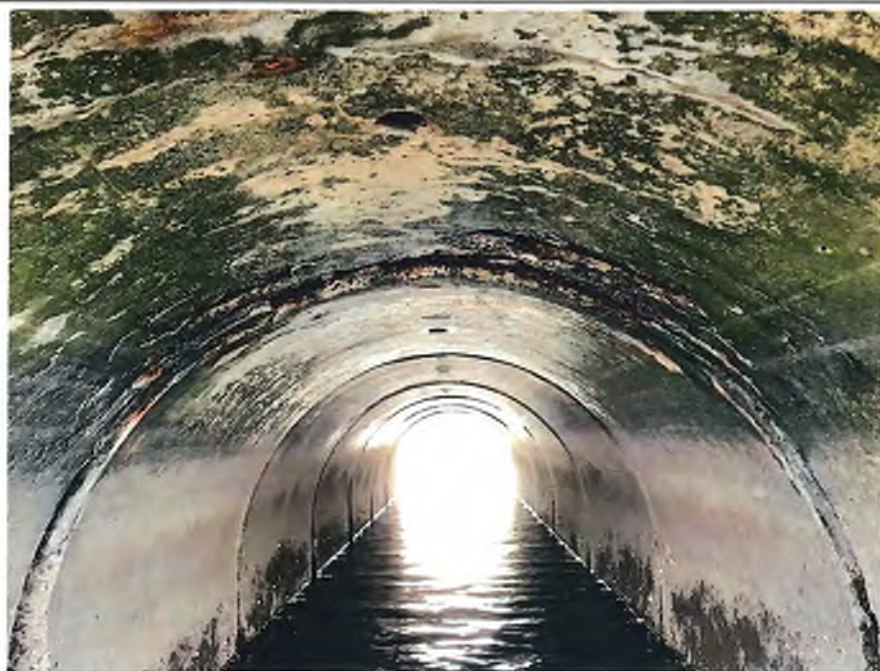
| Photo 7 | Category: | 00 - General View |

| | Description: | Underside, looking east. |

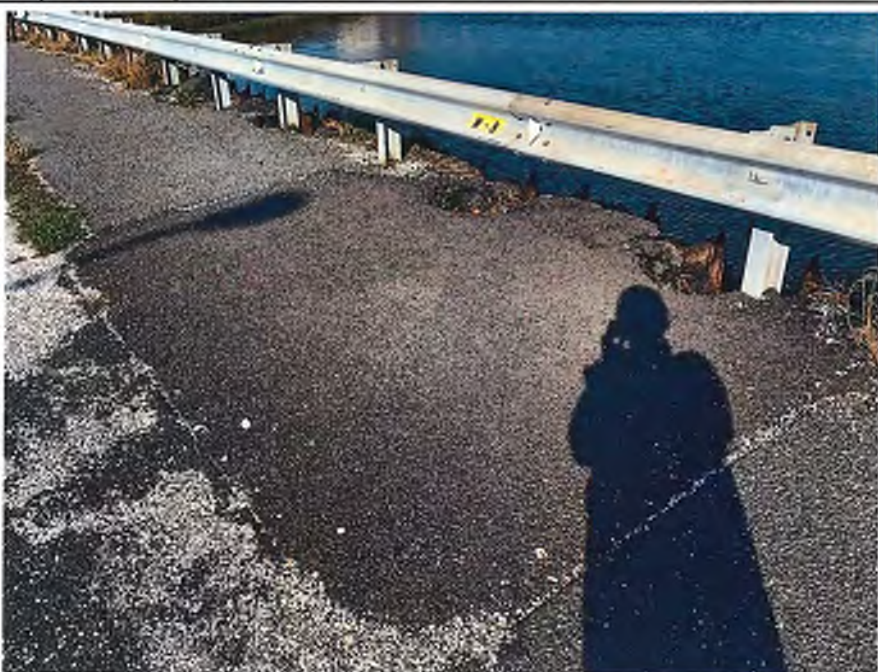
Photo 16

Work Done: Previously noted deteriorated bituminous surface has been patched with bituminous concrete. New broken section has been found near railing at west sidewalk.

| RATING | COMPONENT | REMARKS |
|---|---|---|
| 5 | Sidewalks | West sidewalk: Work Done: Previously noted deteriorated bituminous surface has been patched with bituminous concrete. New broken section has been found near railing at west sidewalk.<br>[See Photo(s): 16] |

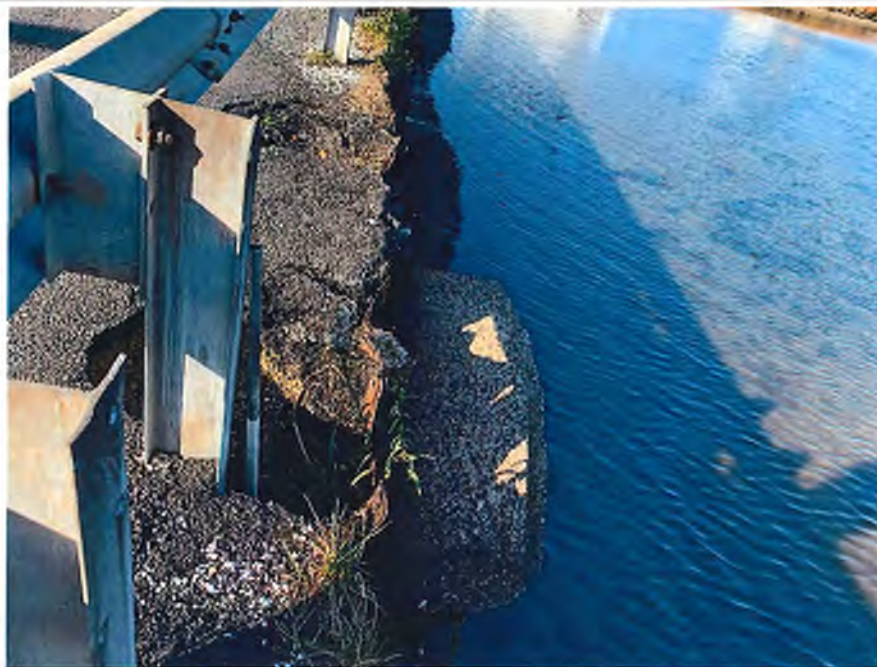
| Photo 1 | Category: | 60 - Priority Repair , 12 - Roadway/Approach Embankment |

| RATING | COMPONENT | REMARKS |
|---|---|---|
| 6 | Approach Roadway<br>Embankment | Heavy erosion has been noted above west end of pipe. (Refer to Priority Repair Letter 2_2022_16941)<br>[See Photo(s): 8] |

Heavy erosion has been noted above west end of the culvert.

| | Description: | West end of culvert, looking south.<br>Note: Heavy erosion has been noted above west end of pipe. |

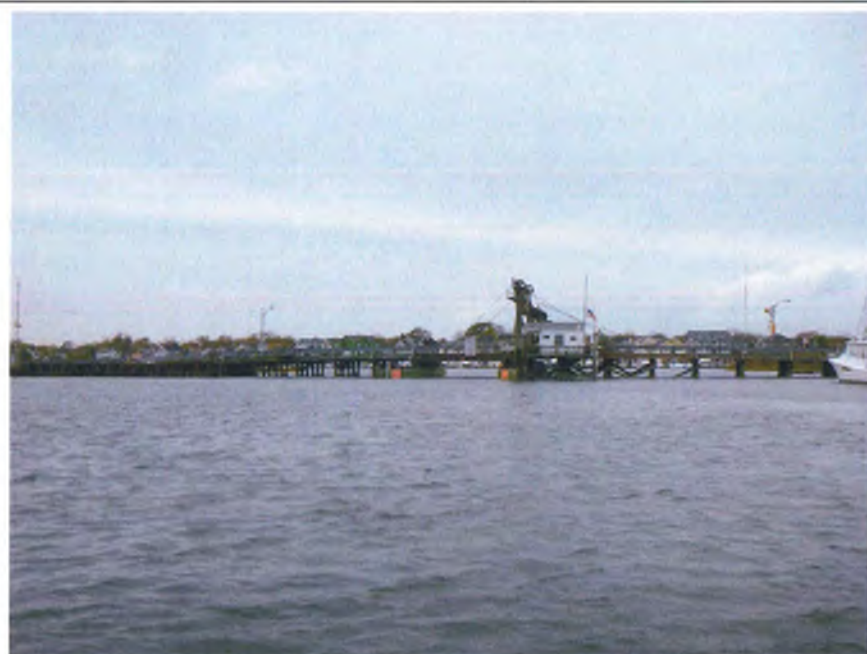
| Photo 1 | Category: | 00 - General View |

| | Description: | South (ebb) elevation, looking north. |

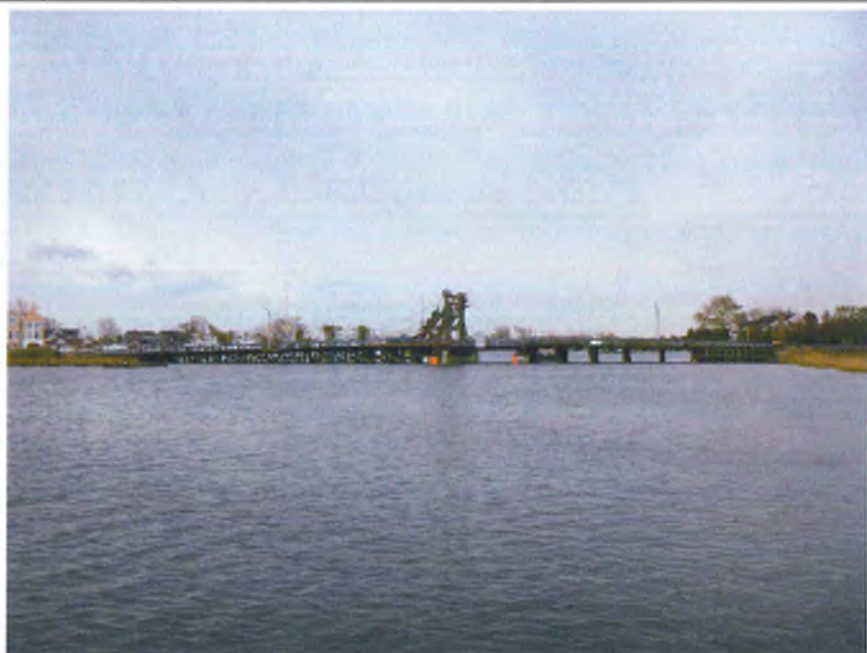
| Photo 2 | Category: | 00 - General View |

| | Description: | North (flood) elevation, looking south. |

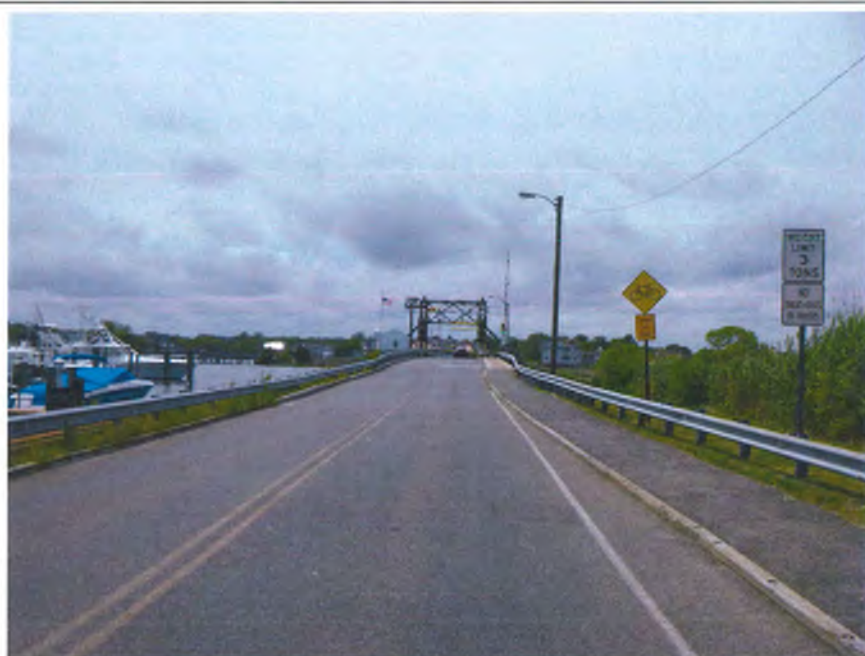
| Photo 3 | Category: | 00 - General View, 02 - Approaches |

| | Description: | East approach roadway, looking west. There is no barrier gate at the east approach. |

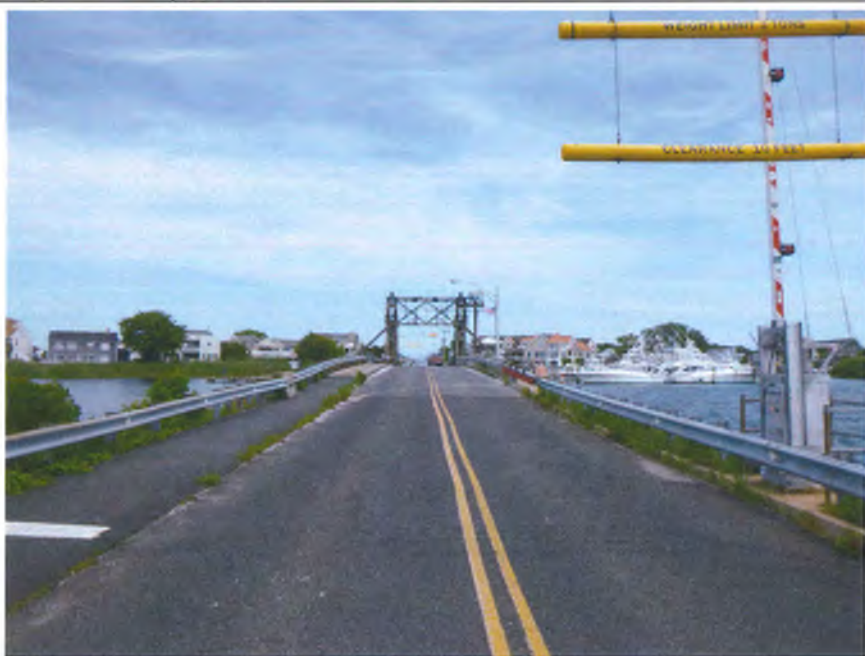
| Photo 4 | Category: | 02 - Approaches, 00 - General View |

| | Description: | West approach roadway, looking east. Wide cracks in pavement throughout the roadway. |

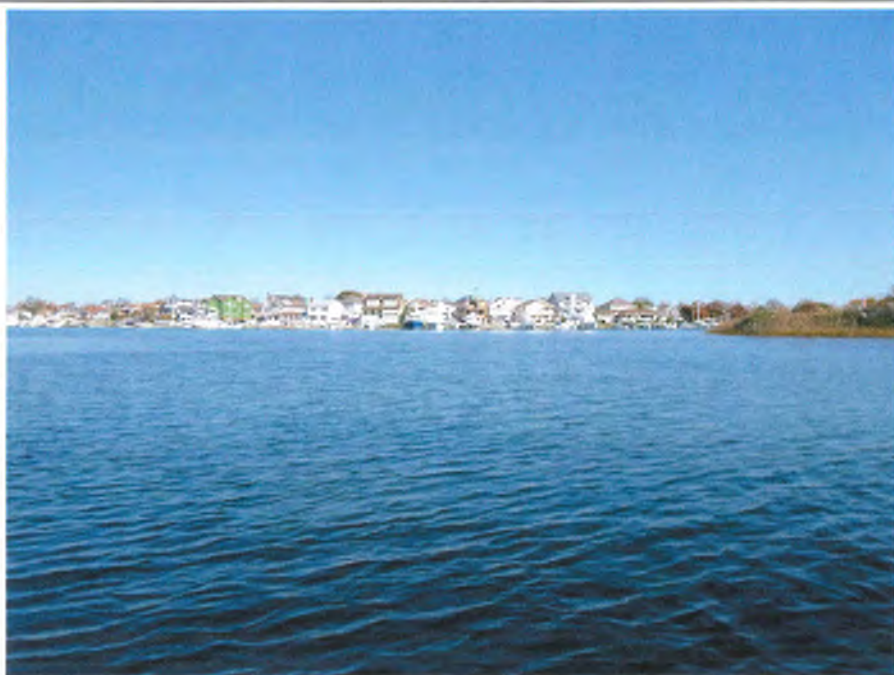
| Photo 5 | Category: | 00 - General View |

| | Description: | Channel (flood), looking north. Channel is tidal. |

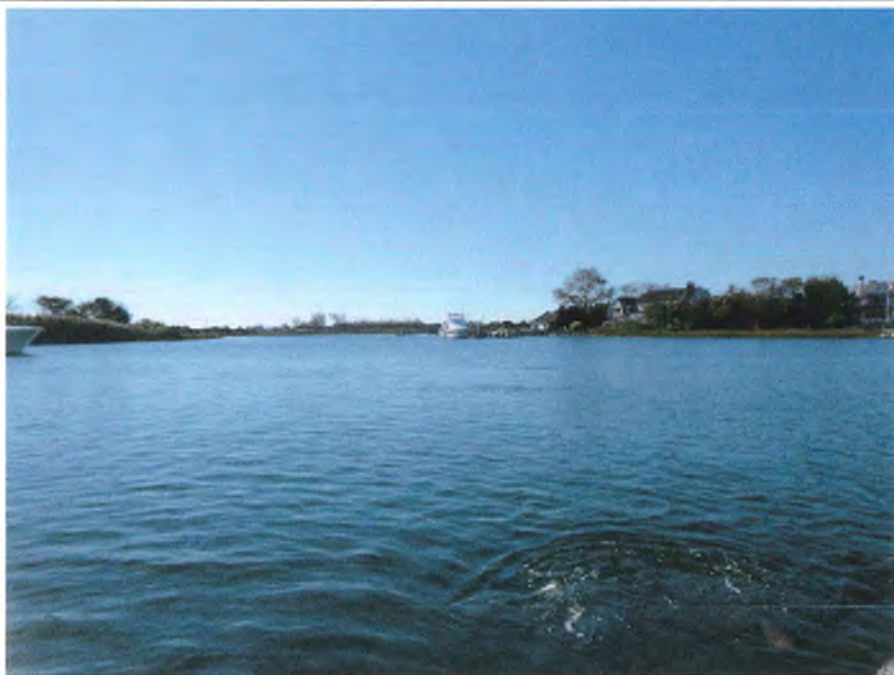
| Photo 6 | Category: | 00 - General View |

| | Description: | Channel (ebb), looking south. Channel is tidal. |

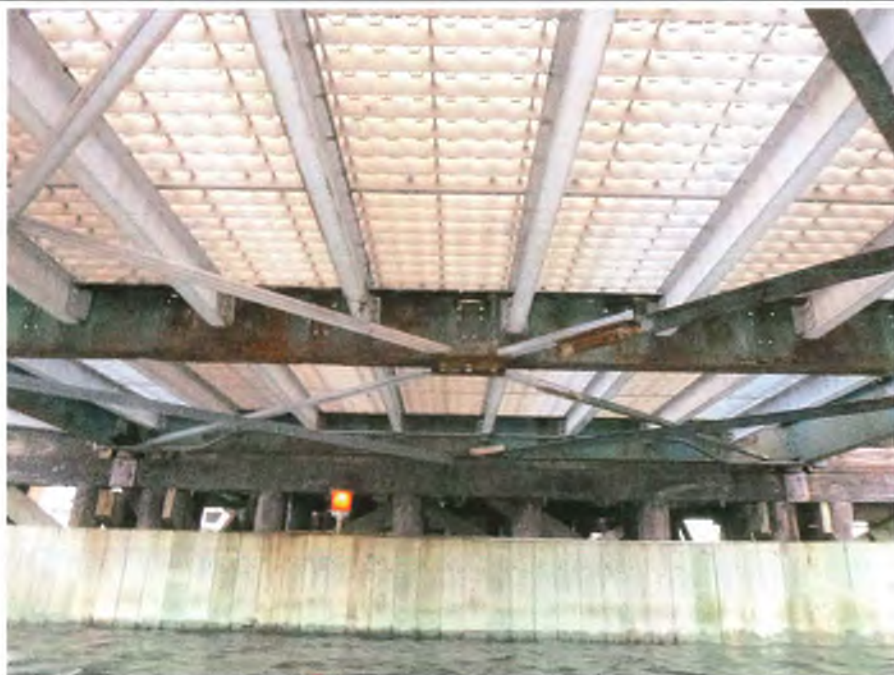
| Photo 7 | Category: | 00 - General View |

| | Description: | Span 6 (lift span), looking west. |

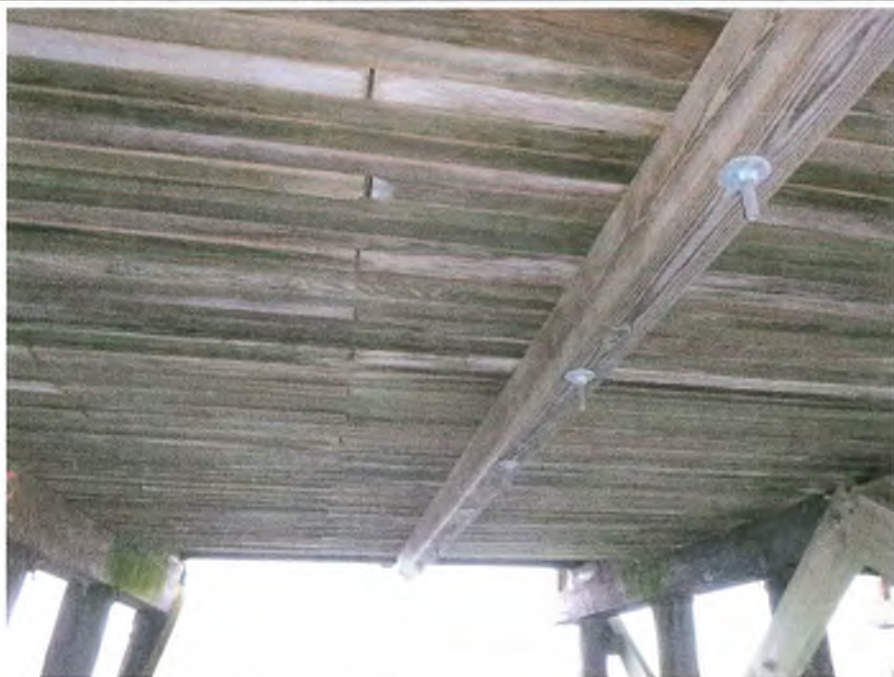
| Photo 8 | Category: | 00 - General View |

| | Description: | Typical approach span superstructure (Span 3), looking south. |

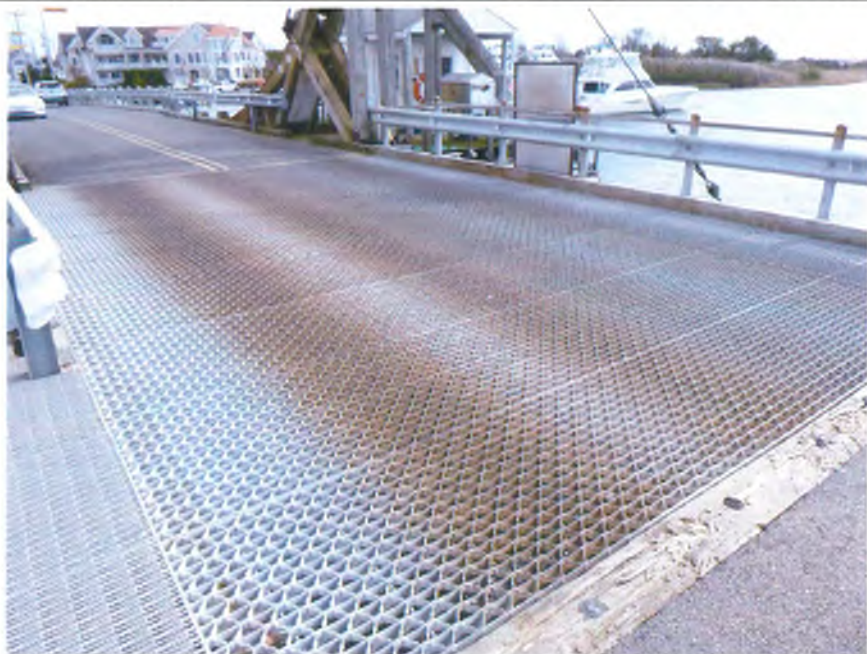
| Photo 10 | Category: | 01 - Deck Defects |

| | Description: | Top of deck in movable span, looking southeast. Deteriorated timber along the Bent 5 joint. |

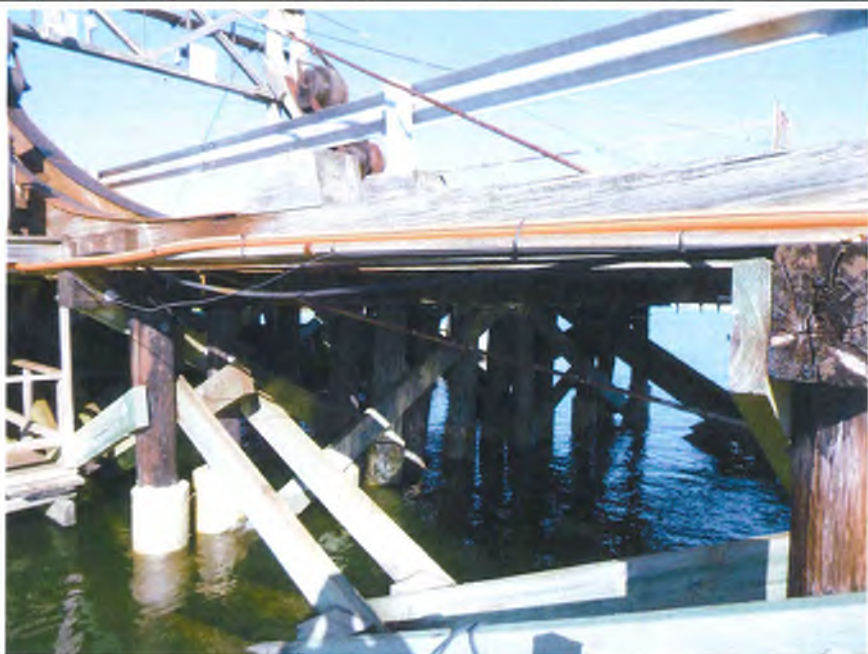
| Photo 12 | Category: | 09 - Utilities/Light Poles |

| | Description: | South fascia in Span 9, looking northwest. Loose wires and hanging conduit. Moderate rust to conduit. |

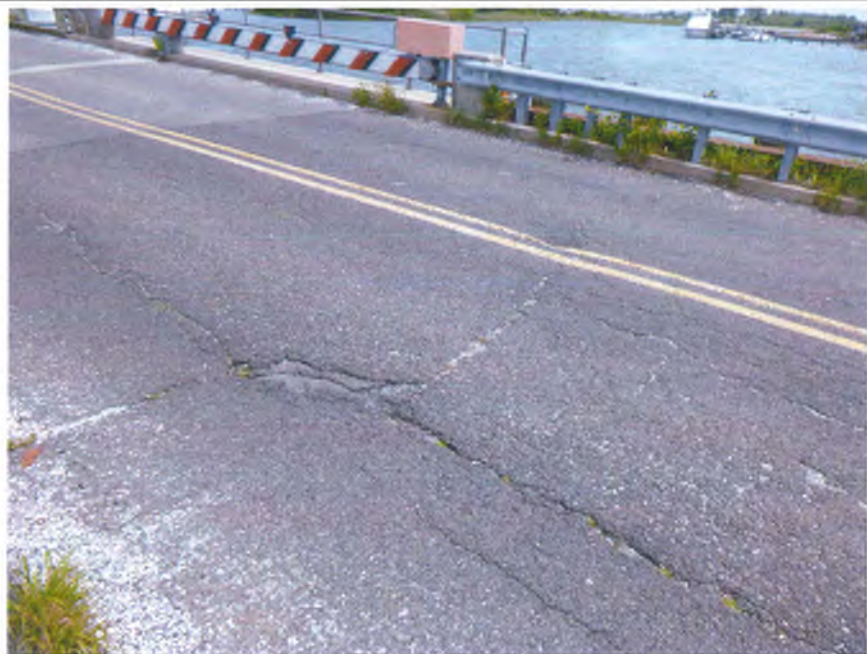
| Photo 14 | Category: | 03 - Roadway, 02 - Approaches |

| | Description: | West approach roadway, looking southeast. Wide cracks and potholes. |

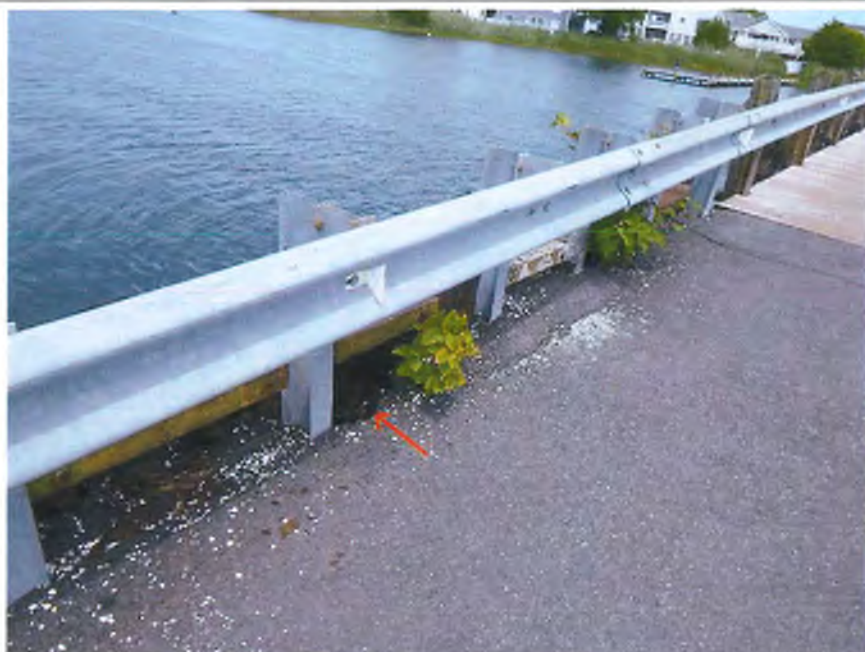
Photo 15 Category: 02 - Approaches

Description: West approach, looking northeast. Large hole in pavement adjacent to the steel sheeting and below guiderail.

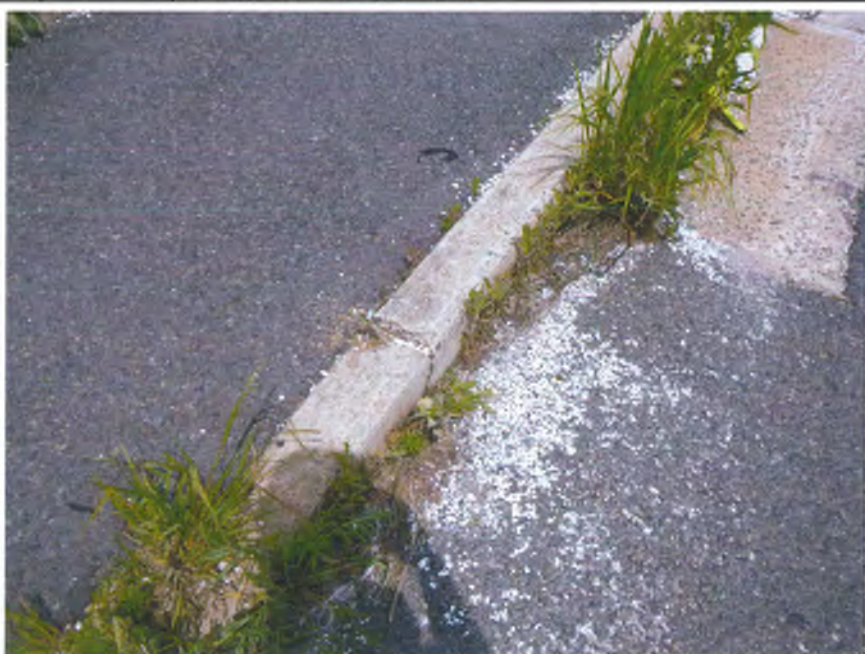
Photo 16 Category: 05 - Sidewalks/Safetywalks/Curbs, 02 - Approaches

Description: North curb at the West Approach, looking northeast. Wide crack in the curb. Moderate to heavy vegetation growth at curb.

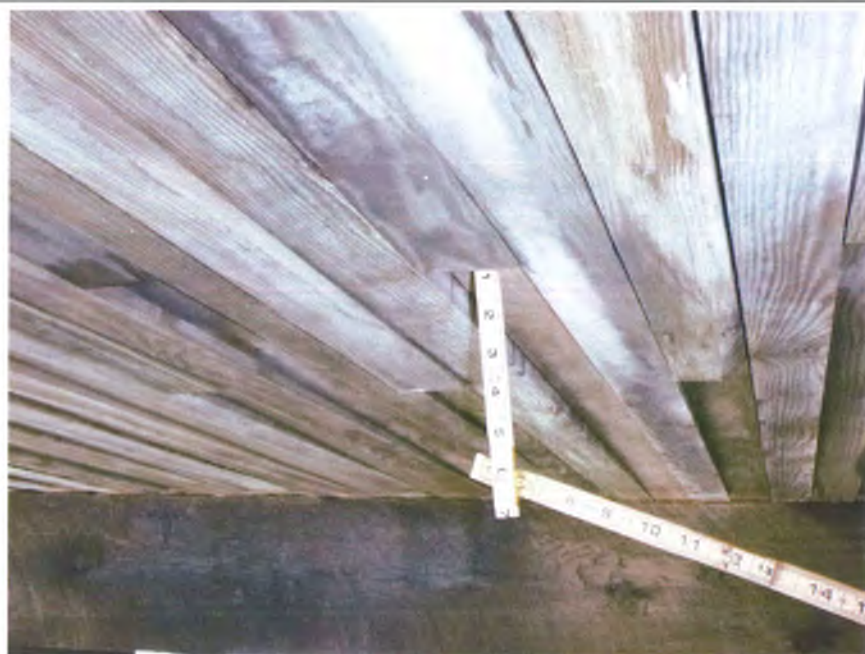
| Photo 17 | Category: | 20 - Superstructure Defects |

| | Description: | Minor misalignment between deck planks in Span 4, looking west. |
