## **APPENDIX D**

### **LATEST AVAILABLE BRIDGE REPORTS**

## BRIDGE RE-EVALUATION SURVEY REPORT

STATE STRUCTURE NO. 13000W7  
COUNTY STRUCTURE NO. W7  
GREEN AVENUE OVER DEBBIES CREEK  
Brielle Borough  
MONMOUTH COUNTY

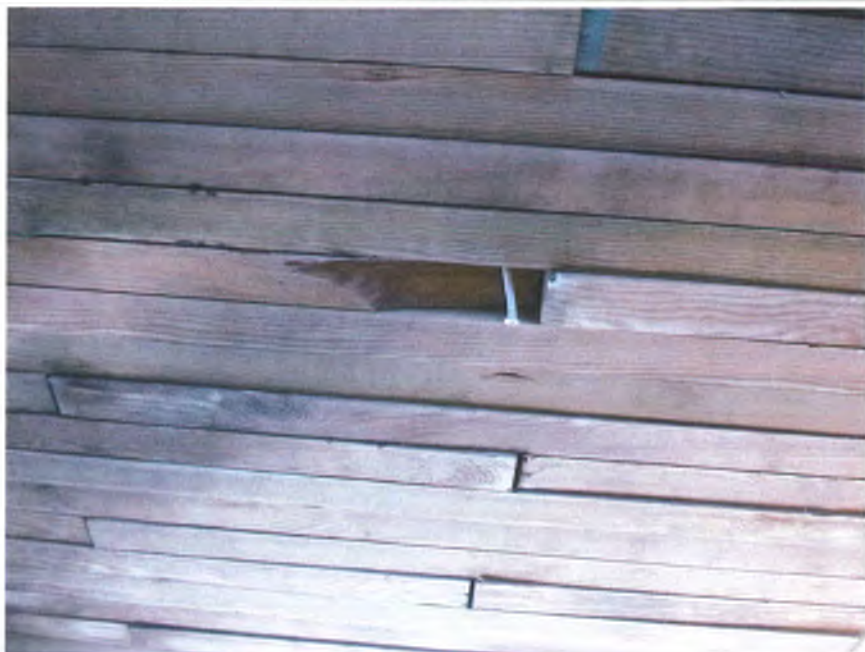
| Photo 18 | Category: | 20 - Superstructure Defects |

| | Description: | Damaged deck plank and exposed nail in Span 12, looking south. |

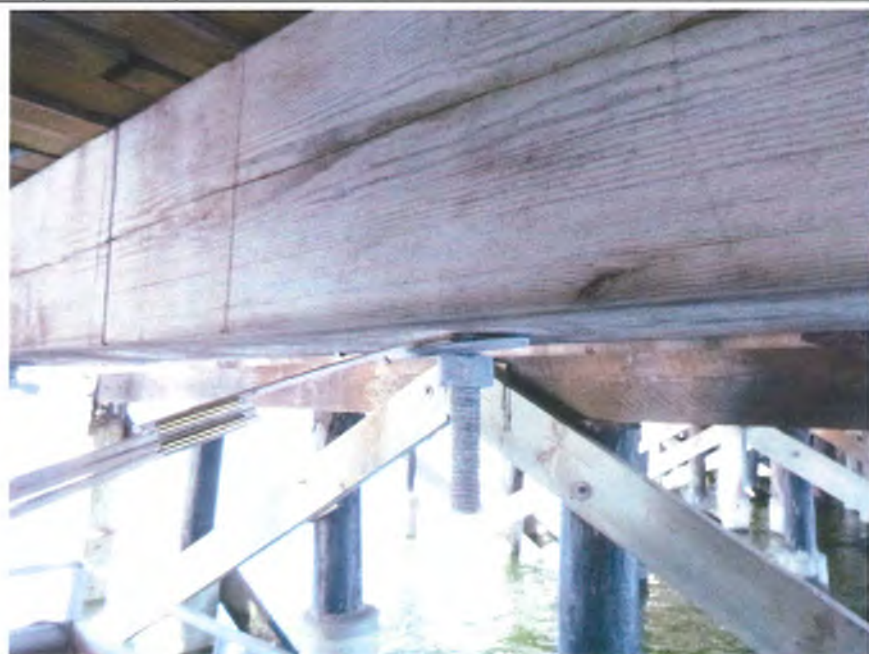
| Photo 20 | Category: | 20 - Superstructure Defects |

| | Description: | Loose deck hardware between deck and transverse tie in Span 12, looking southwest. |

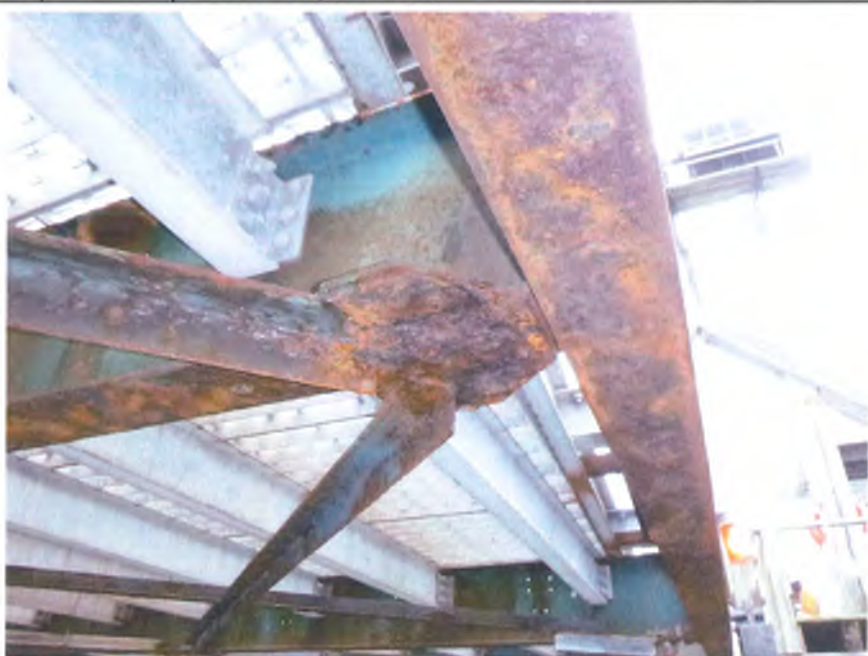
| Photo 24 | Category: | 20 - Superstructure Defects |

| | Description: | Floorbeam 2 in Span 6, near the South Girder, looking east. Section loss to rivets in connection plate between lateral bracing and floorbeam. |

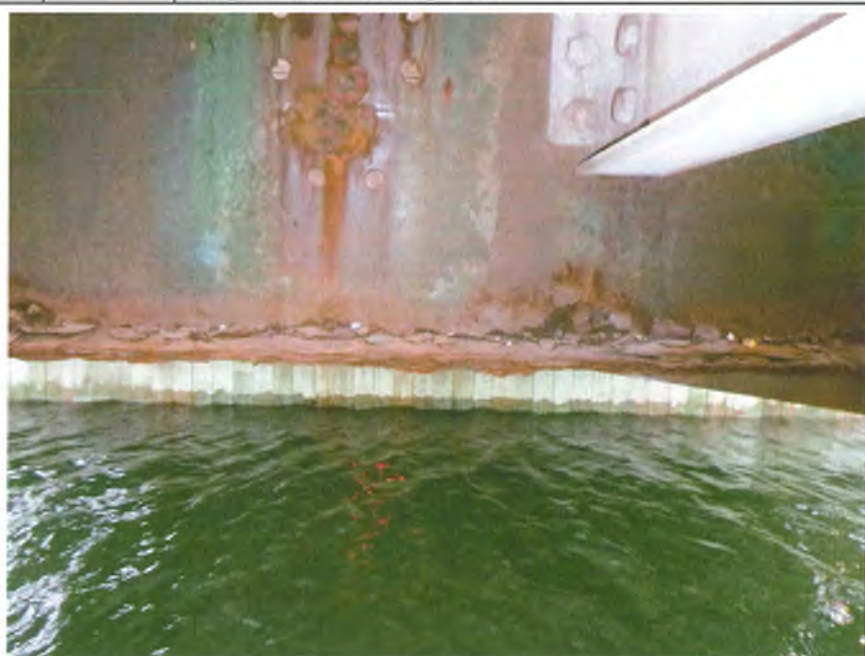
| Photo 26 | Category: | 20 - Superstructure Defects |

| | Description: | Section loss in bottom flange of Floorbeam 2, in midspan of Span 6, looking east. |

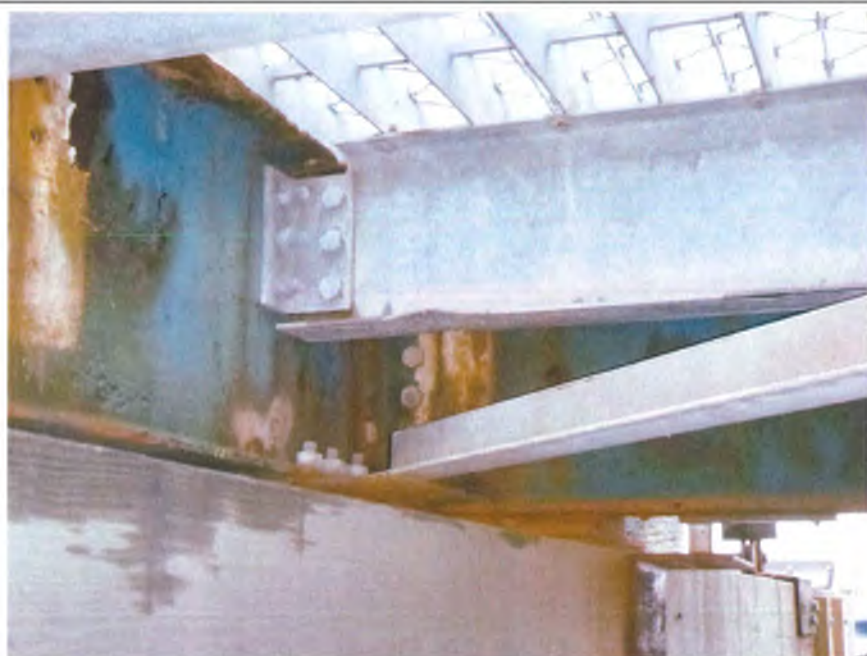
Photo 27 Category: 20 - Superstructure Defects

Description: Dent in bottom flange of Stringer 8, near connection to Floorbeam 5 in Span 6, looking north.

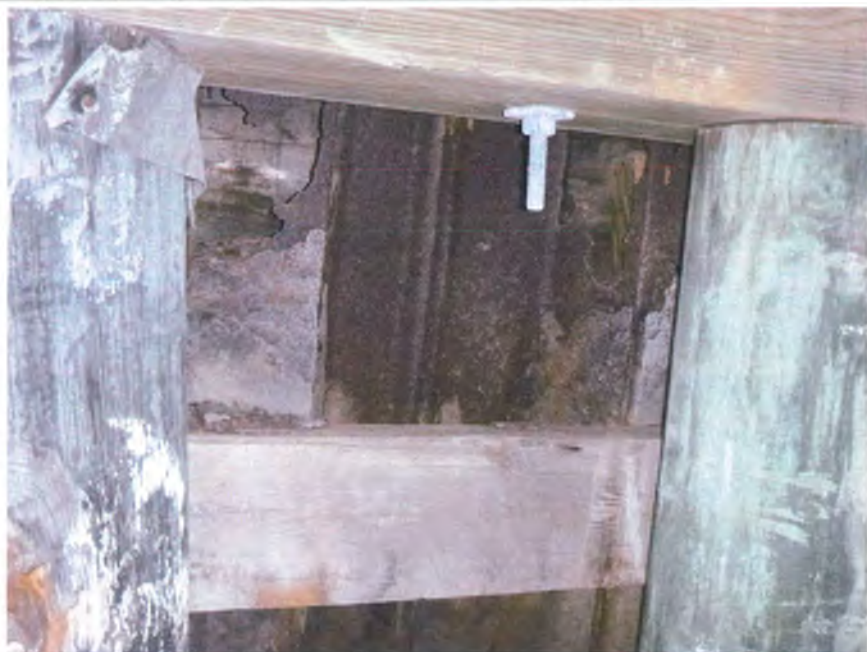
| Photo 29 | Category: | 59 - Other |

| | Description: | Missing connection bolt in north counterweight track, looking west. |

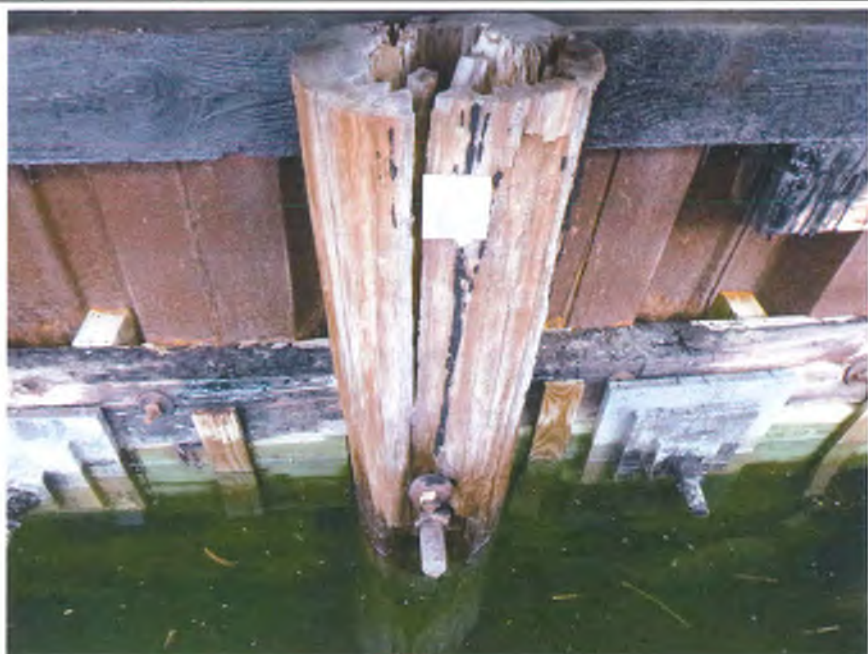
| Photo 31 | Category: | 35 - Pile Bent/Cap/Bracing/Foundation, 30 - Abutments |

| | Description: | West Abutment, looking northeast. Timber piles are offset up to 5" from pile cap. |

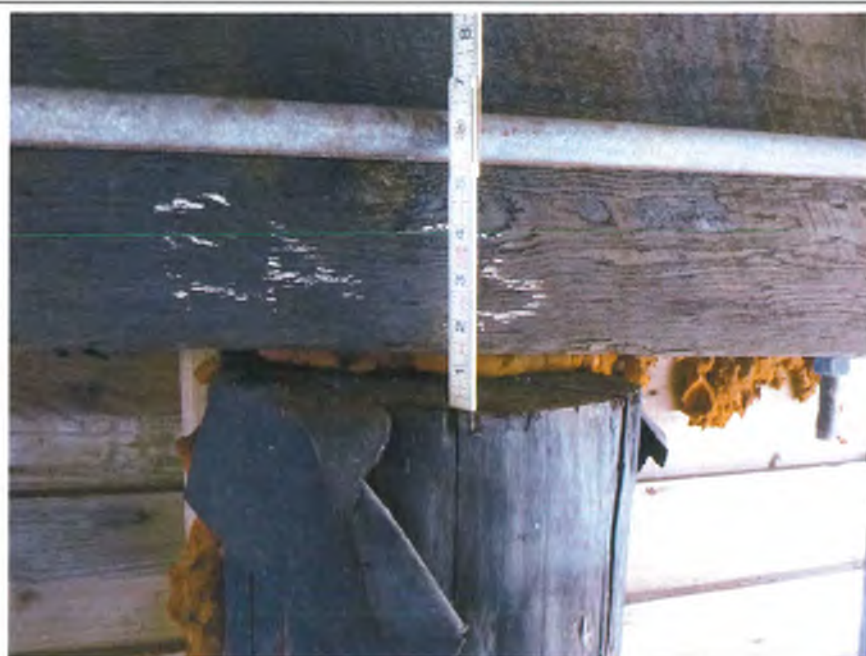
| Photo 33 | Category: | 36 - Piles/Sheeting/Wales |

| | Description: | Pile 3 at the East Abutment, looking east. 1" gap between the abutment cap and pile. |

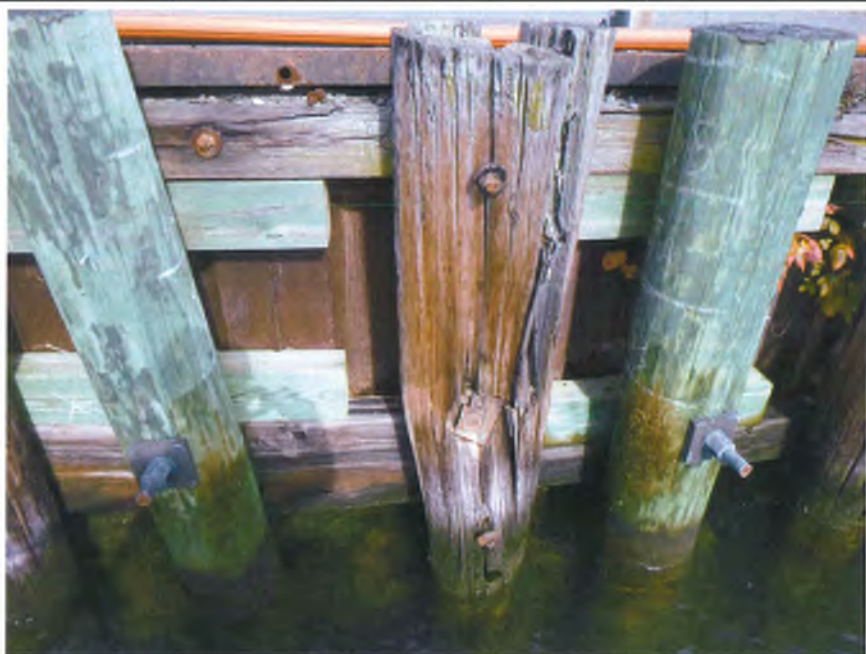
| Photo 34 | Category: | 31 - Wingwalls/Retaining Walls/Headwalls |

| | Description: | Southeast wingwall, looking north. The 14th pile from the East Abutment is deteriorated. |

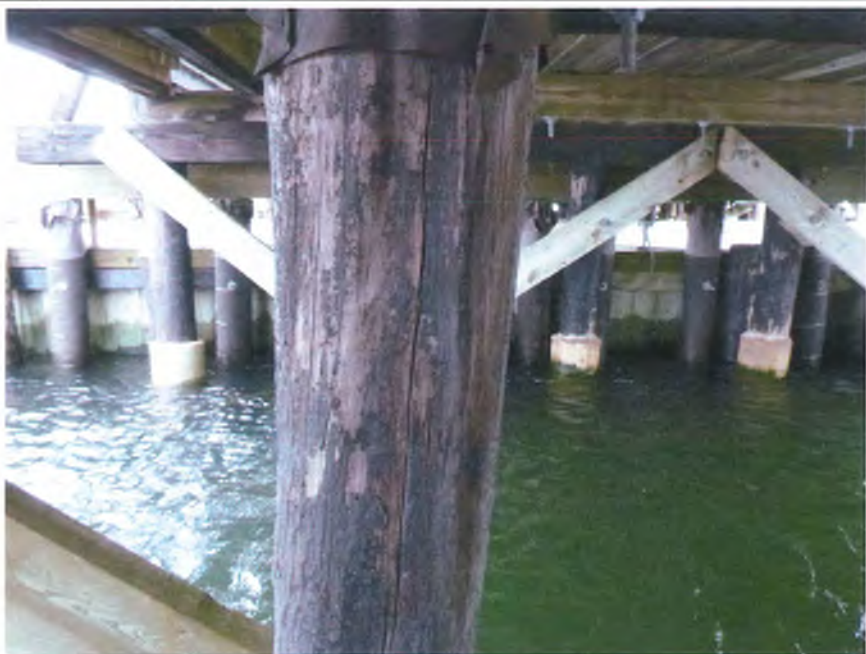
| Photo 36 | Category: | 35 - Pile Bent/Cap/Bracing/Foundation |

| | Description: | Bent 4, Pile 5, in Span 4, looking east. Surface check in pile. |

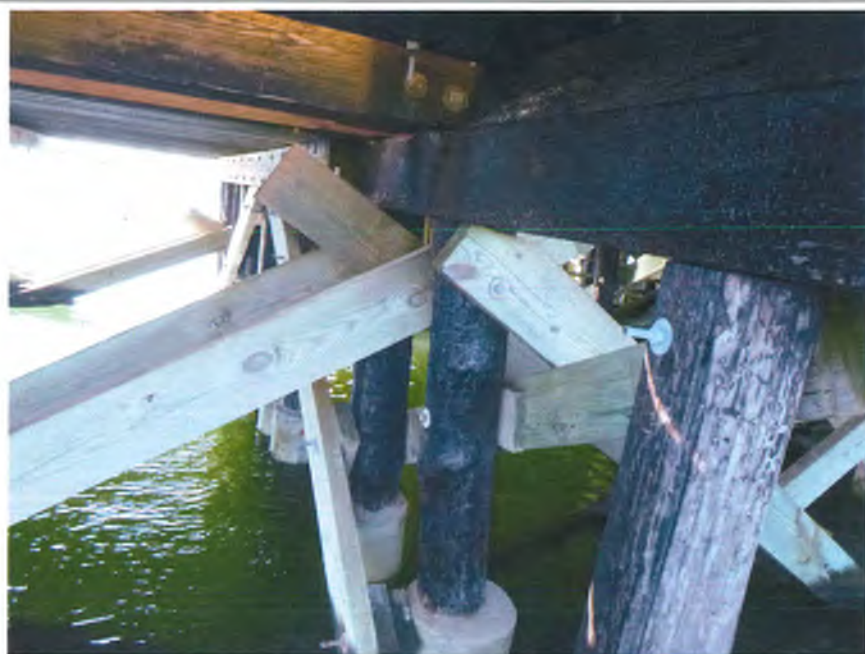
| Photo 37 | Category: | 59 - Other |

| | Description: | Bent 8 in Span 9, looking south. Bent is charred from previous fire damage. |

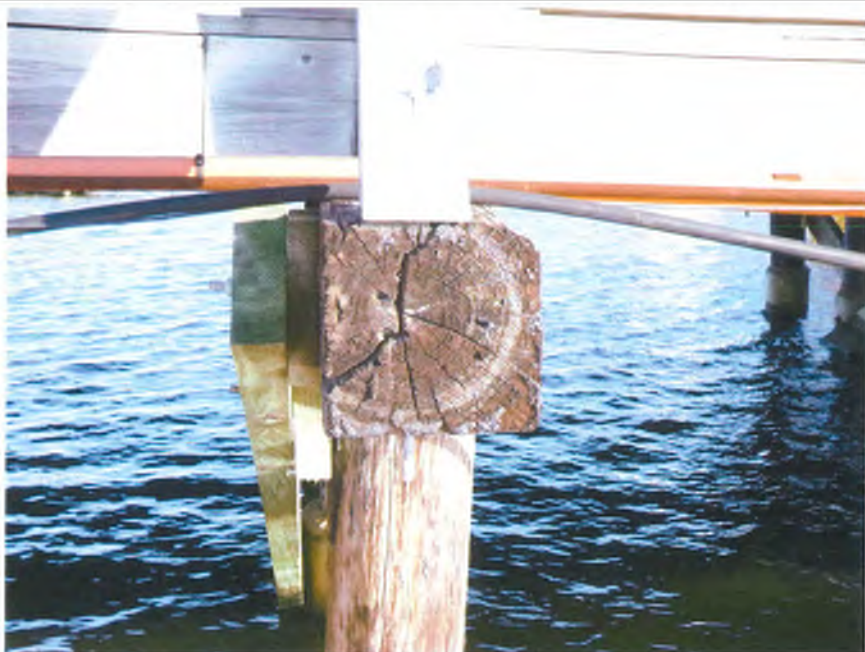
| Photo 38 | Category: | 35 - Pile Bent/Cap/Bracing/Foundation |

| | Description: | Bent 15 pier cap, looking north. South nose has wide checks. |

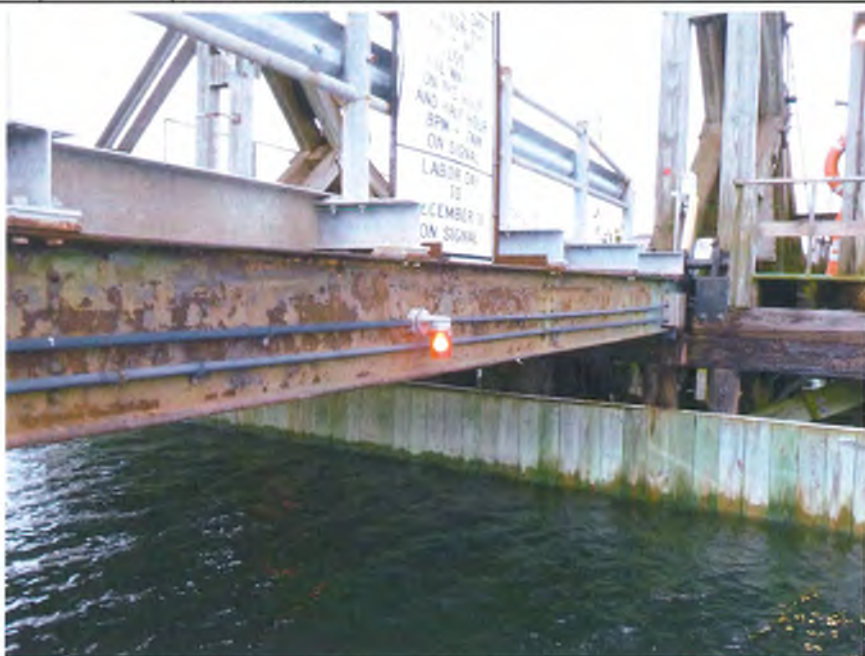
Photo 42 Category: 61 - Work Done, 39 - Fender System/Navigation Lighting

Description: South fascia at Span 6, looking northeast.  
Work Done: The navigational light on the north fascia at the midspan of Span 6 has been replaced.

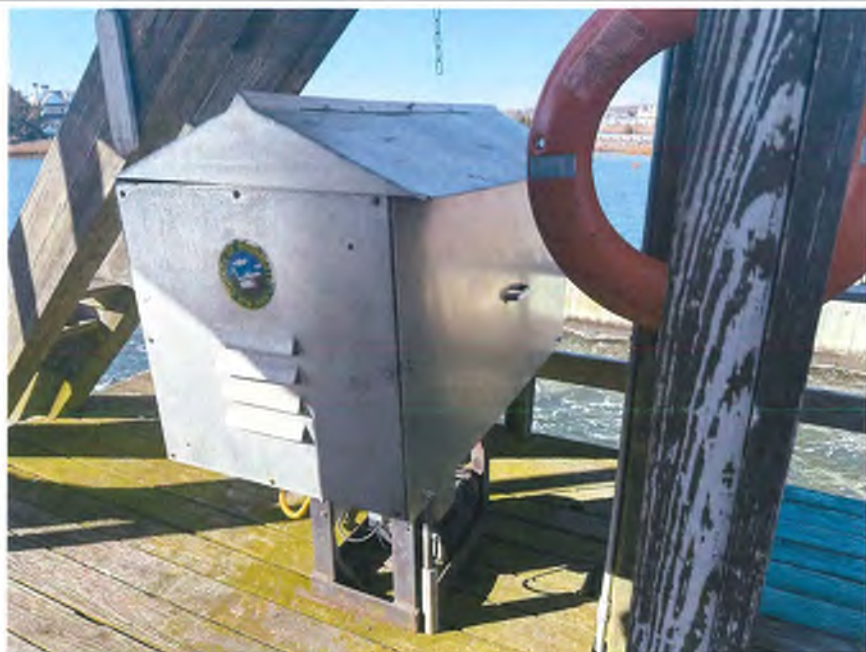
| Photo 1 | Category: | 59 - Other, 60 - Priority Repair |

| | Description: | Genset on the operator's platform, looking east. Genset is inoperable. |

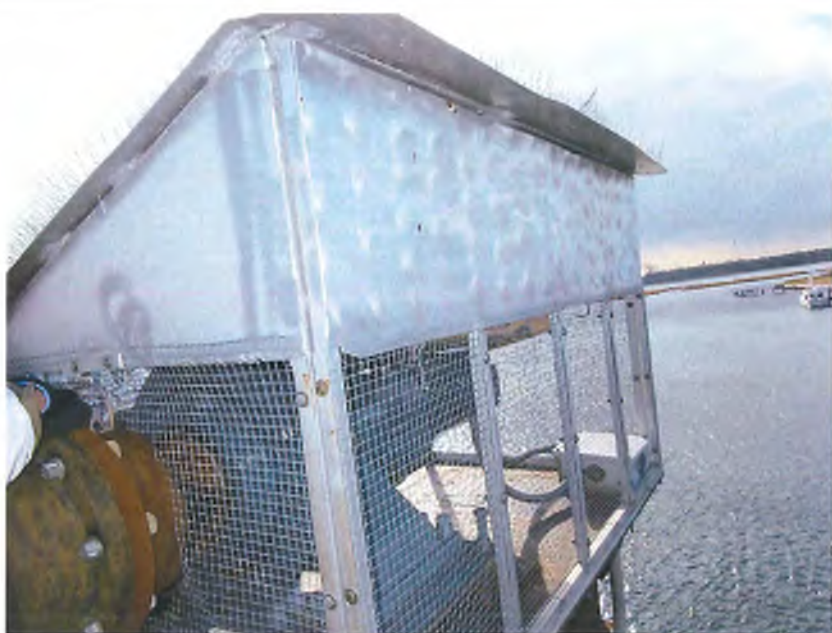
Photo No: M03

**Description:** The gearmotor enclosure removable panel could not be removed as the cotter pins were heavily corroded and frozen in place.

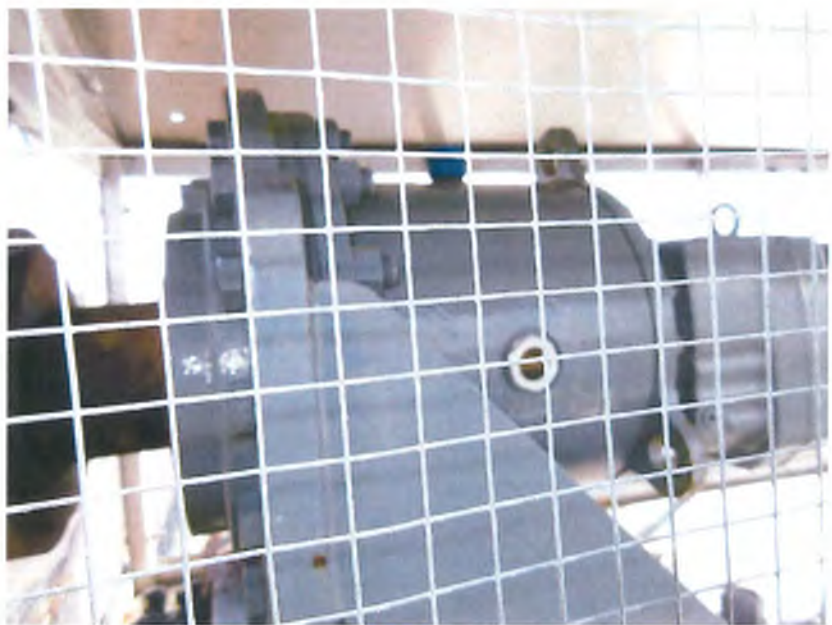
Photo No: M04

**Description:** The output shaft of the gearmotor is not painted.

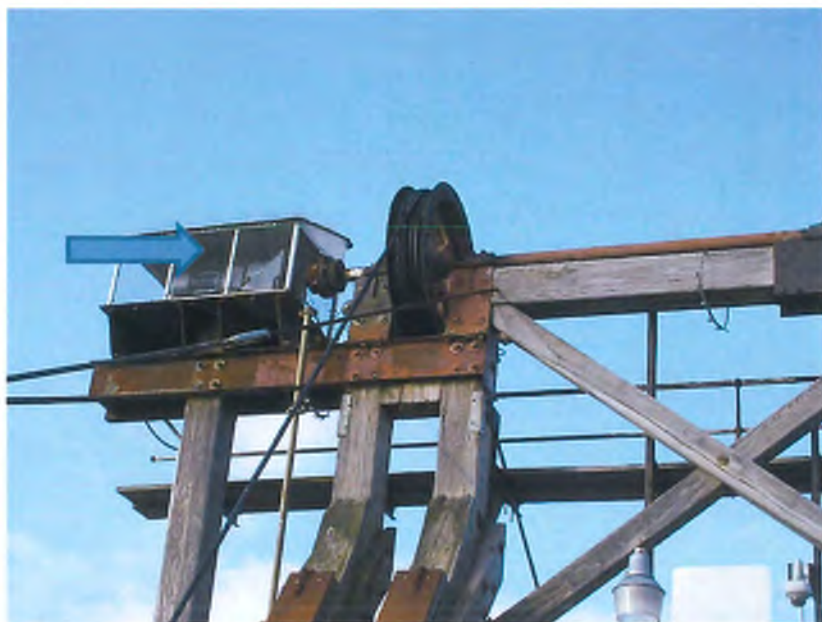
Photo No: M05

**Description:** The machinery supports exhibit paint deterioration and light corrosion.

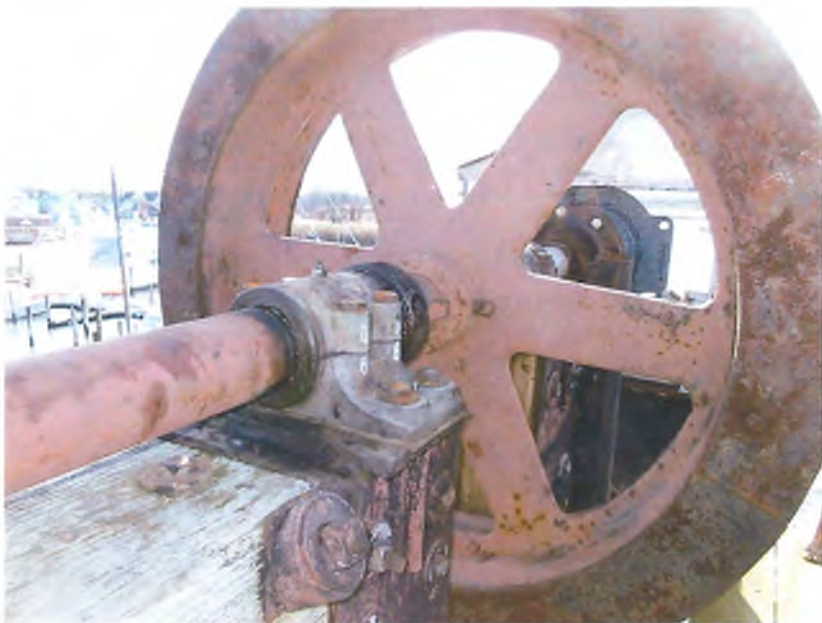
Photo No: M06

**Description:** South operating drum and shaft bearing. The bearing and drum are in fair condition with light corrosion in spots.

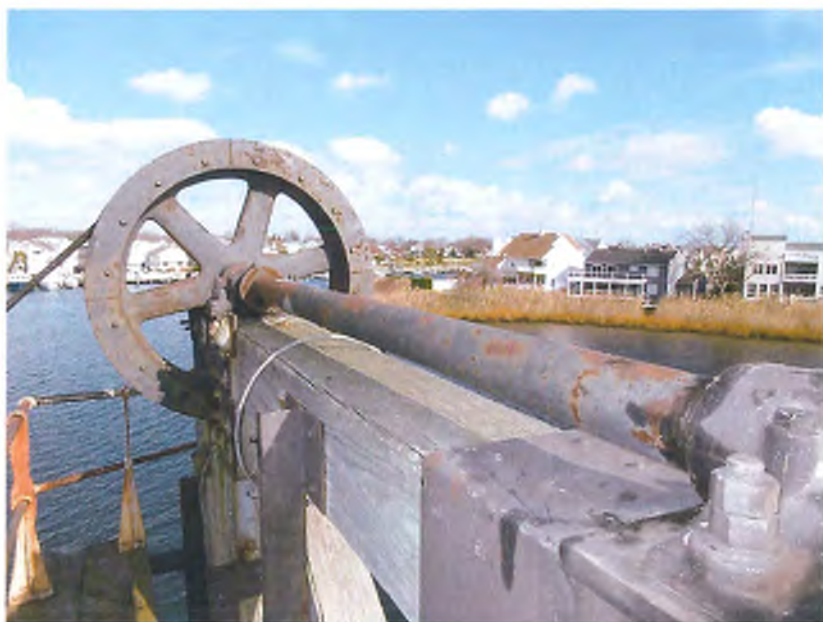
Photo No: M07

| <b>Description:</b> | The shafts had isolated areas of minor corrosion. |

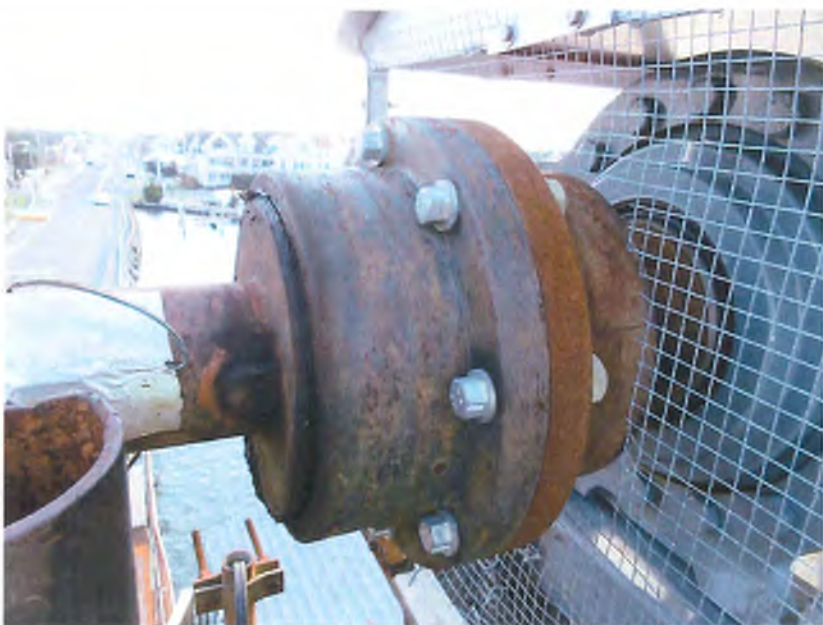
Photo No: M08

| <b>Description:</b> | South coupling. Note the corrosion of the assembly. |

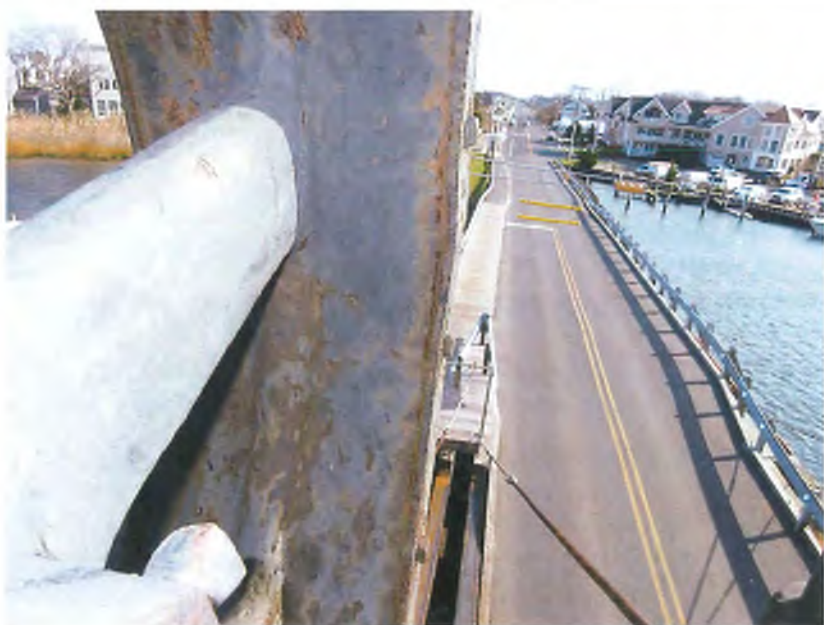
Photo No: M10

**Description:** North operating drum. Note the impacted corrosion between the flange and the drum.

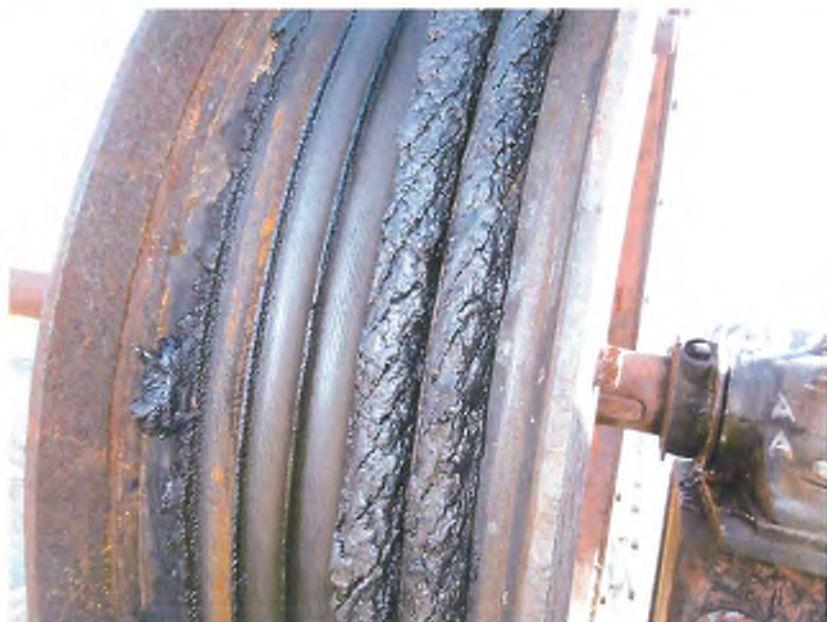
**Photo No: M11**

**Description:** South operating drum. Note the corrosion and wire imprints in the rope grooves.

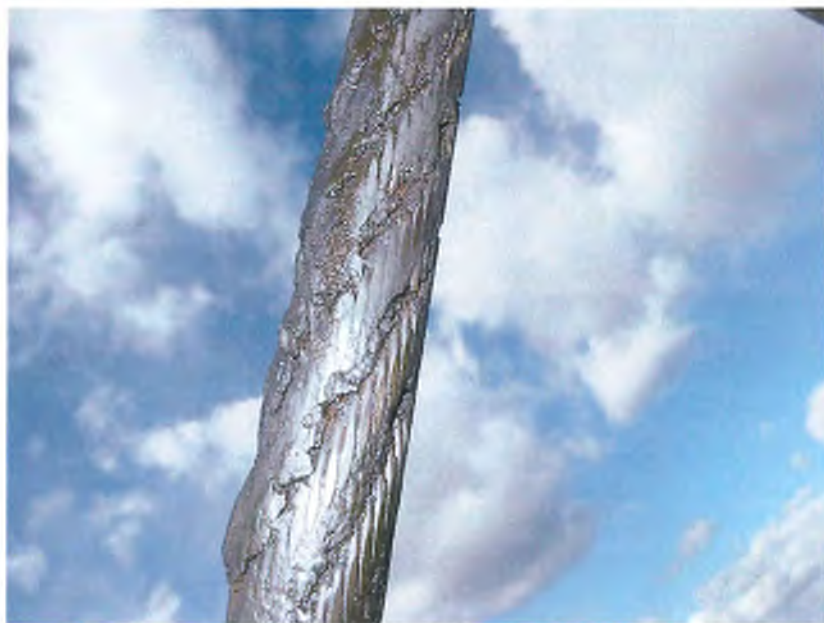
**Photo No: M12**

**Description:** North Counterweight Rope. Area of the rope in contact with the drum grooves have flats that indicate the wire rope has experienced moderate wear.

- rope flats indicate moderate wear - seen from machinery platform

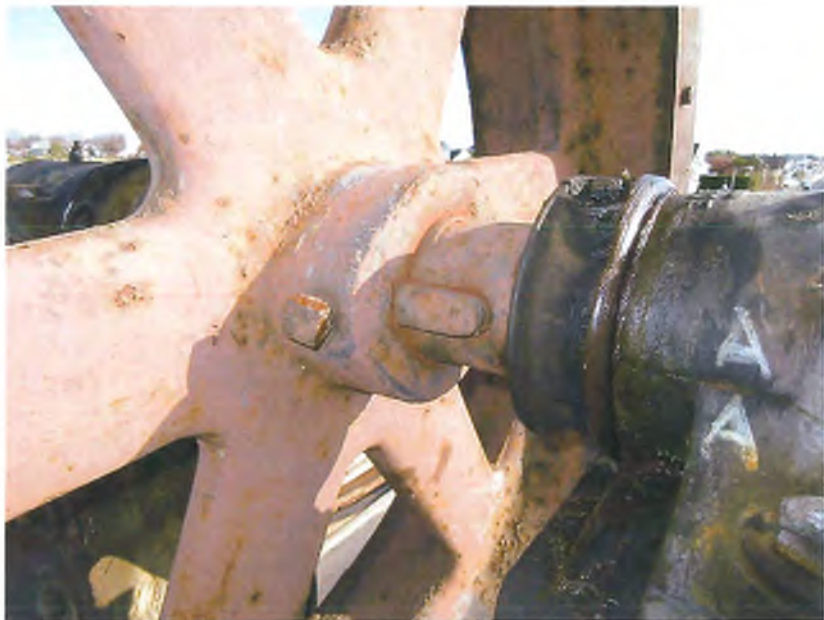
Photo No: M13

**Description:** North drum assembly. There is light fretting corrosion at the hub, key and shaft interfaces.

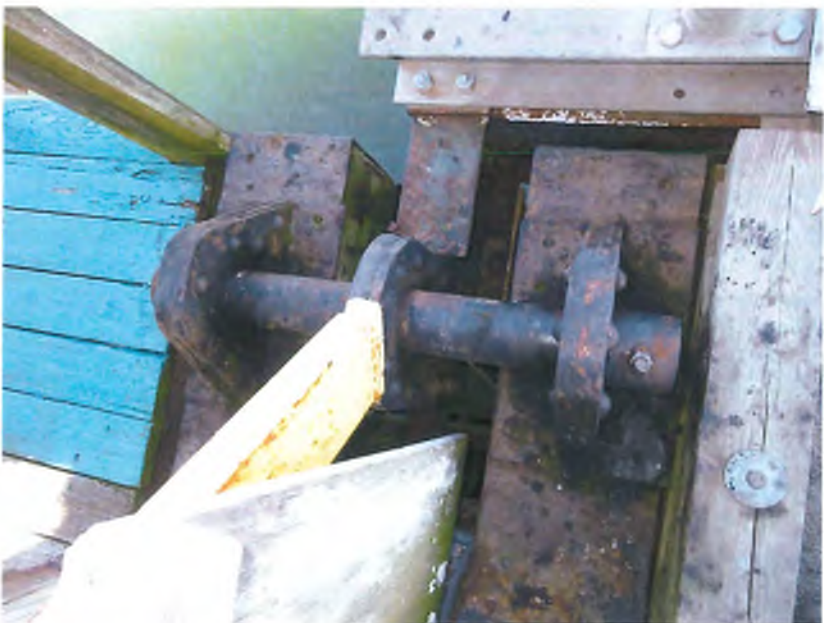
Photo No: M14

**Description:** South heel trunnion assembly. The components have light surface corrosion in spots.

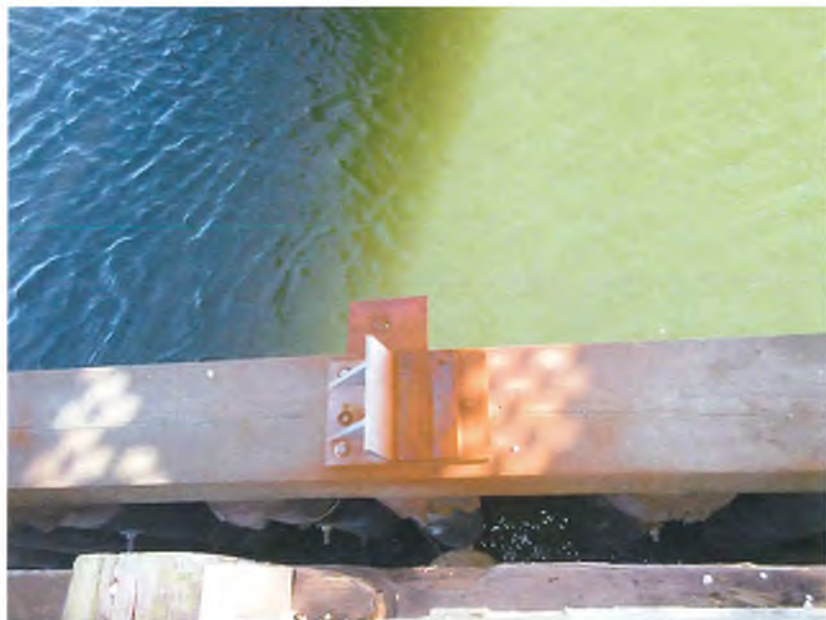
Photo No: M15

**Description:** South Forward Live Load Support. The strike plate and centering guide are in good condition.

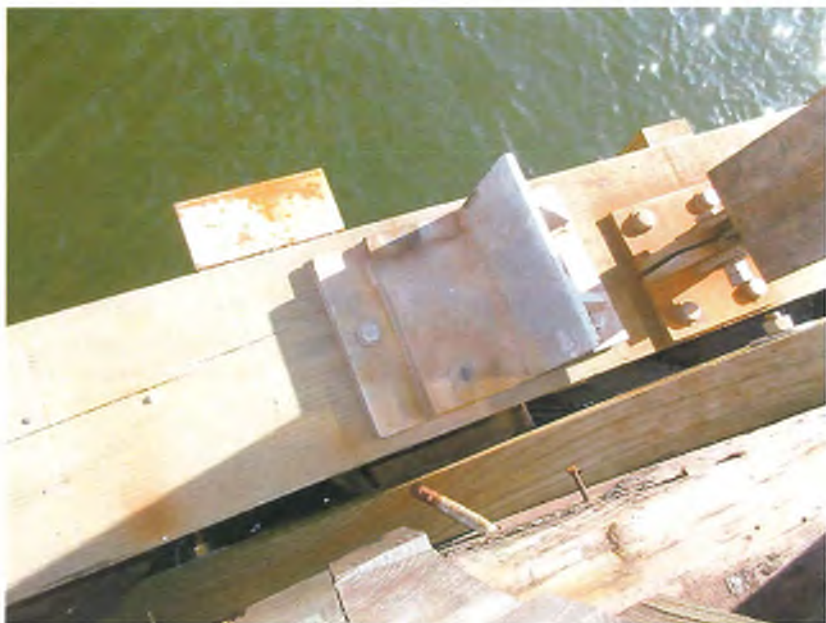
Photo No: M16

**Description:** North Forward Live Load Support. Note the contact on the strike plate.

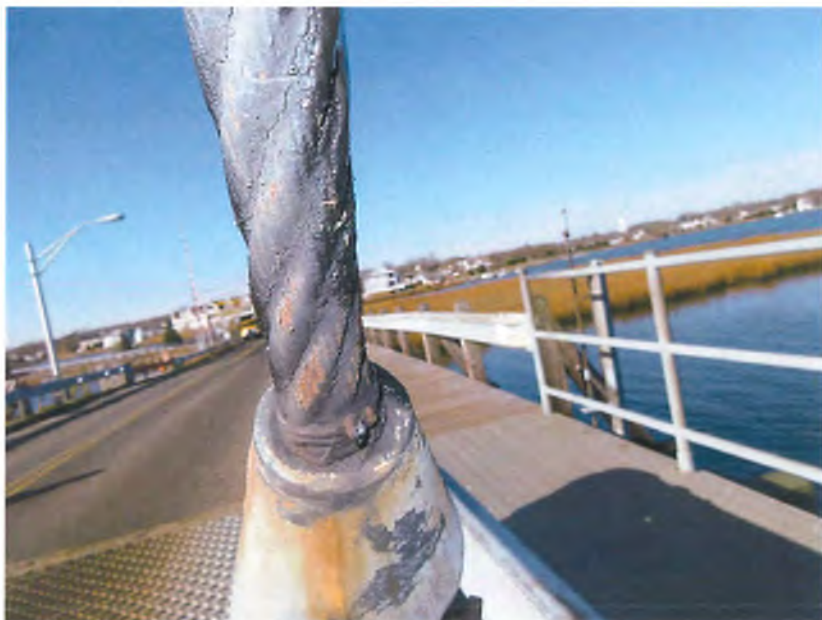
Photo No: M17

| <b>Description:</b> | North rope connection to lift span. The rope is corroded due to inadequate lubricant. |

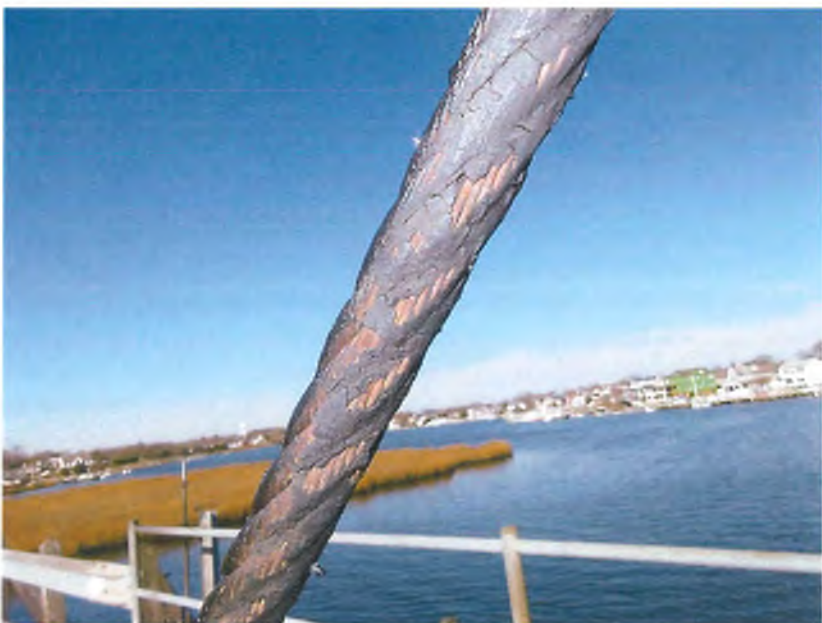
Photo No: M18

| <b>Description:</b> | North rope connection to lift span. The rope is corroded due to inadequate lubricant. |

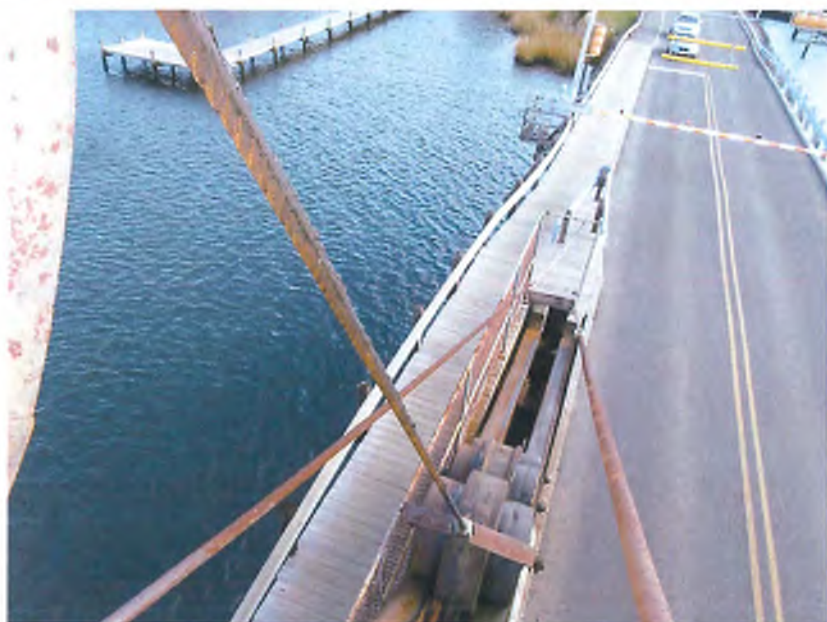
Photo No: M19

| <b>Description:</b> | North rope that contacts the sheave on the counterweight side. The rope is corroded due to inadequate lubricant. |

Areas of moderate corrosion on north rope that contacts the sheave on the counterweight side.

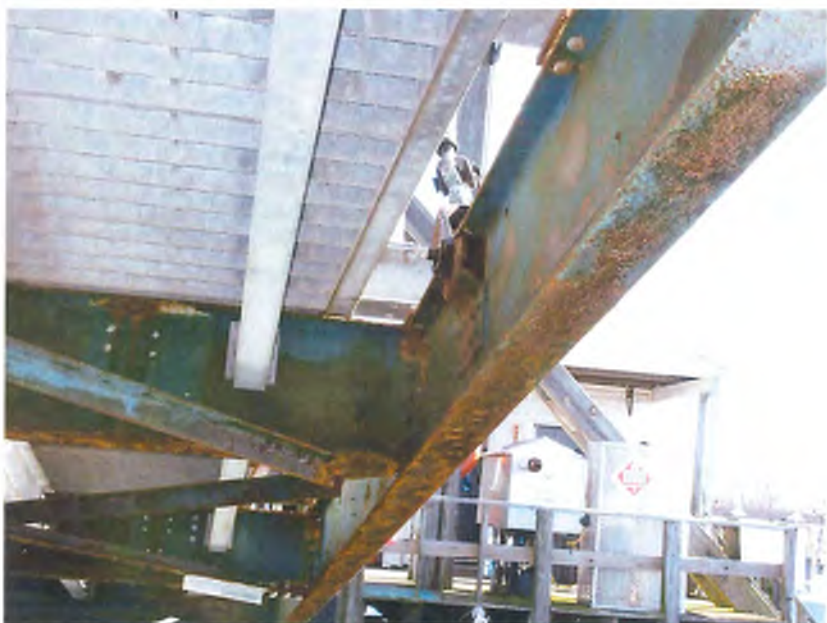
Photo No: M20

| <b>Description:</b> | South rope connection to span. Note the corrosion. |

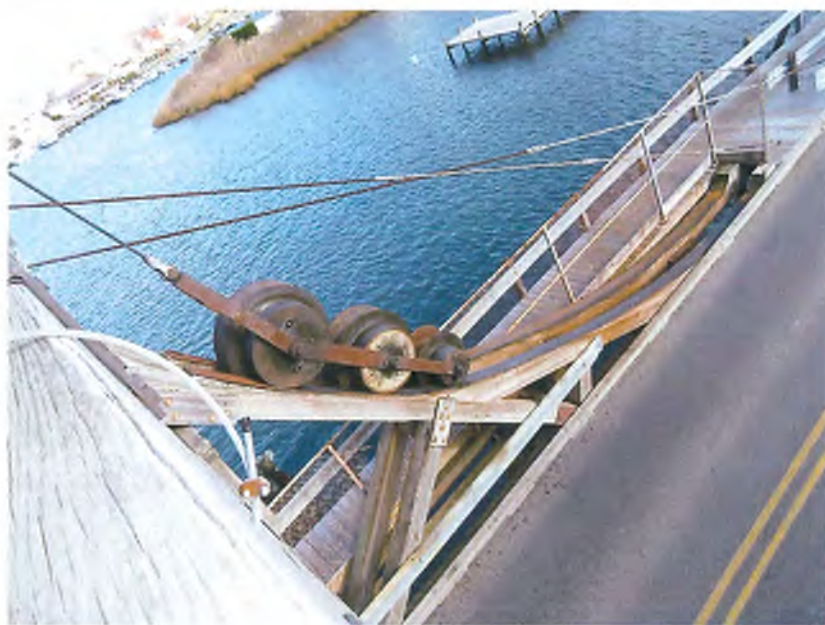
Photo No: M21

**Description:** North counterweight assembly. The components are not painted and were covered in surface corrosion, though the integrity of the connections appears to be good.

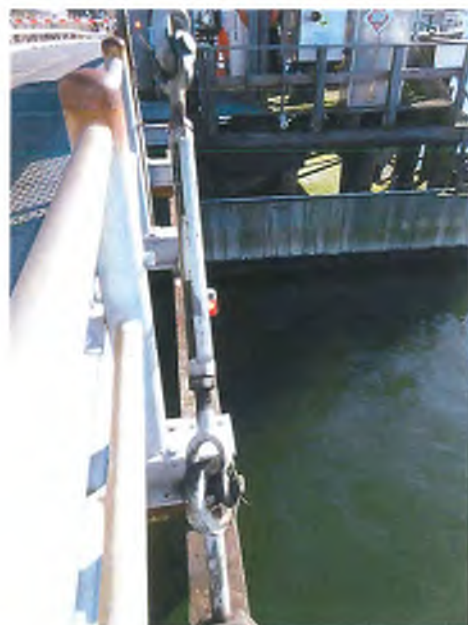
Photo No: M22

**Description:** South Take-up Threads. Covered with heavy corrosion and may not allow for adjustment of the rope when needed.

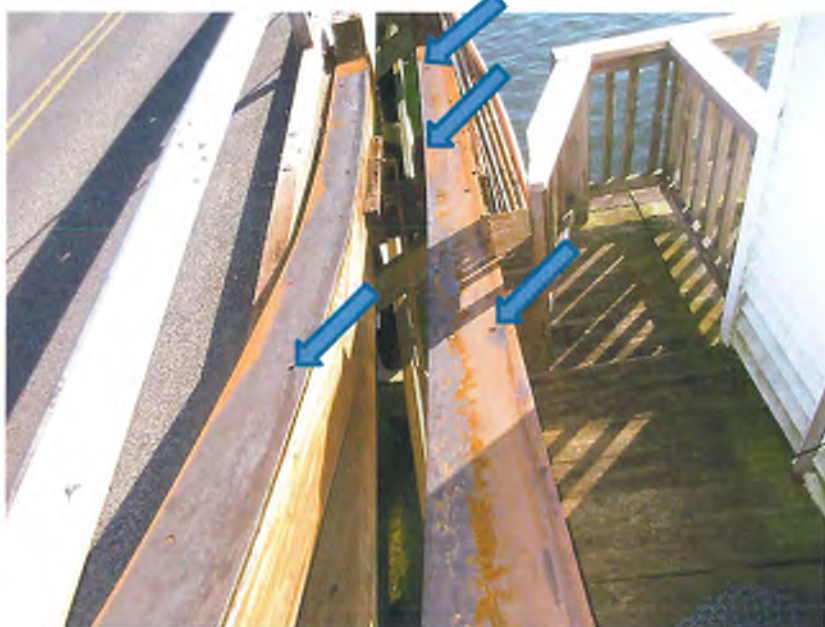
Photo No: M23

**Description:** South counterweight assembly curved tread plates. Note the missing lag screws (arrows).

-Missing / damaged lag screws in roller plates:

15 Total either damaged or missing

-Clear that over time screw heads get contacted and are damaged.

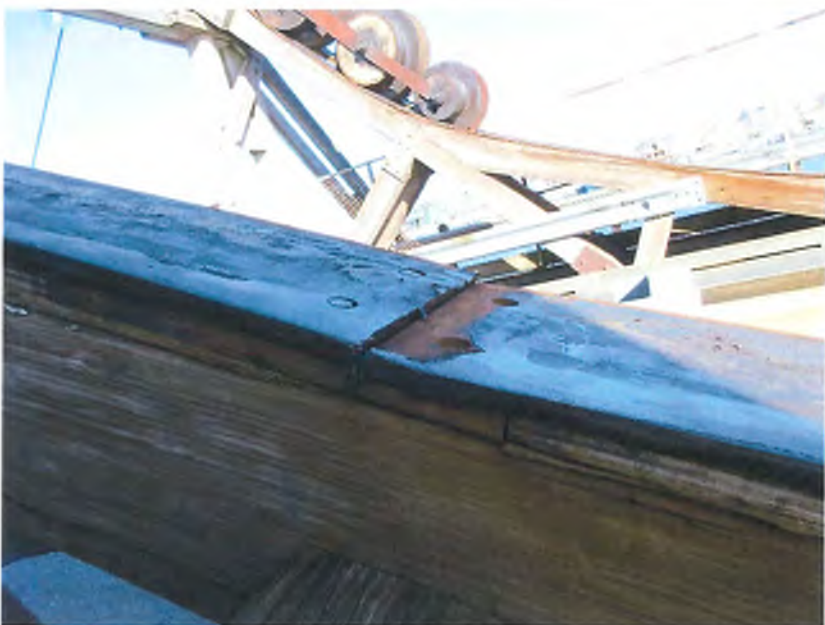
Photo No: M24

**Description:** South counterweight assembly inboard curved tread plates. Note the step between the upper and lower curved tread plate.

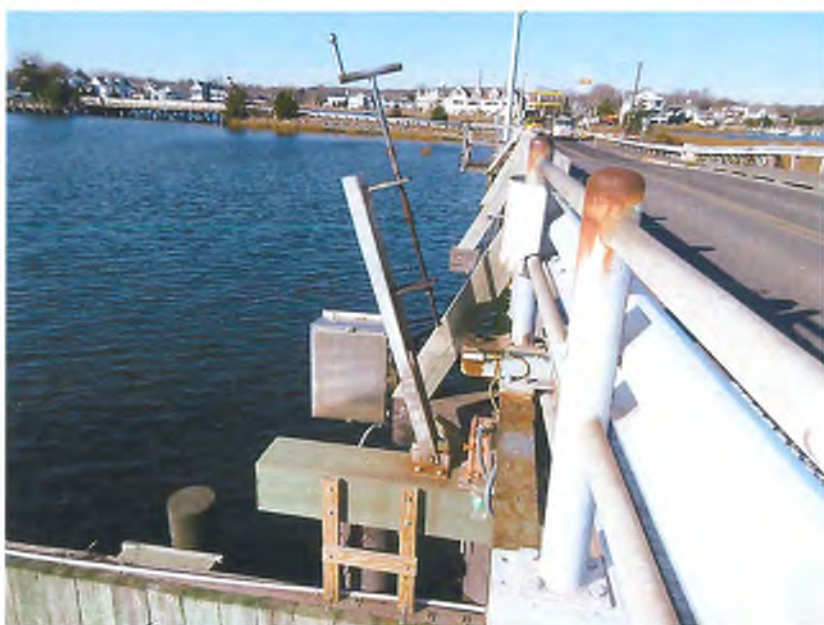
Photo No: M25

**Description:** South span lock assembly. Many of the components are galvanized steel and only minor corrosion was noted at the components.

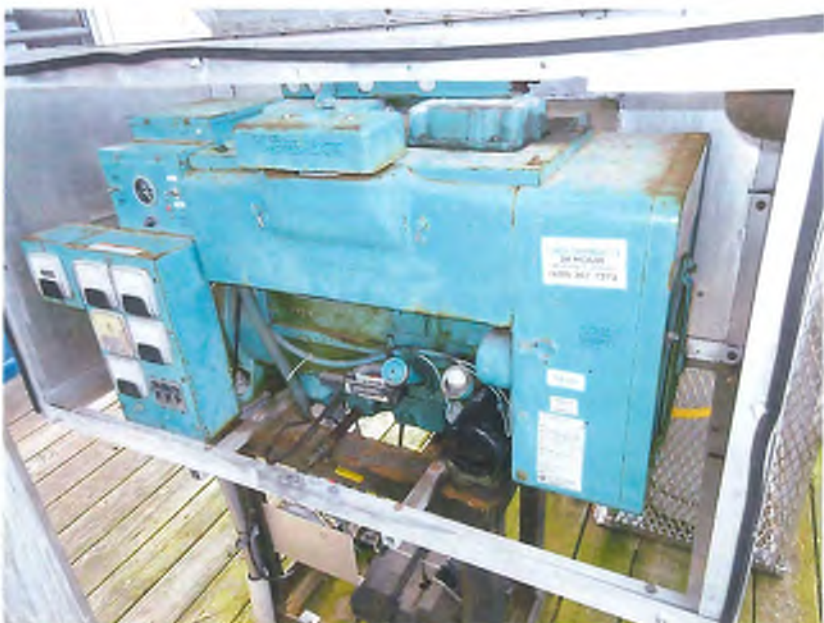
Photo No: M26

**Description:** Auxiliary generator. The generator did not turn on during the inspection.

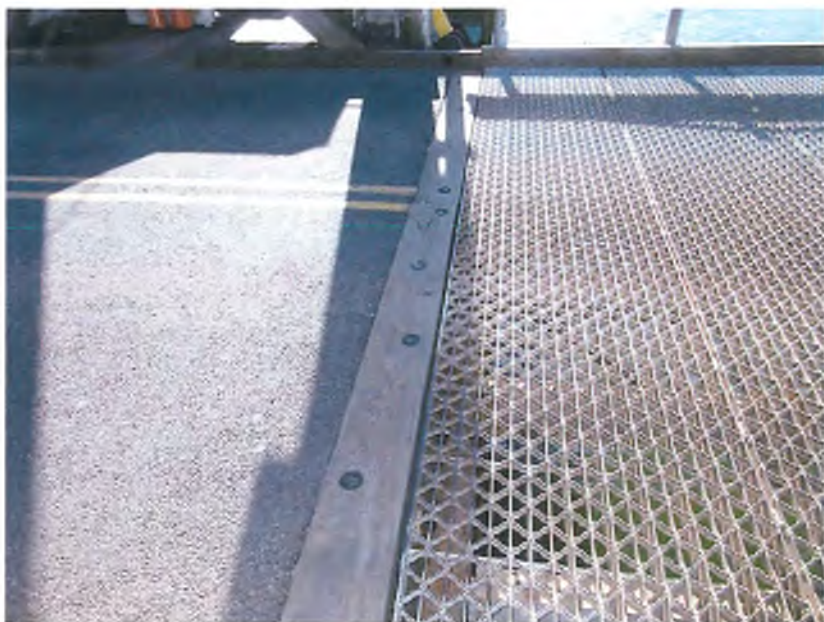
Photo No: M27

**Description:** The elevation difference and horizontal gap across the roadway joints is good at all locations.

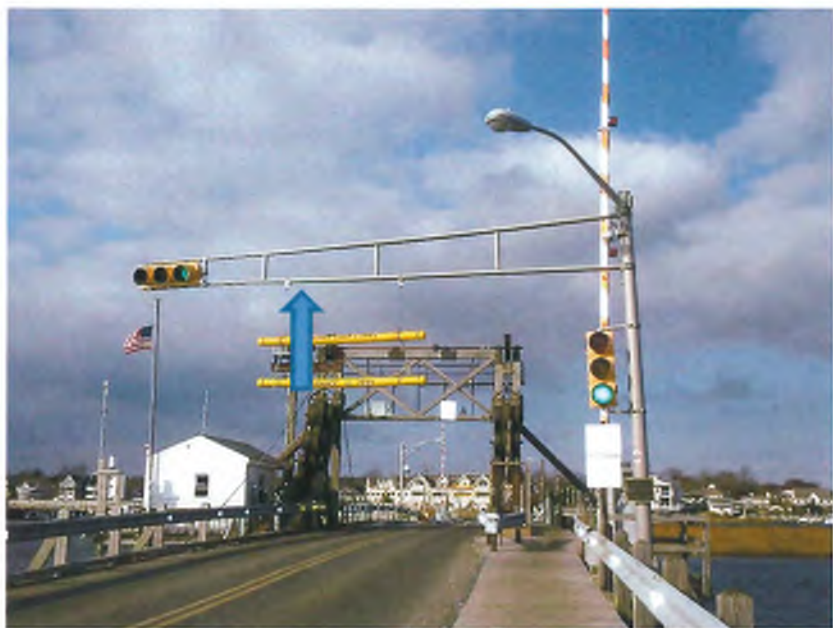
Photo No: E01

**Description:** The mast arm is turned away from traffic.

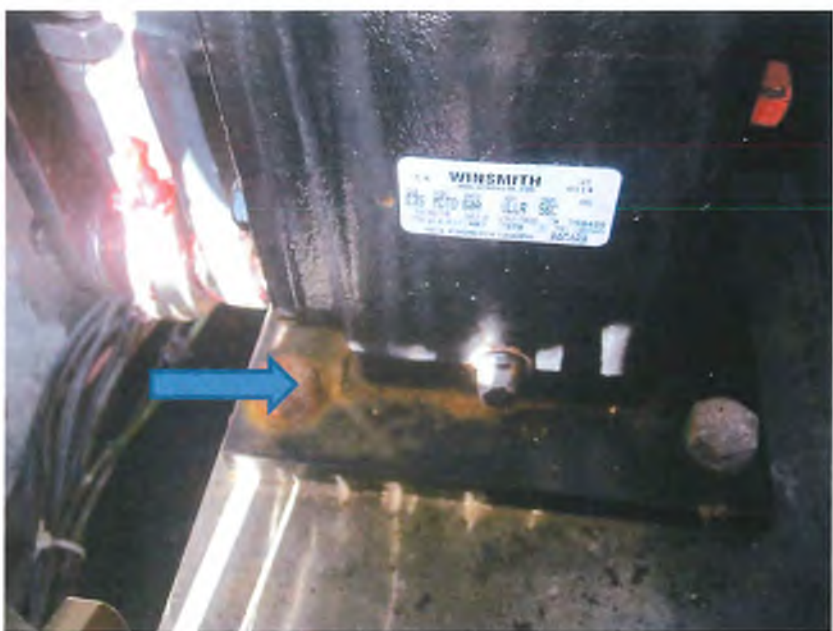
Photo No: E02

**Description:** There is evidence of water intrusion and corrosion on the reducer fasteners and base inside the warning gate.
