## **APPENDIX D**

### **LATEST AVAILABLE BRIDGE REPORTS**

## BRIDGE RE-EVALUATION SURVEY REPORT

STATE STRUCTURE NO. 13000W7  
COUNTY STRUCTURE NO. W7  
GREEN AVENUE OVER DEBBIES CREEK  
Brielle Borough  
MONMOUTH COUNTY

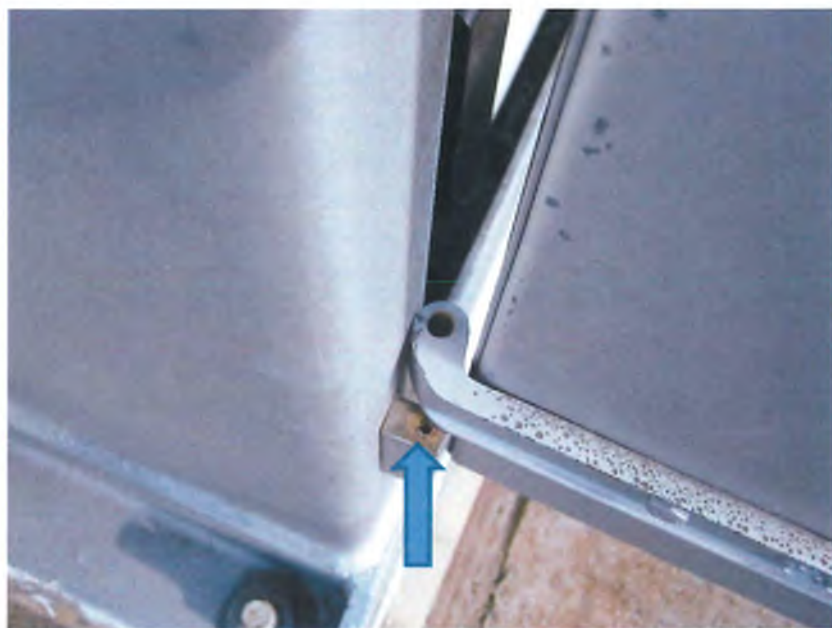
Photo No: E03

| <b>Description:</b> | A hinge on the door is missing its pin. |

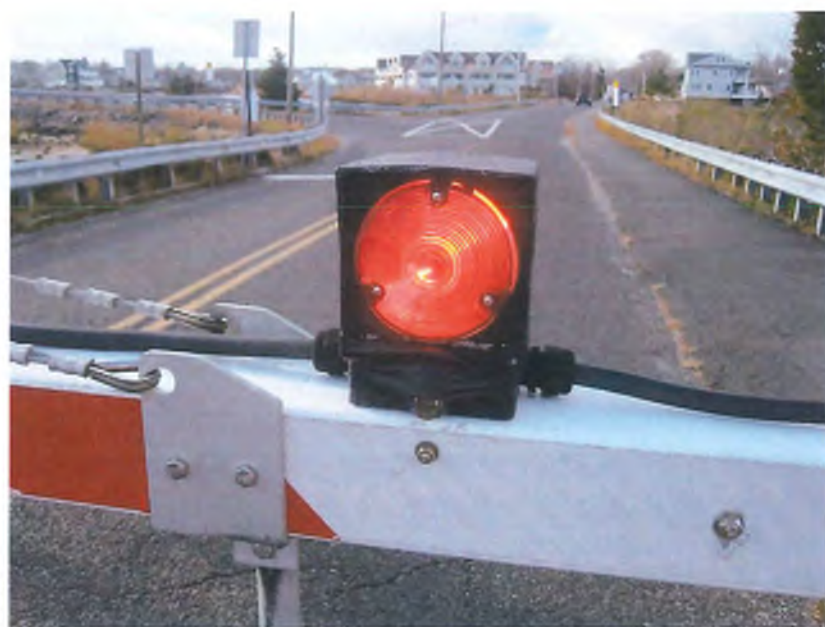
Photo No: E04

| <b>Description:</b> | The center light on the gate arm is secured with electrical tape. |

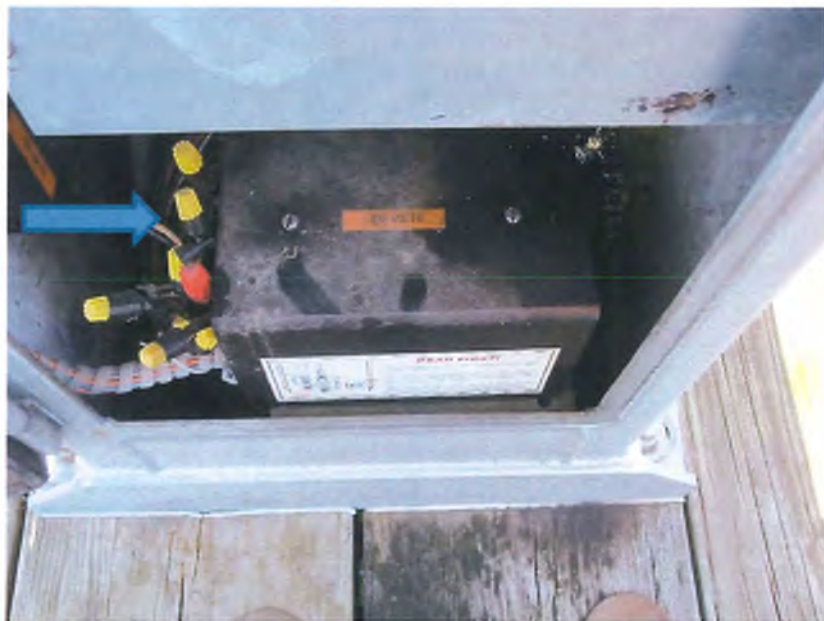
Photo No: E05

| <b>Description:</b> | Wire nut splices are present within the gate. This is typical for the west warning gate. |

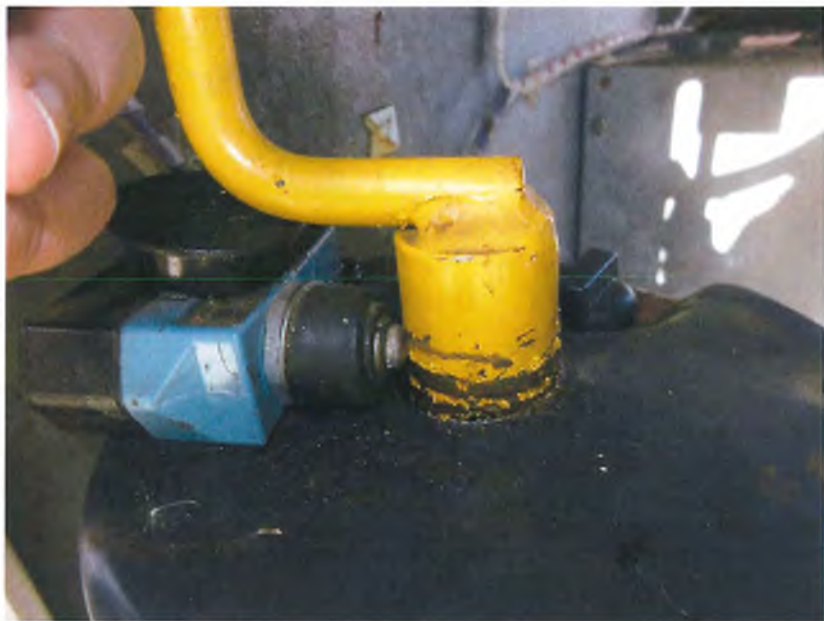
Photo No: E07

| <b>Description:</b> | The hand crank limit switch does not actuate reliably with the hand crank inserted. |

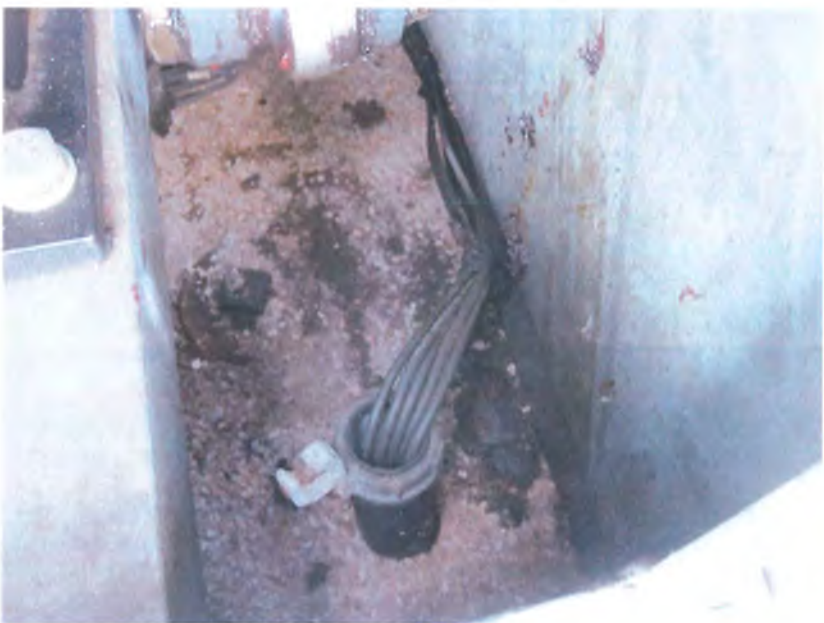
Photo No: E08

| <b>Description:</b> | The interior conduit hub is not ground bonded. |

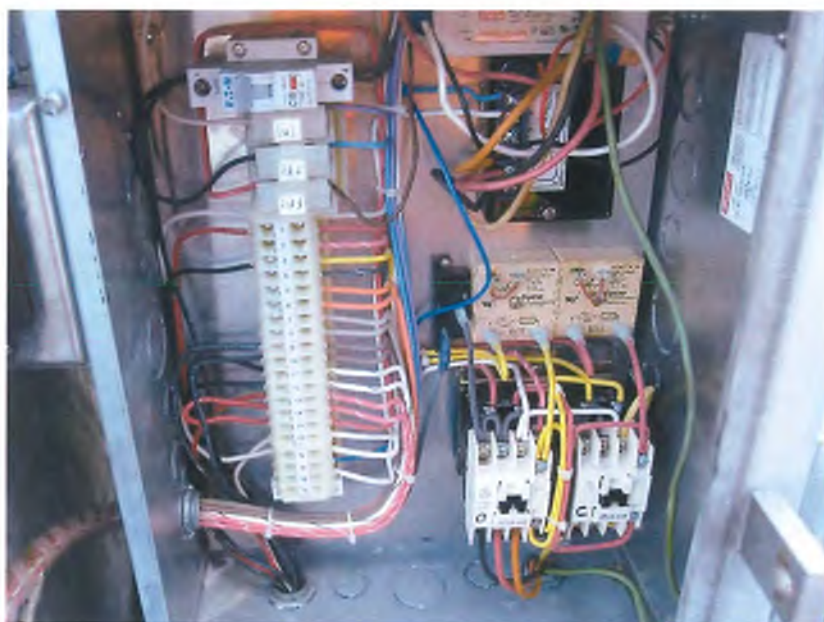
Photo No: E09

| <b>Description:</b> | The gate has unlabeled conductors. This is typical for the west warning gate. |

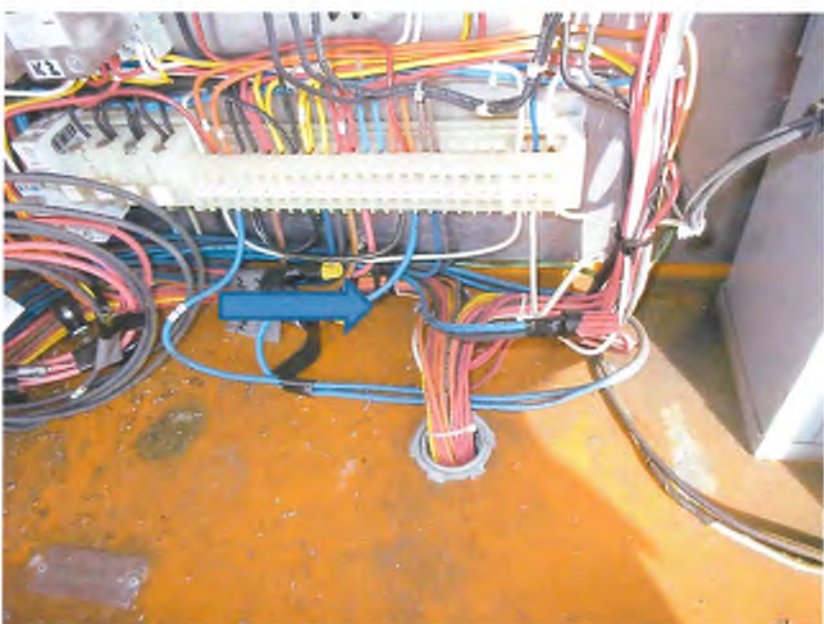
Photo No: E10

| <b>Description:</b> | Wire nut splices are present within the gate motor junction box. |

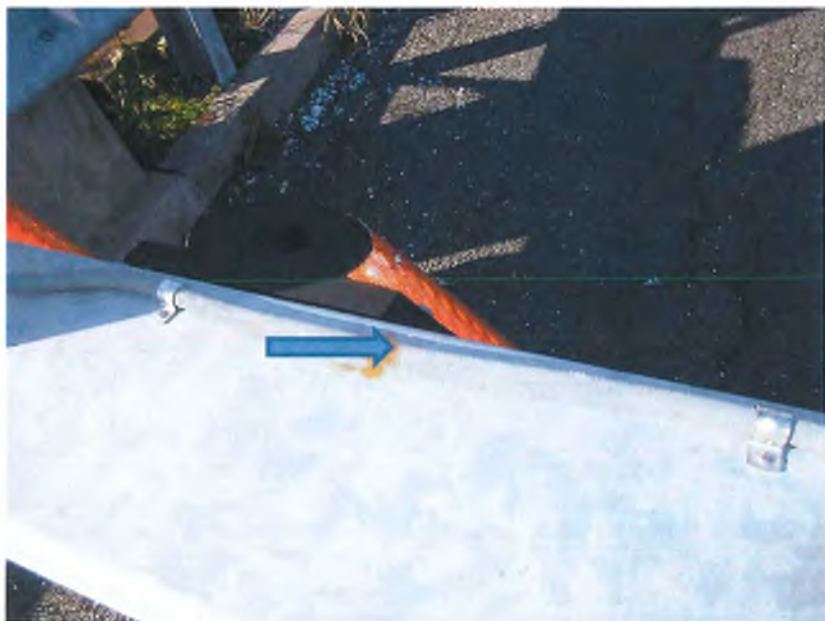
Photo No: E11

| <b>Description:</b> | There is corrosion on the LFMC feeding the lights on the gate. |

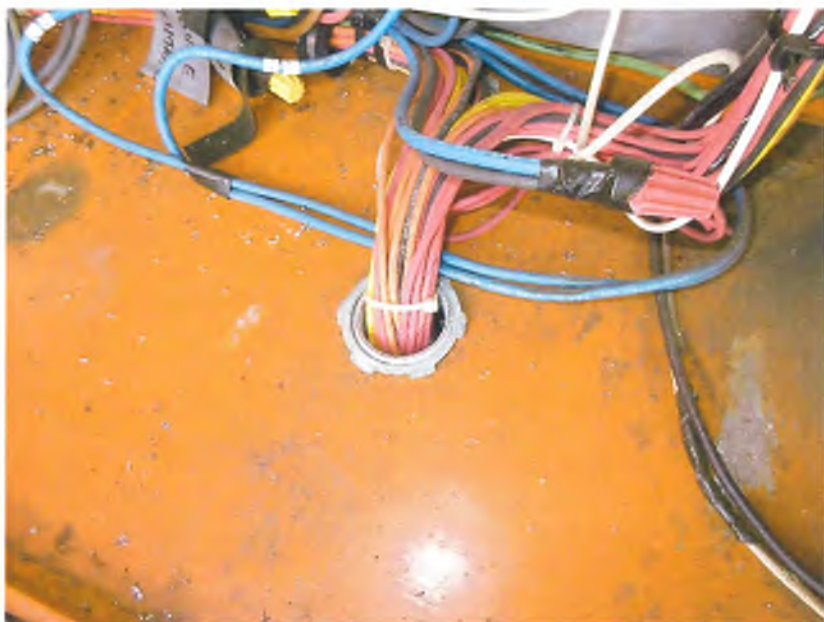
Photo No: E13

| <b>Description:</b> | There is a missing grommet for the control conductors inside the gate motor junction box. |

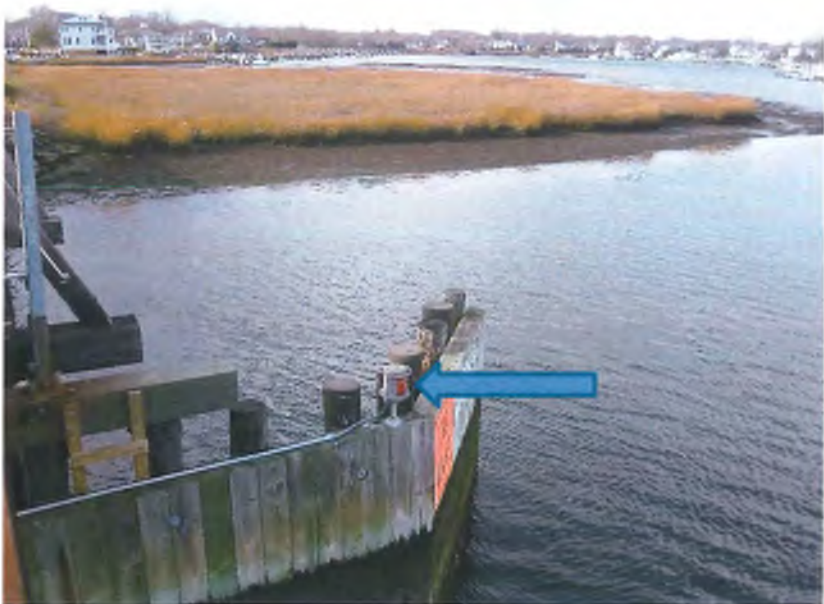
Photo No: E14

| <b>Description:</b> | The pier light is not located at the end of the fender. This is typical for all four corners of the fender system. |

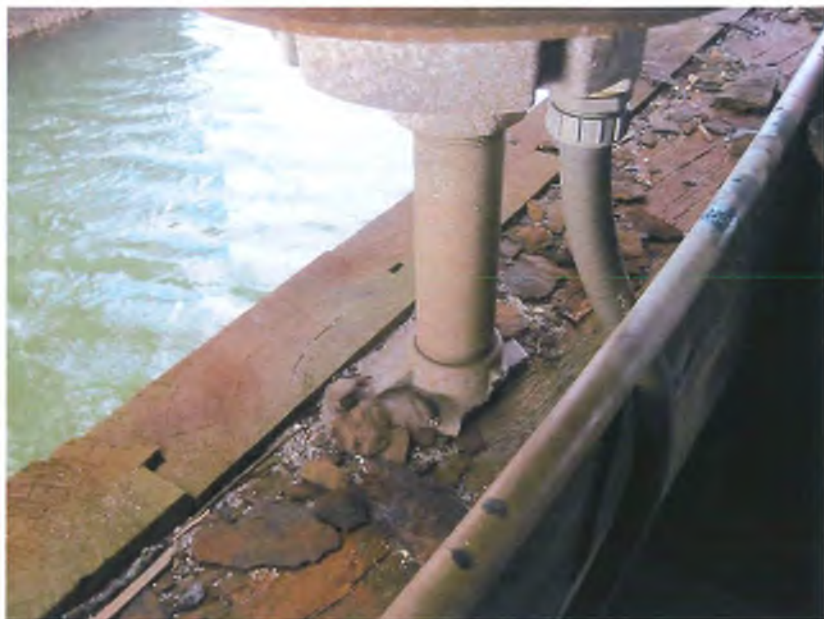
Photo No: E15

| Description: | The axis light has a cracked mounting base. |

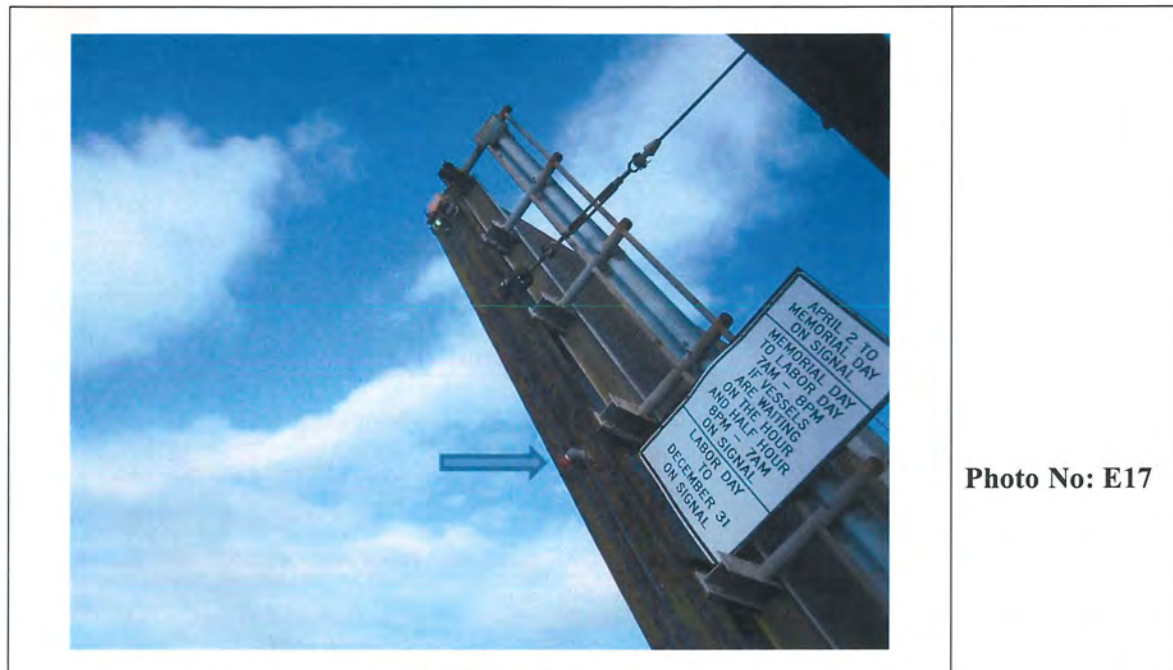
**Photo No: E17**

| <b>Description:</b> | The red lift span light is not located at the free end of the span. This is typical for the north approach. |

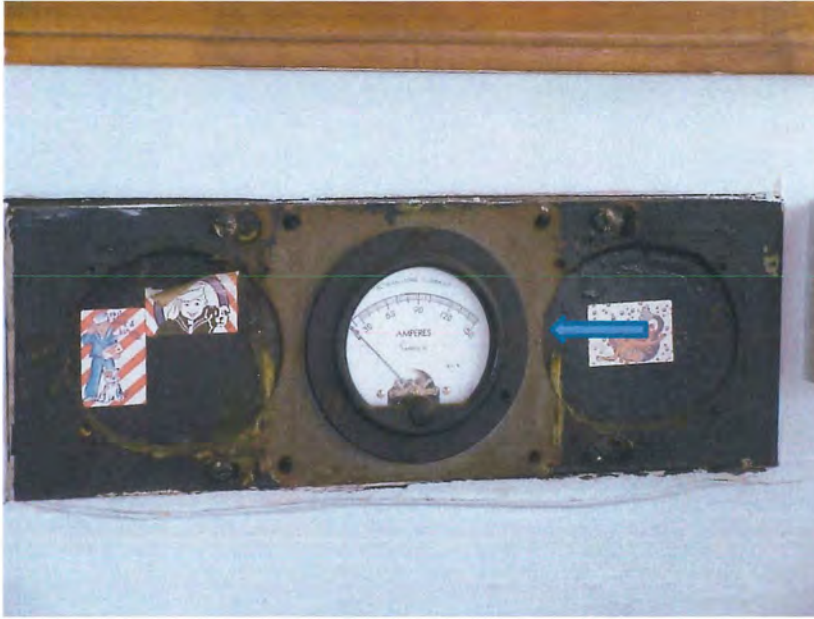
**Photo No: E19**

| <b>Description:</b> | The meters installed above the control console have been abandoned in place. |

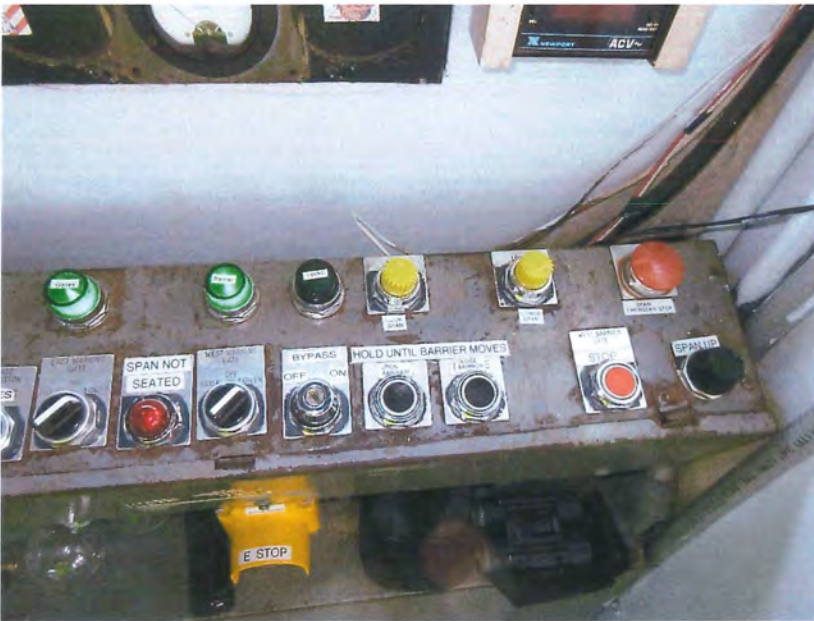
**Photo No: E20**

| <b>Description:</b> | The labels on the control console switches, pushbuttons, and indicating lights are temporary. |

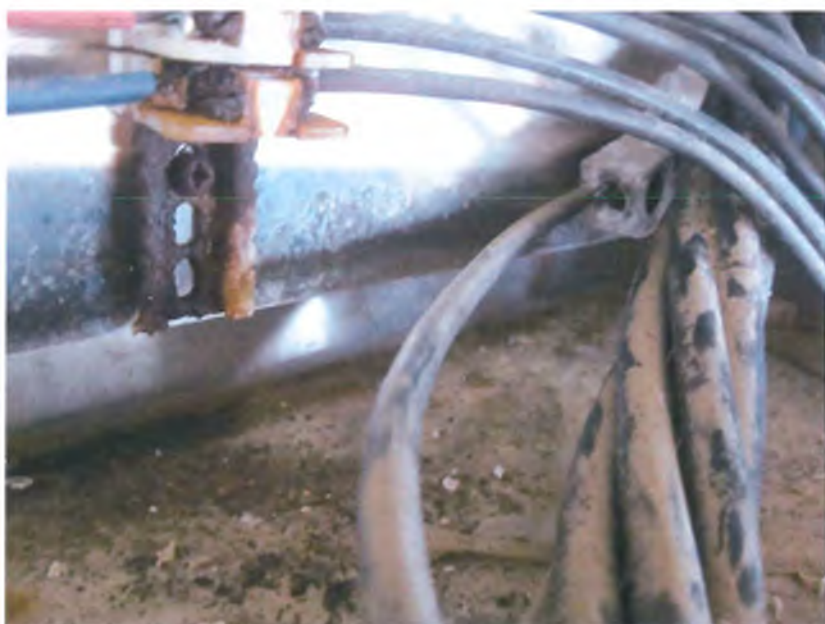
Photo No: E24

| <b>Location:</b> | East Rest Pier |

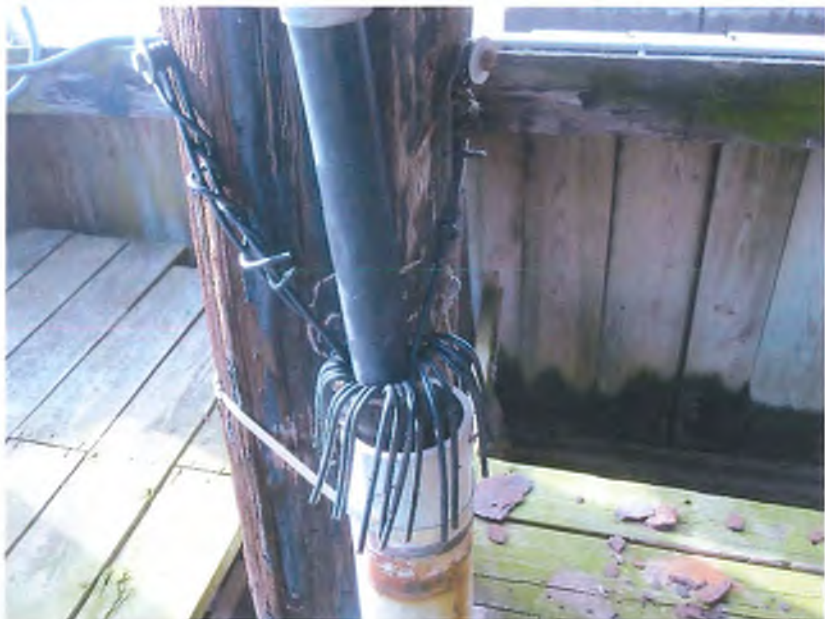
Photo No: E25

**Location:** Platform below Operator's House

**Description:** The cable is supported with four strands of its cable armor wrapped around two lag bolts which may provide inadequate support.

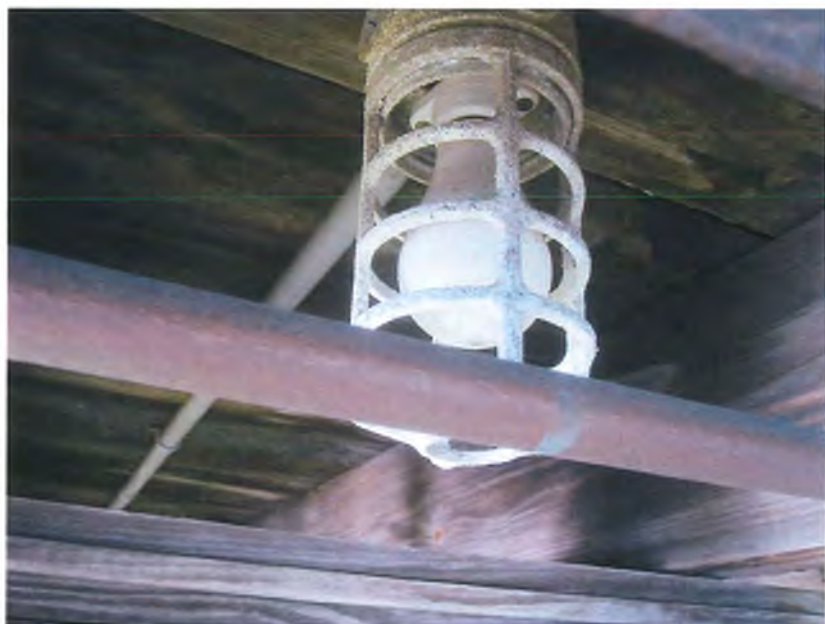
Photo No: E26

**Location:** Platform below Operator's House

**Description:** The lamp has failed and is missing a globe.

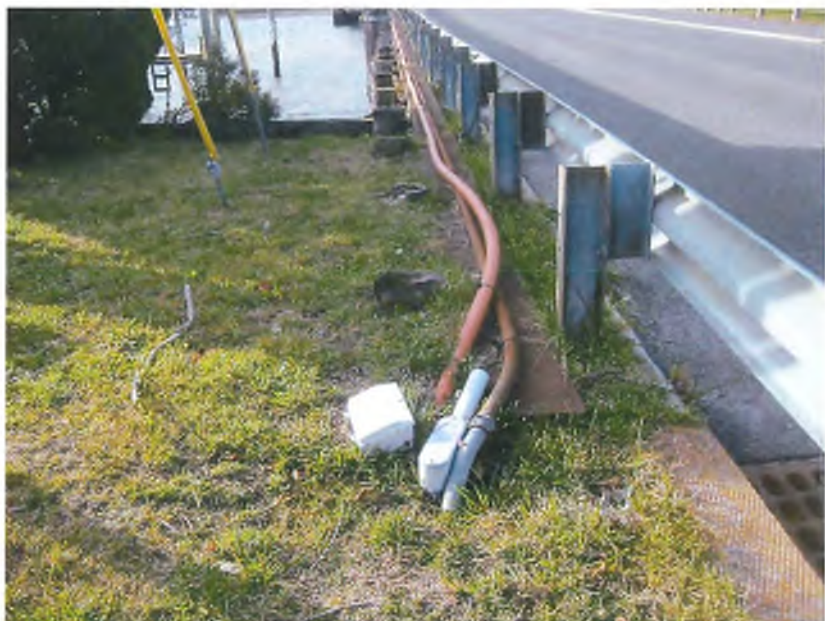
Photo No: E27

**Location:** Southeast Approach

**Description:** There are signs of corrosion on the utility feed conduit at the southeast approach from the meter and pole mounted transformers to the bridge.

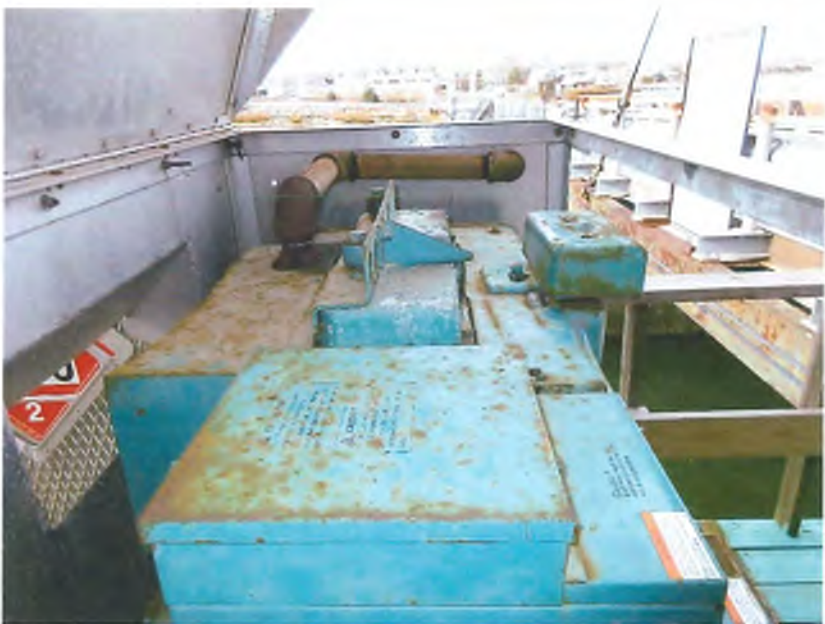
Photo No: E28

**Location:** East Roadway Level

**Description:** The standby generator shows signs of surface corrosion.

- Did not start.
- GFCI was tripped for the block heater
- Runtime: 21.8 hours (SR 0936)
- Surface Corrosion (SR 0939)
- Gauge – not operational due to water ingress (SR 0938)

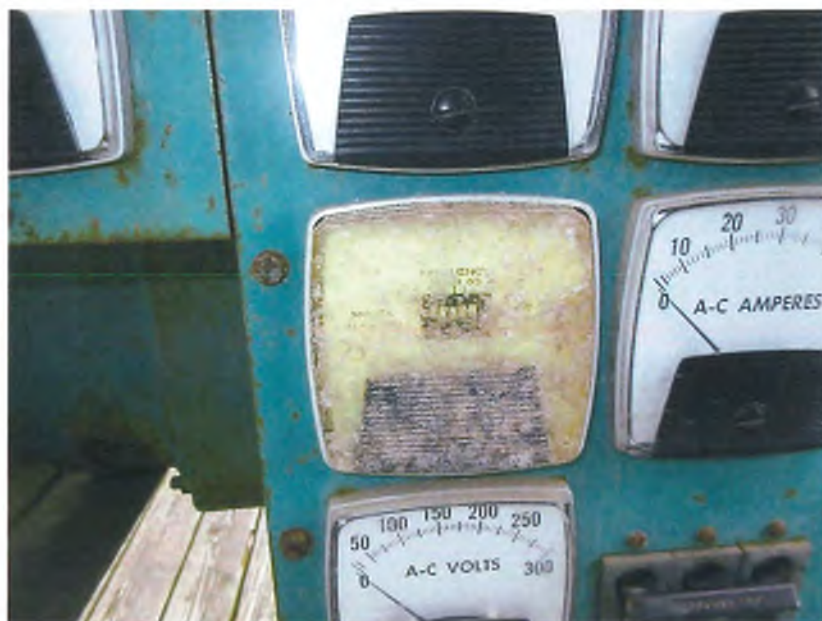
Photo No: E29

| <b>Location:</b> | East Roadway Level |
| <b>Description:</b> | The cover for the frequency meter on the standby generator is cloudy. |

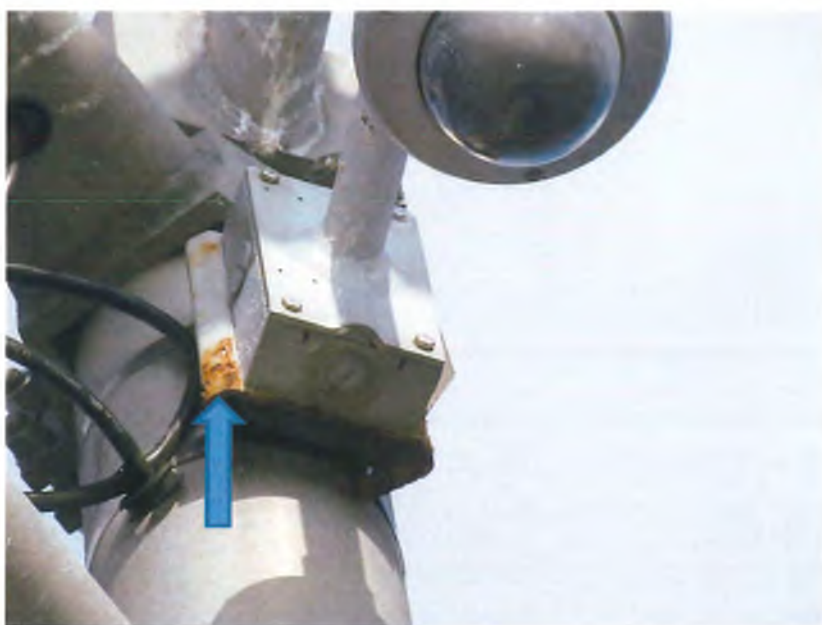
Photo No: E30

| <b>Location:</b> | East Traffic Signal |
| <b>Description:</b> | There are signs of corrosion on the camera enclosure mounted on the signal arm. |

- Camera mount at near signal arm is corroded (SR 0909)
- Camera lens at near signal arm is clouded (SR 0906)
- Monitor is off/system is inoperable (SR 0855) since a year.

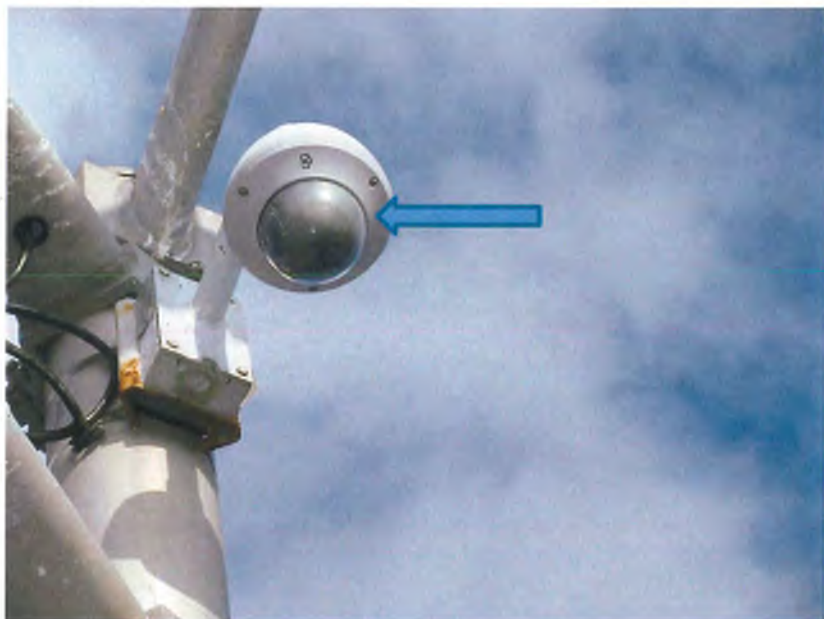
Photo No: E31

| Location: | East Traffic Signal |
| Description: | The camera lens is cloudy. |

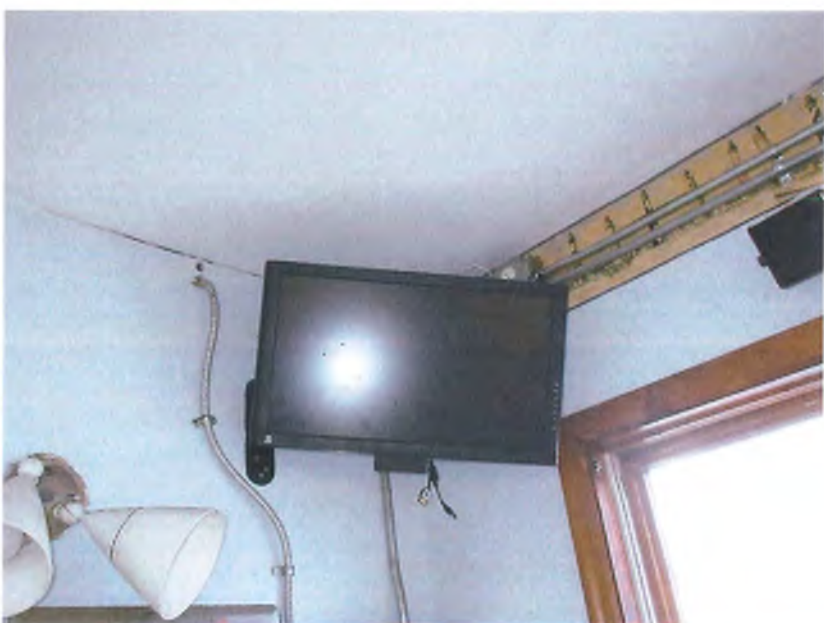
Photo No: E32

| Location: | Operator's House |
| Description: | The overhead monitor has been inoperable for at least a year. |

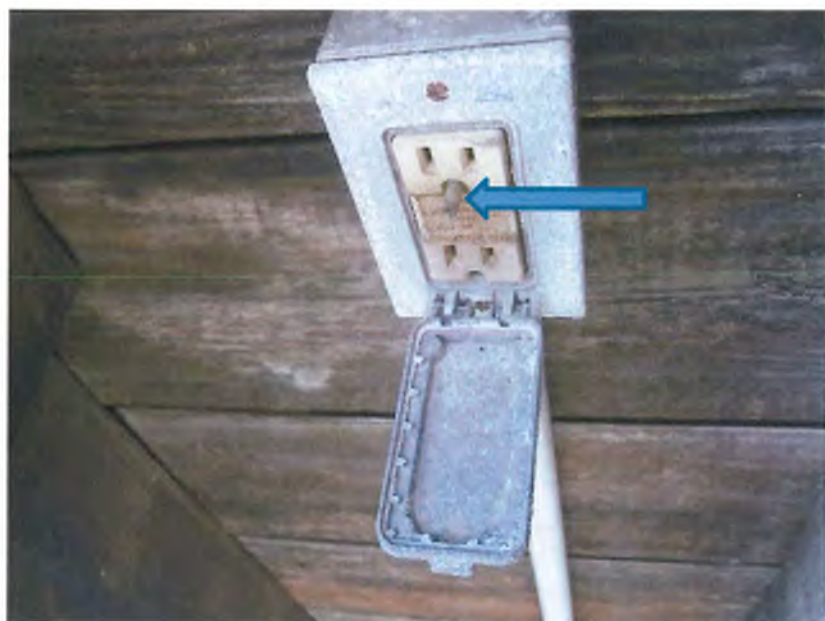
Photo No: E33

| <b>Location:</b> | Platform below Operator's House |
| <b>Description:</b> | The receptacle cover is open and has a pin stuck in the ground connection of the receptacle. |

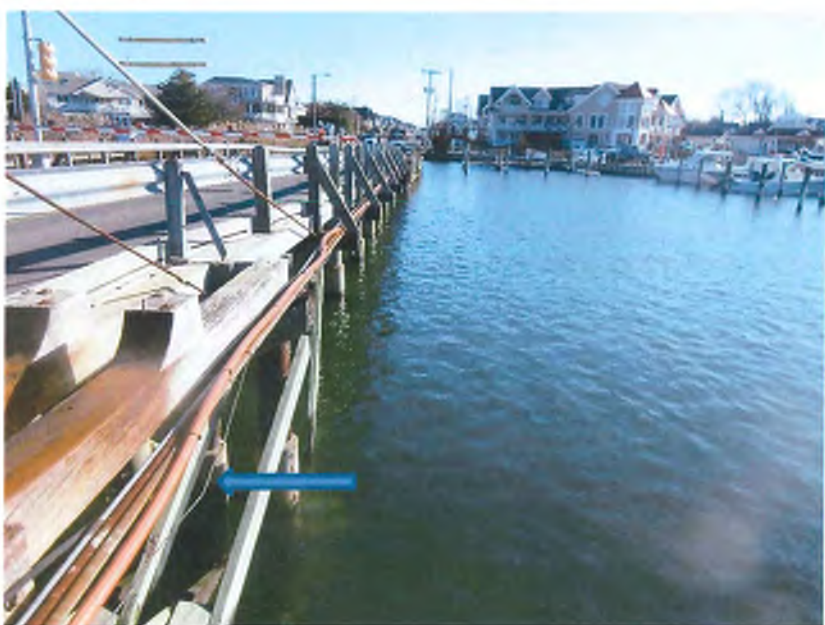
Photo No: E34

| <b>Location:</b> | Southeast Approach |
| <b>Description:</b> | The conduit has rust and is missing conduit straps. |

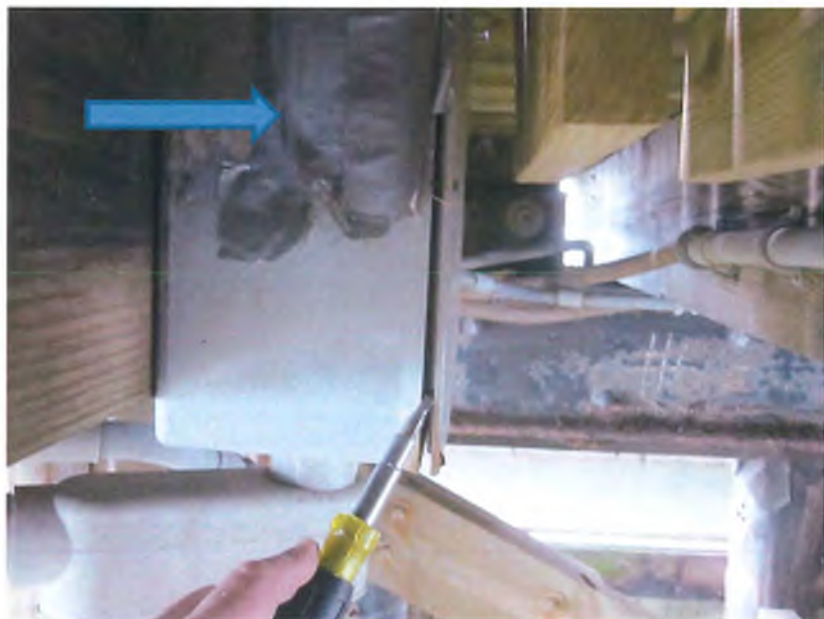
Photo No: E35

**Location:** Platform below Operator's House

**Description:** The junction box has a loose cover with missing screws and is taped off on the side.

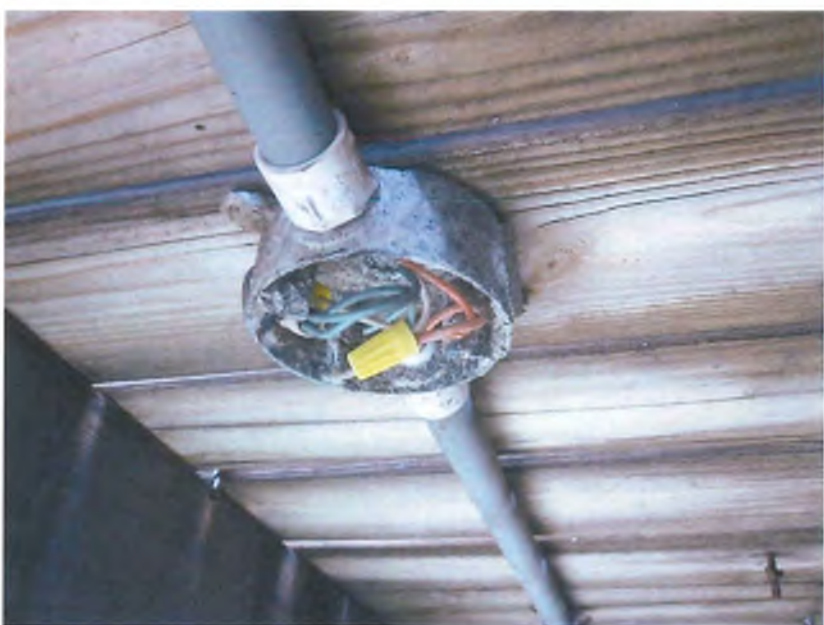
Photo No: E36

**Location:** Platform below Operator's House

**Description:** The cover is missing for the circular conduit body with wire nut splices within.

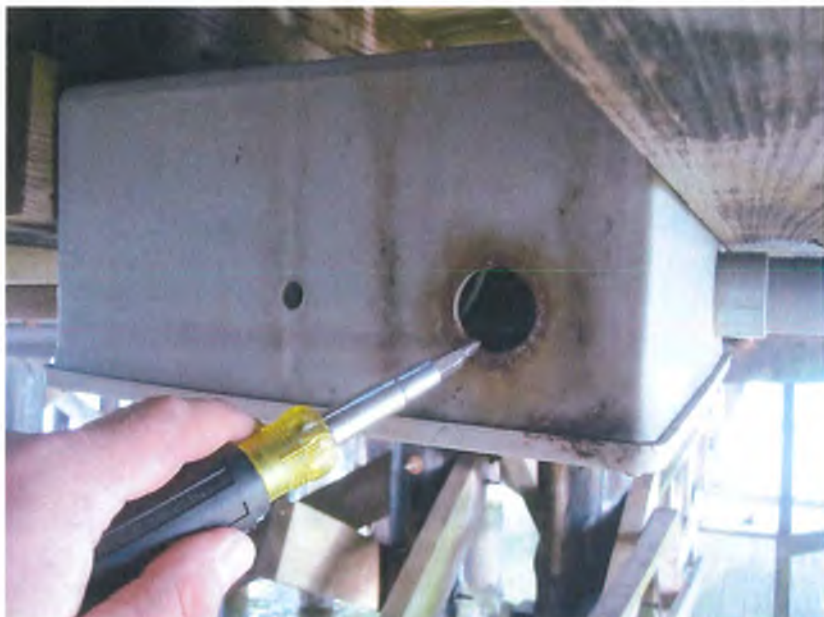
Photo No: E37

| <b>Location:</b> | Platform below Operator's House |
| <b>Description:</b> | There is an unplugged hole in the junction box. |

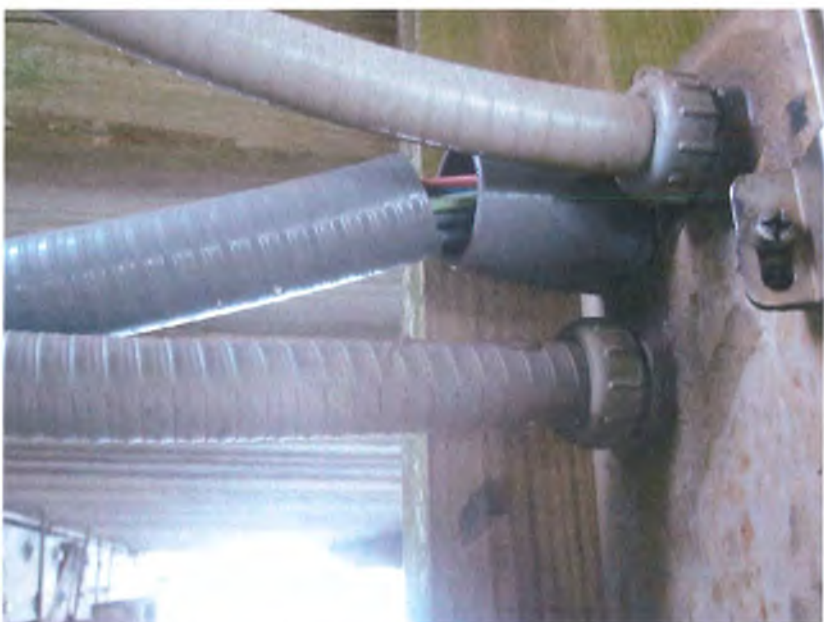
Photo No: E38

| <b>Location:</b> | Platform below Operator's House |
| <b>Description:</b> | The flexible conduit is pulled loose from its fitting. |

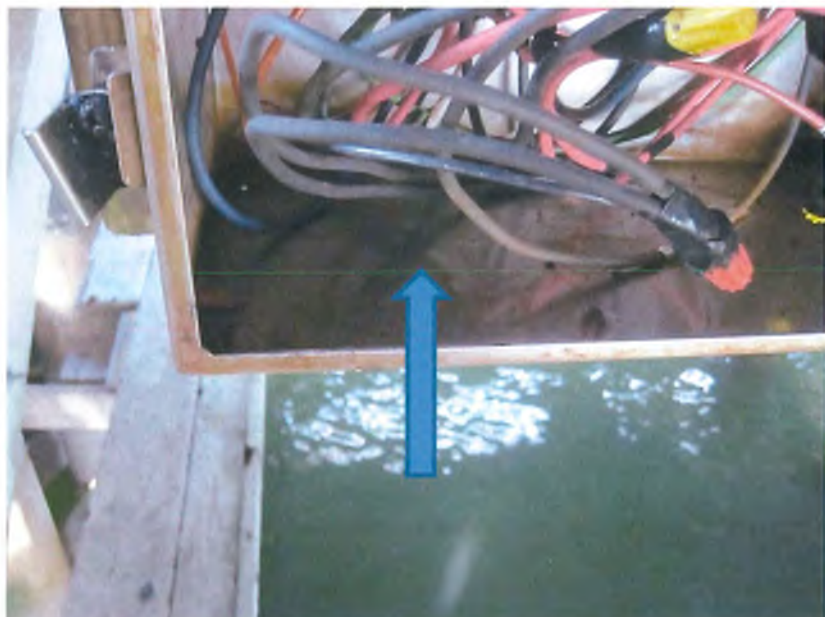
Photo No: E39

| <b>Location:</b> | Platform below Operator's House |
| <b>Description:</b> | The junction box has signs of water intrusion. |

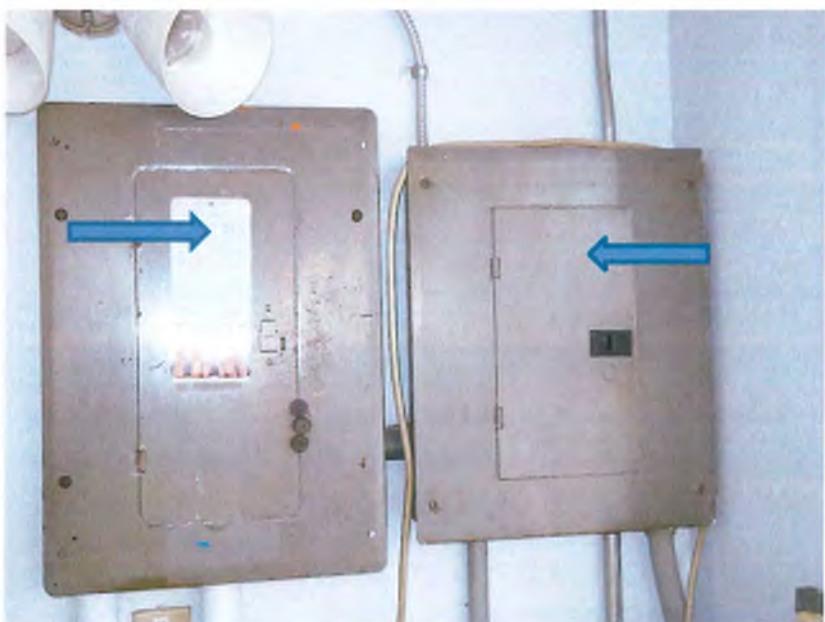
Photo No: E40

| <b>Location:</b> | Operator's House |
| <b>Description:</b> | The panelboards are not provided with panel labels. |

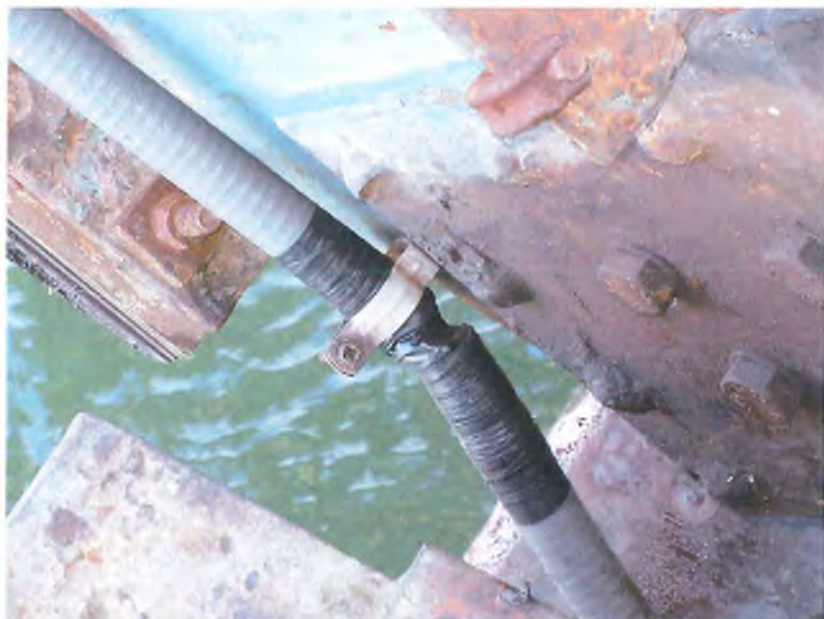
Photo No: E41

| <b>Location:</b> | Southeast Approach |
| <b>Description:</b> | The flexible conduit is damaged and secured with tape. |

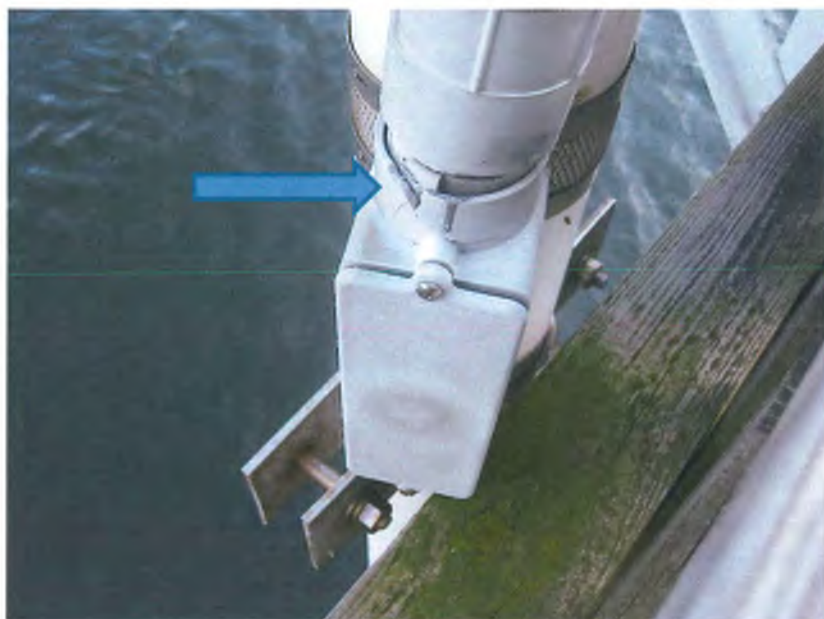
**Photo No: E43**

| <b>Location:</b> | Platform Below Operator's House |
| <b>Description:</b> | The conduit body is damaged. |

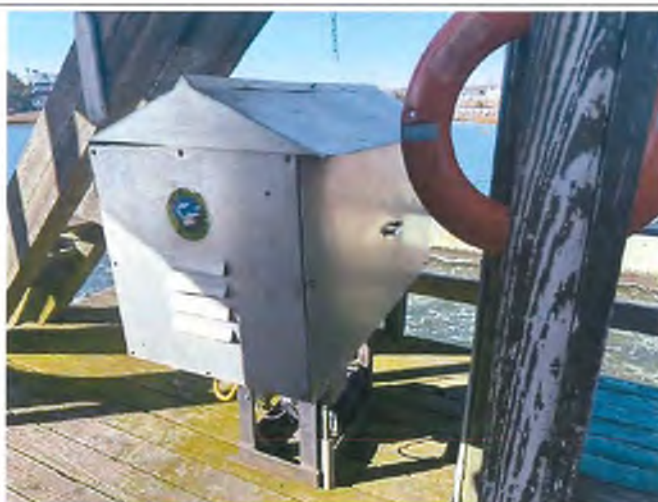
| Photo 1 | Category: | 59 - Other, 60 - Priority Repair |

| | Description: | Genset on the operators platform, looking east. Genset is inoperable. |

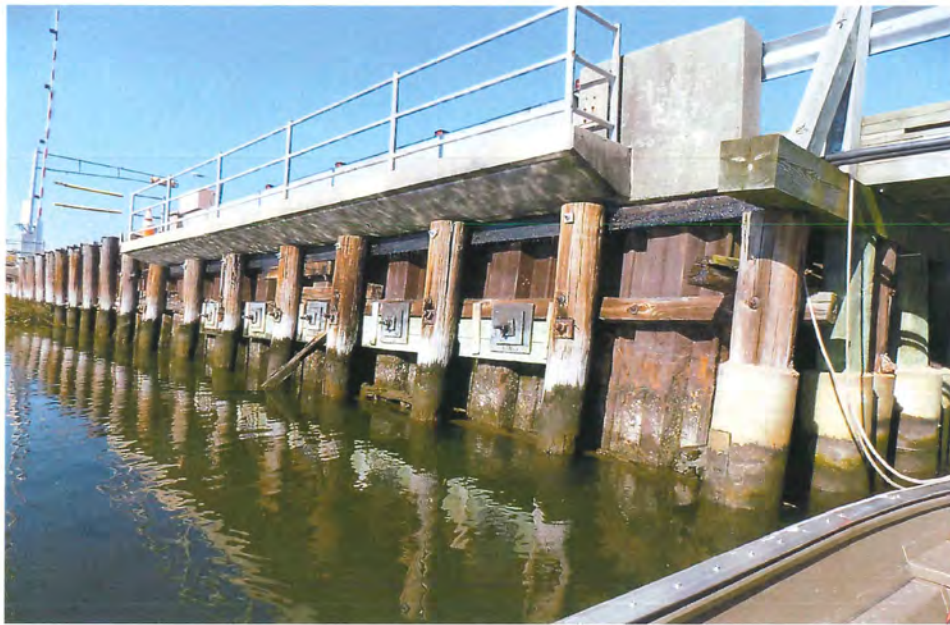
**Photo No: UW-05**

| <b>Location:</b> | West abutment and southwest wall, looking northwest. |

| <b>Description:</b> | Moderate to severe corrosion of the steel sheeting in the tidal zone. |

| RATING | COMPONENT | REMARKS |
|---|---|---|
| 5 | Sheeting<br>(Steel) | Moderate to severe corrosion through the tidal zone.<br>There are corrosion holes to the steel sheeting at both abutments with exposed fill (Photo UW-05). |
| 5 | SW Wingwall<br>Sheeting<br>(Steel) | Moderate to severe corrosion through the tidal zone with areas of 100% section loss (Photo UW-05). |
| 5 | SW Wingwall<br>Piles | Piles exhibit moderate deterioration through the tidal zone.<br>Piles exhibit checks and splits up to 1" wide typical (Photo UW-05) |

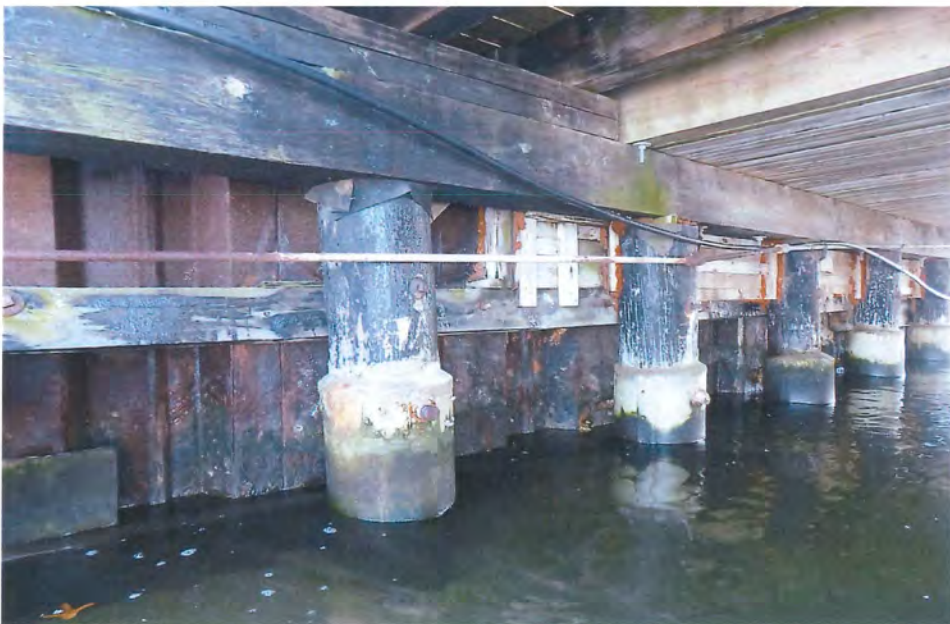
**Photo No: UW-06**

| <b>Location:</b> | East abutment, looking northeast. |

| <b>Description:</b> | Moderate to severe corrosion of the steel sheeting in the tidal zone. Note: Piles exhibit checks above structural jackets (typical). |

| RATING | COMPONENT | REMARKS |
|---|---|---|
| 5 | Sheeting<br>(Steel) | Moderate to severe corrosion through the tidal zone.<br>There are corrosion holes to the steel sheeting at both abutments with exposed fill (Photo UW-06). |
| 5 | Wales<br>(3 – Timber) | Top: ¼" penetration<br>Middle: ½" penetration, up to 30% section loss.<br>Bottom: Advanced decay with up to 40% section loss (Photo UW-06). |

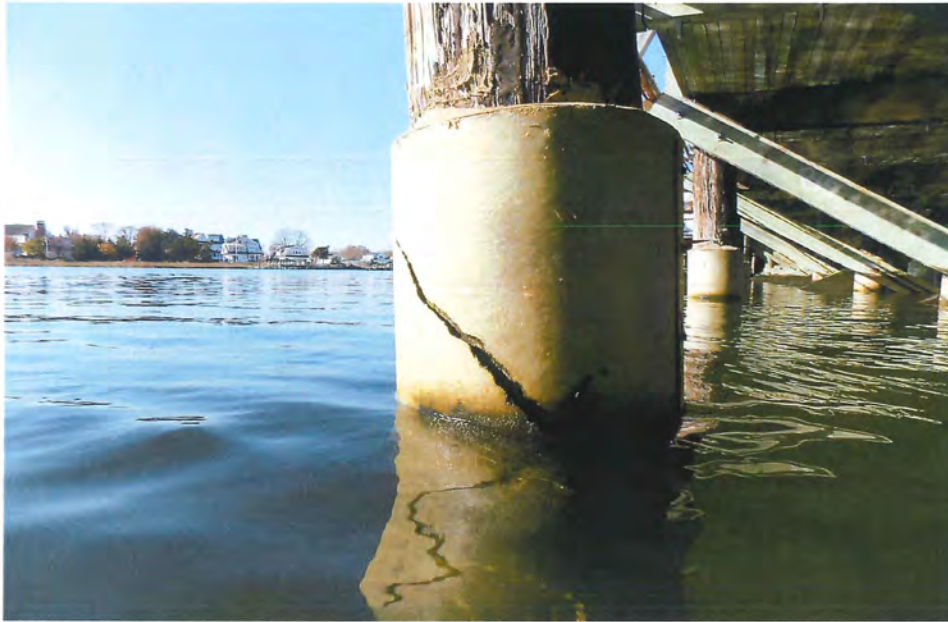
Photo No: UW-09

| <b>Location:</b> | Pier 15, pile 1, looking west. |

| <b>Description:</b> | Typical cracked fiberglass jacket. |

| RATING | COMPONENT | REMARKS |
|---|---|---|
| 6 | Piles<br>(13 Timber, 12" Ø, No. South to North) | All piles jacketed into channel bottom with structural jackets. Piles exhibit checks above structural jackets (Photo UW-06 Typical).<br>Pile 11: Fiberglass jacket is cracked (Photo UW-09 typical). |

| RATING | COMPONENT | REMARKS |
|---|---|---|
| 5 | Posts/Piles<br>(6 Timber, 12" Ø,<br>No. South to<br>north) | All piles jacketed into channel bottom with structural jackets.<br>Pile 1: Fiberglass jacket is cracked ( <a href="#">Photo UW-09 typical</a> ). |
